AGENDA

STATE BUILDING CODE TECHNICAL REVIEW BOARD

Friday, September 20, 2013 – 10:00 a.m.

In Re: Appeal of Keith Kurtz
Appeal No. 13-2

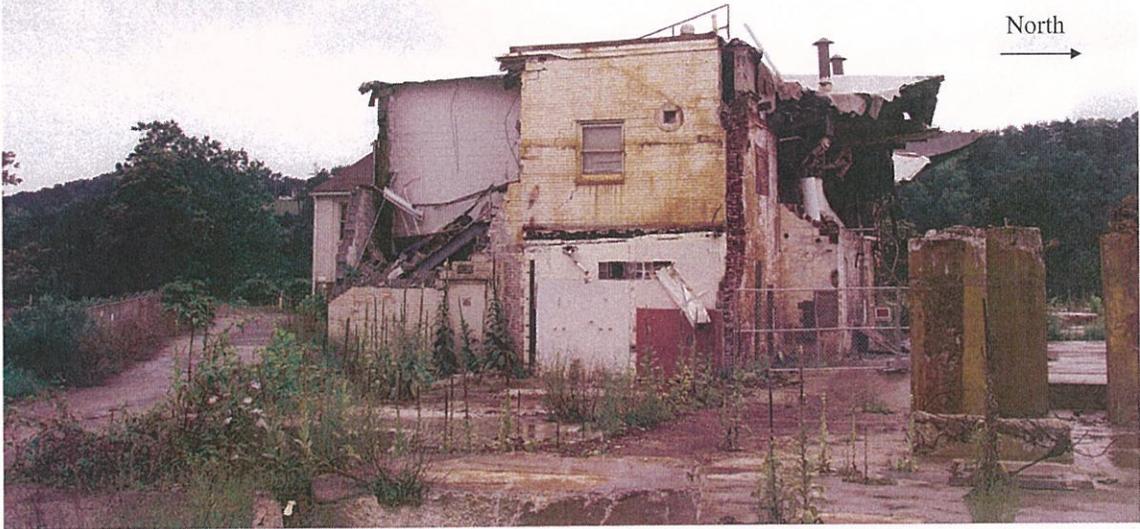
(BUILDING 1)

Structure is unsafe and unsecured. Roof and walls collapsing, structure not protected from the elements

REQUIRED REPAIR IMPROVEMENT OR ABATEMENT: Bring structure up to USBC Code Or Remove from site.

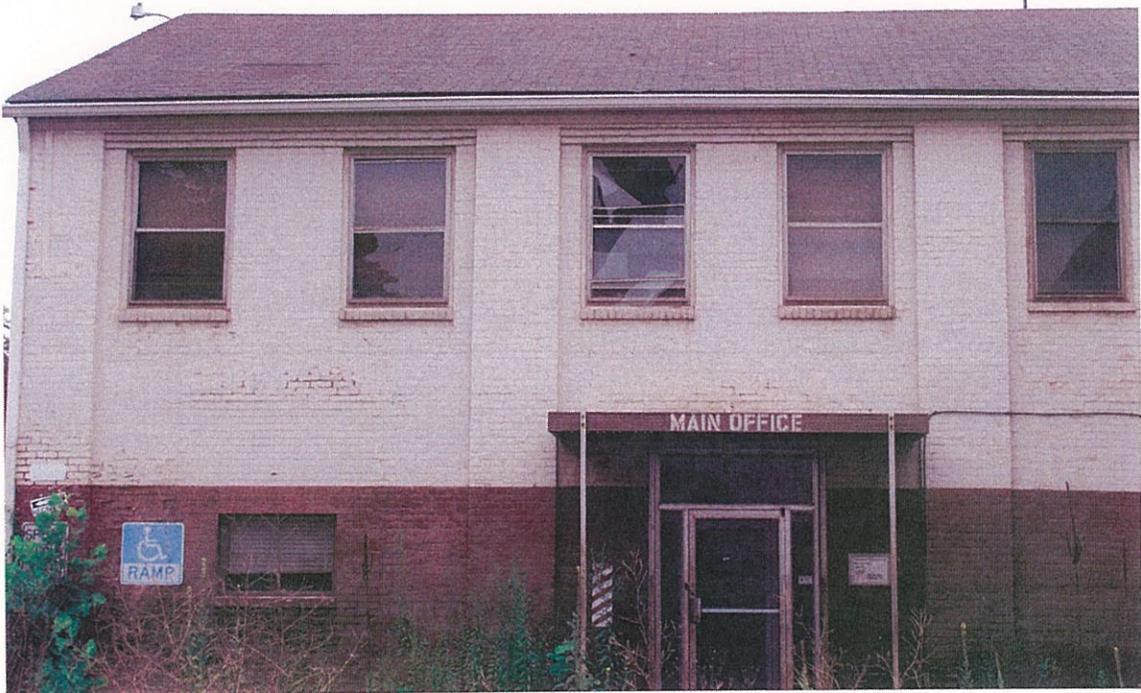
(BUILDING 1)

Structure open to elements and not weather tight

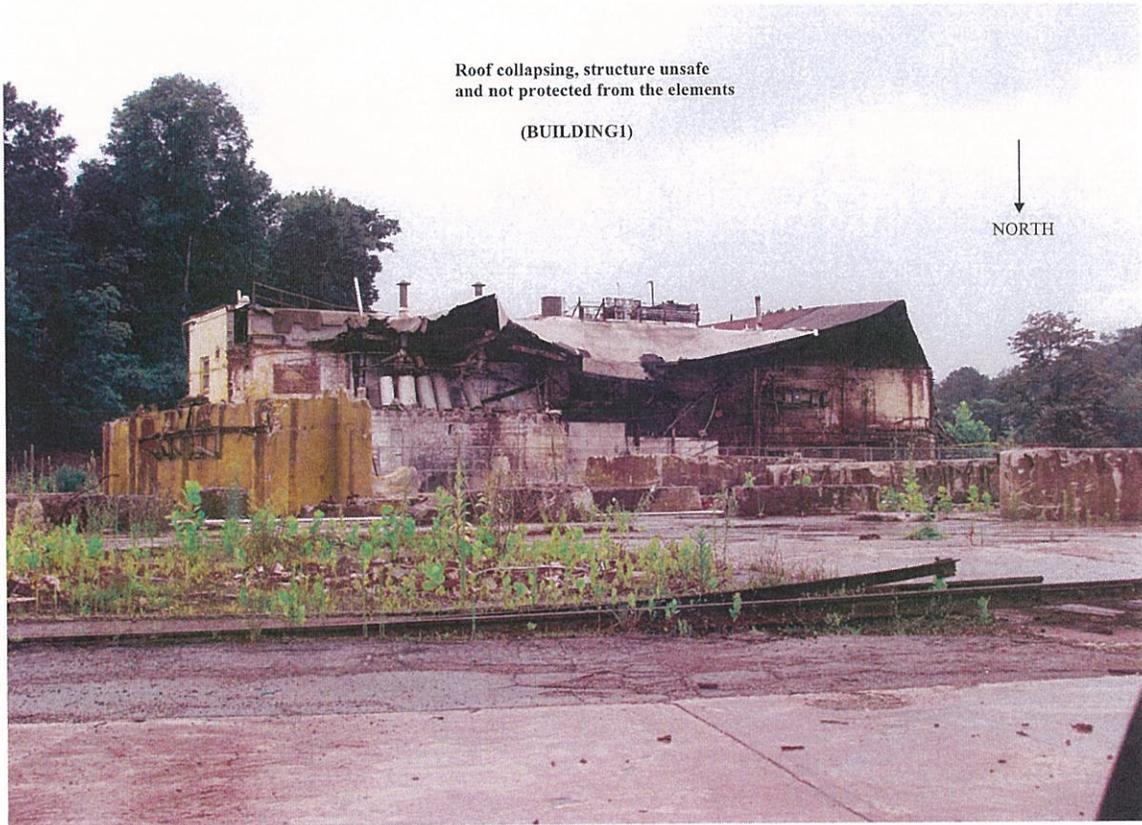
(BUILDING 2)

Structure, roof and widows
not in good repair, not
weather tight.

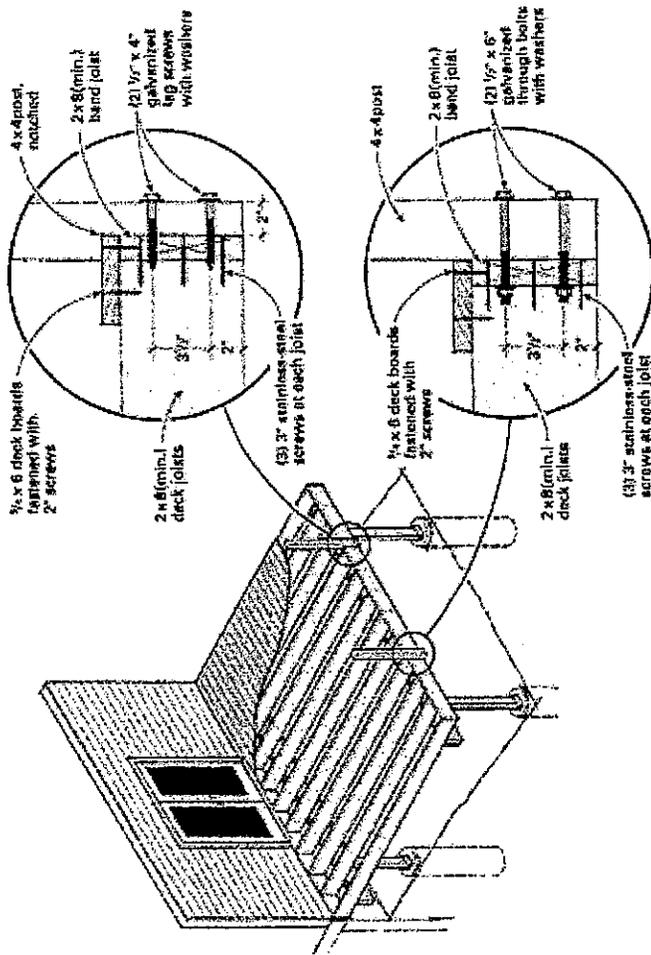
Tested Post Connections That Failed

Cracks will typically develop from the corner of a notch (left). As a crack develops, a steep "slope of grain" can critically reduce the section of the post, as the drawing (right) shows.

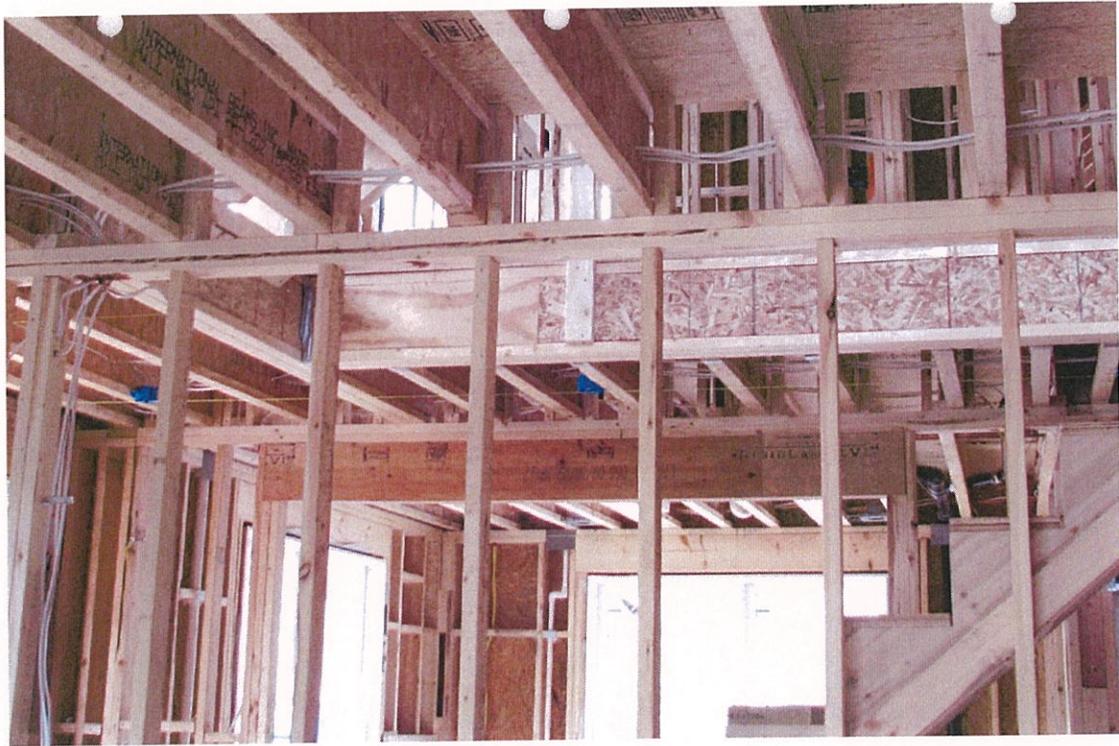
Dining Room Entrance Support
Image 1406

The photo taken before the drywall was installed shows some of the detail on the load being supported (Image 1406), with the floor joists resting on the beam above the opening.

We believe that it is reasonable to ask that the County cite the entire discontinuous load path and plan deviation and not just one side, or just one of the two levels, as that is the remedy required to correct the contravention of R601.2.

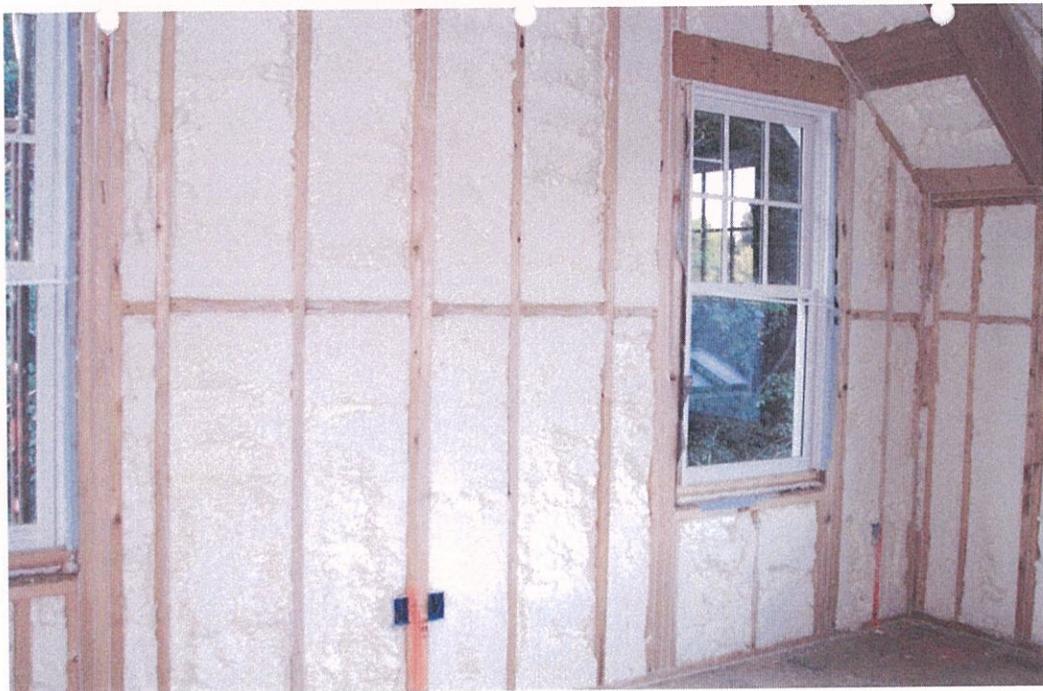
Master BR rear wall after insulation
About 2 weeks after framing inspection
Image 1612

The builder has provided no evidence that the deviation from a properly constructed triple 2x6 post, as specified in the approved drawings, is acceptable for this location.

The County has been told of the problem and has not cited it as a violation of VUSBC R601.2.

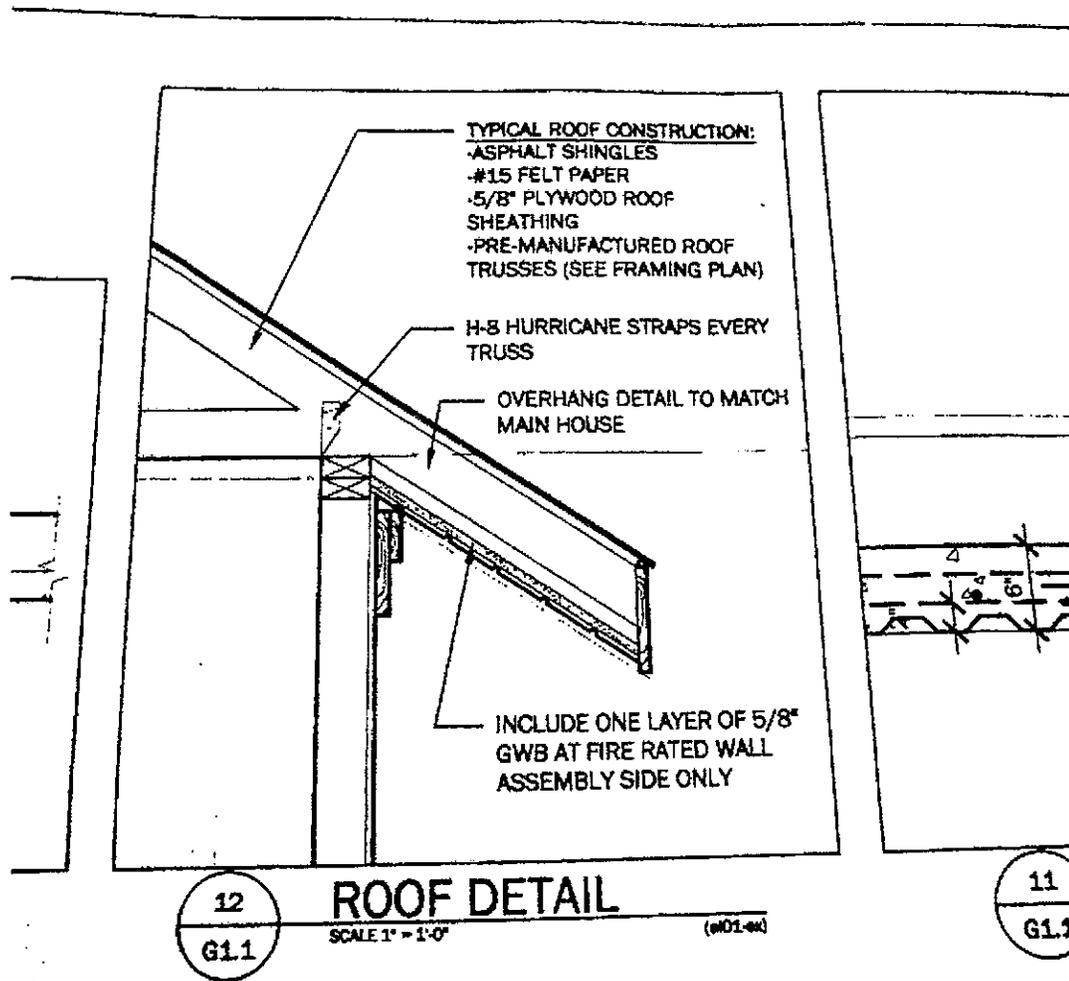
Simpson H8
Hurricane Tie

Photos that follow include the requirement from the approved drawings, the required ties, and photos of the two sides of one of the rafters. There are no hurricane ties on any of the rafters.

The County building department was shown that the ties were missing, issued no violation, and provided no explanation.

Photo shows left and right side of rafter without the ties.
All rafters in the Garage lacked these ties.

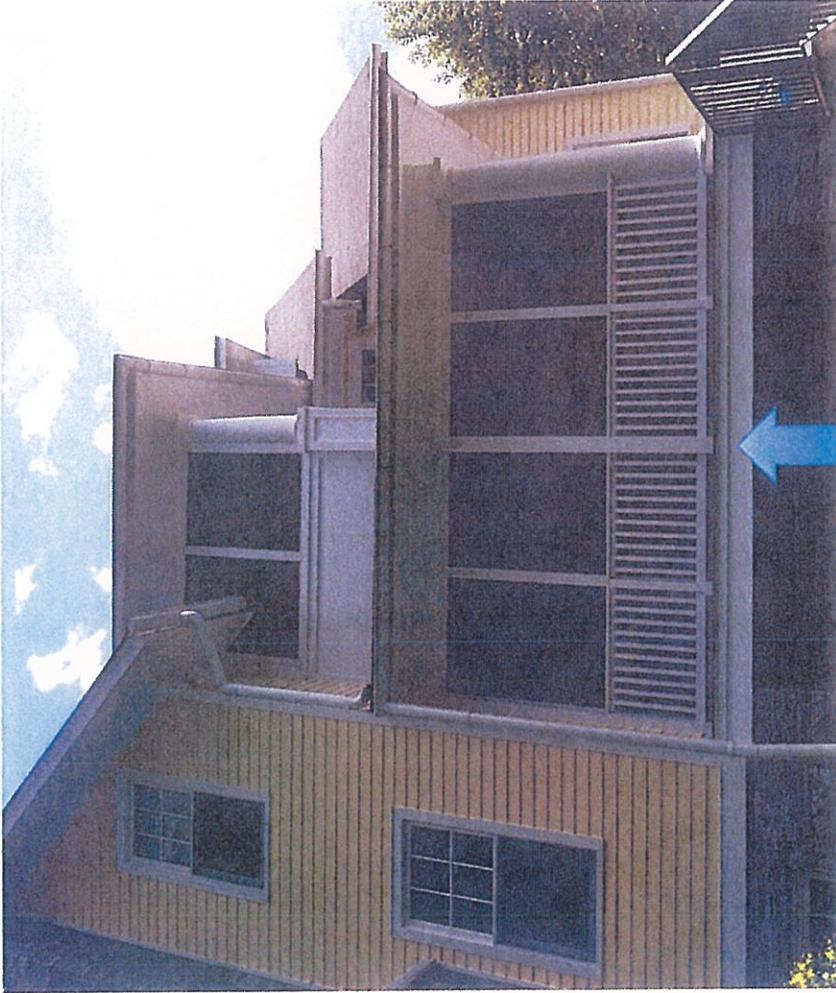
Post supporting 4577 lbs.

The only attachment of this notched 4x4 carrying over 4500 lbs. load appears to be two lag screws installed at angles on left side of the post.

We believe the combination of the questionable use of a notched 4x4 and inadequate attachment results in a structural element that could fail to carry the identified load over time.

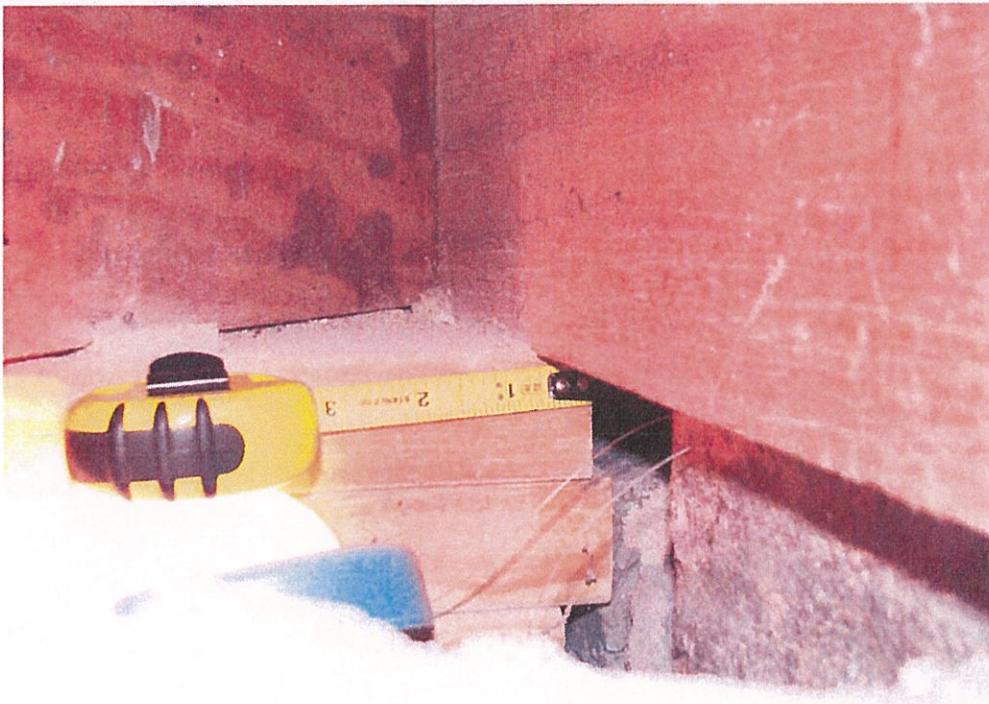
Bearing issue: LVL beam slightly bearing on the wood

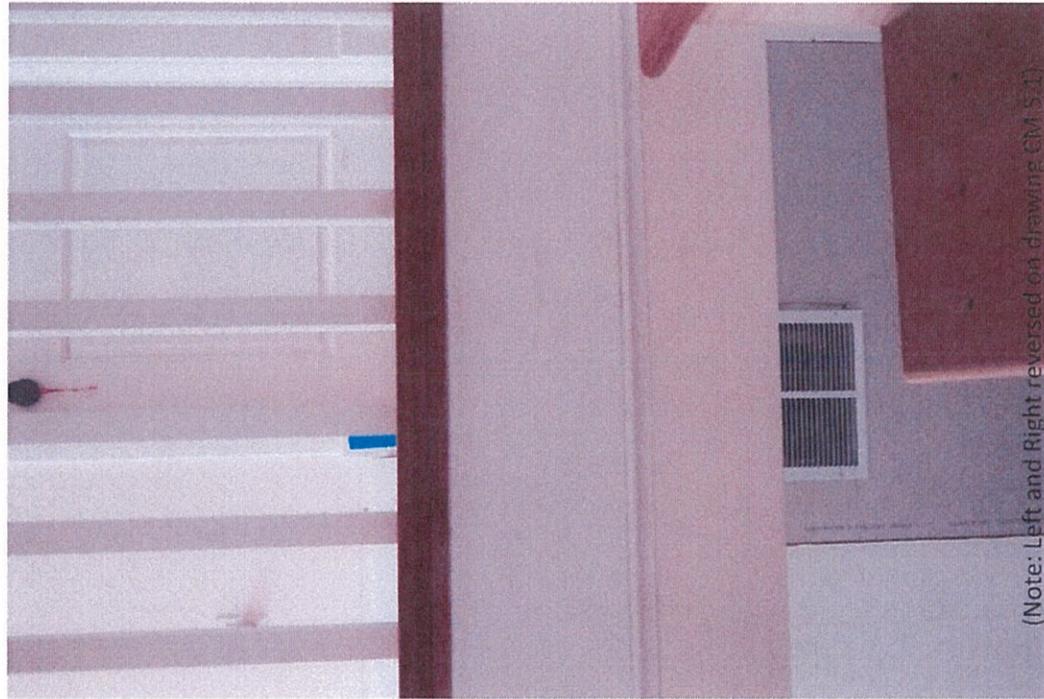
(Note: Left and Right reversed on drawing GM S.1)

It only takes a few seconds to see that this drawing is not accurate. Standing on the stairs and tracing the line of the door frame down from the second floor to the first, a large vent is clearly in the way. It was clear from photos, from visible evidence and from the use of a stud finder that this drawing was wrong. No attempt was made to contact us to verify the accuracy of the drawing.

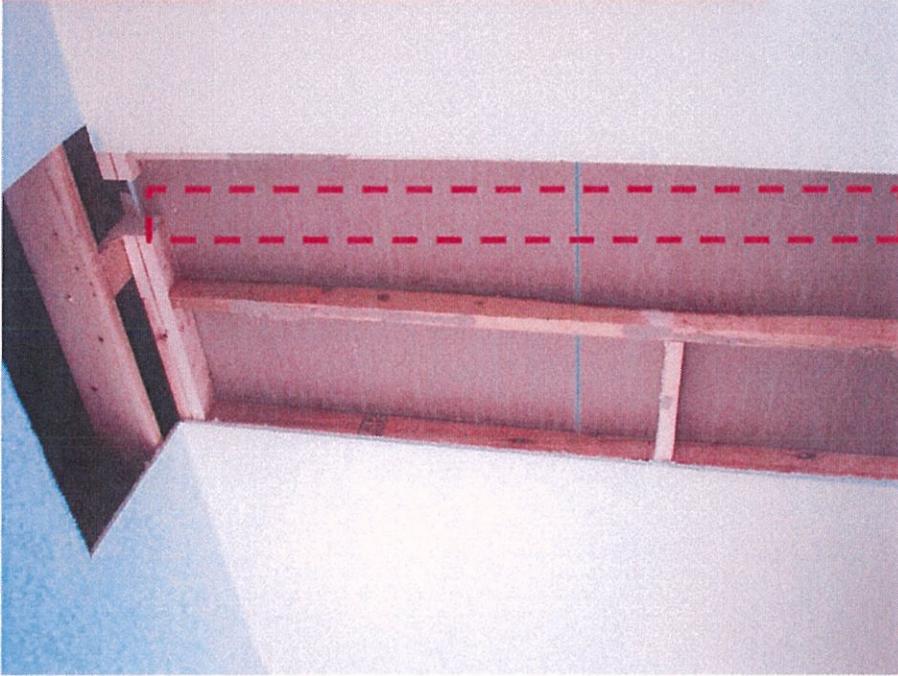
Missing 4x6 Post from MBR floor to Ridge Beam

(Fixed May 2012)

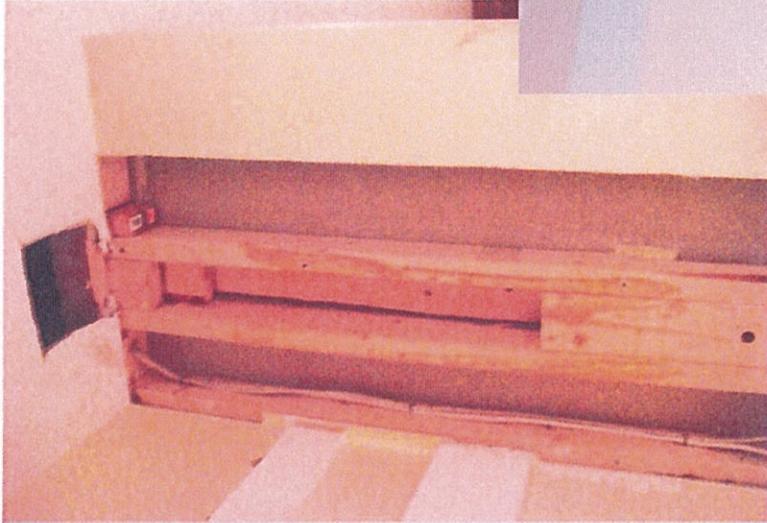
Missing 3" Steel Pipe
Post rate at 16000 lbs.
