AGENDA

STATE BUILDING CODE TECHNICAL REVIEW BOARD

Friday, May 21, 2021 - 10:00am (Virtual Meeting)

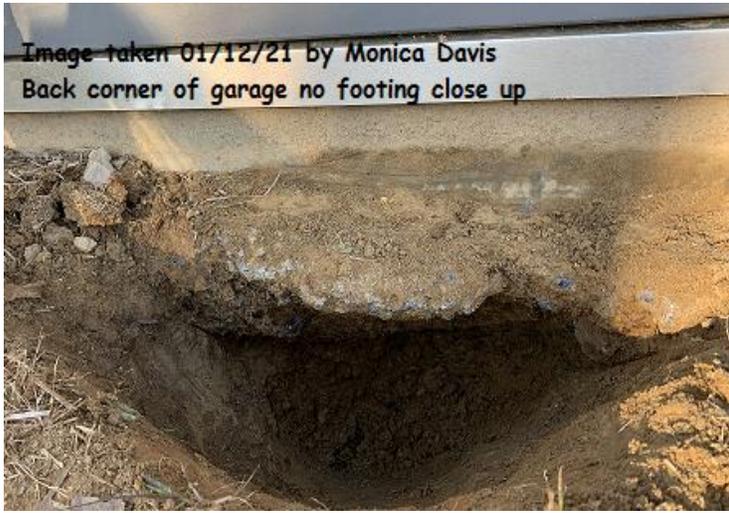
Image taken 01/12/21 by Monica Davis
Back corner of garage no footing close up

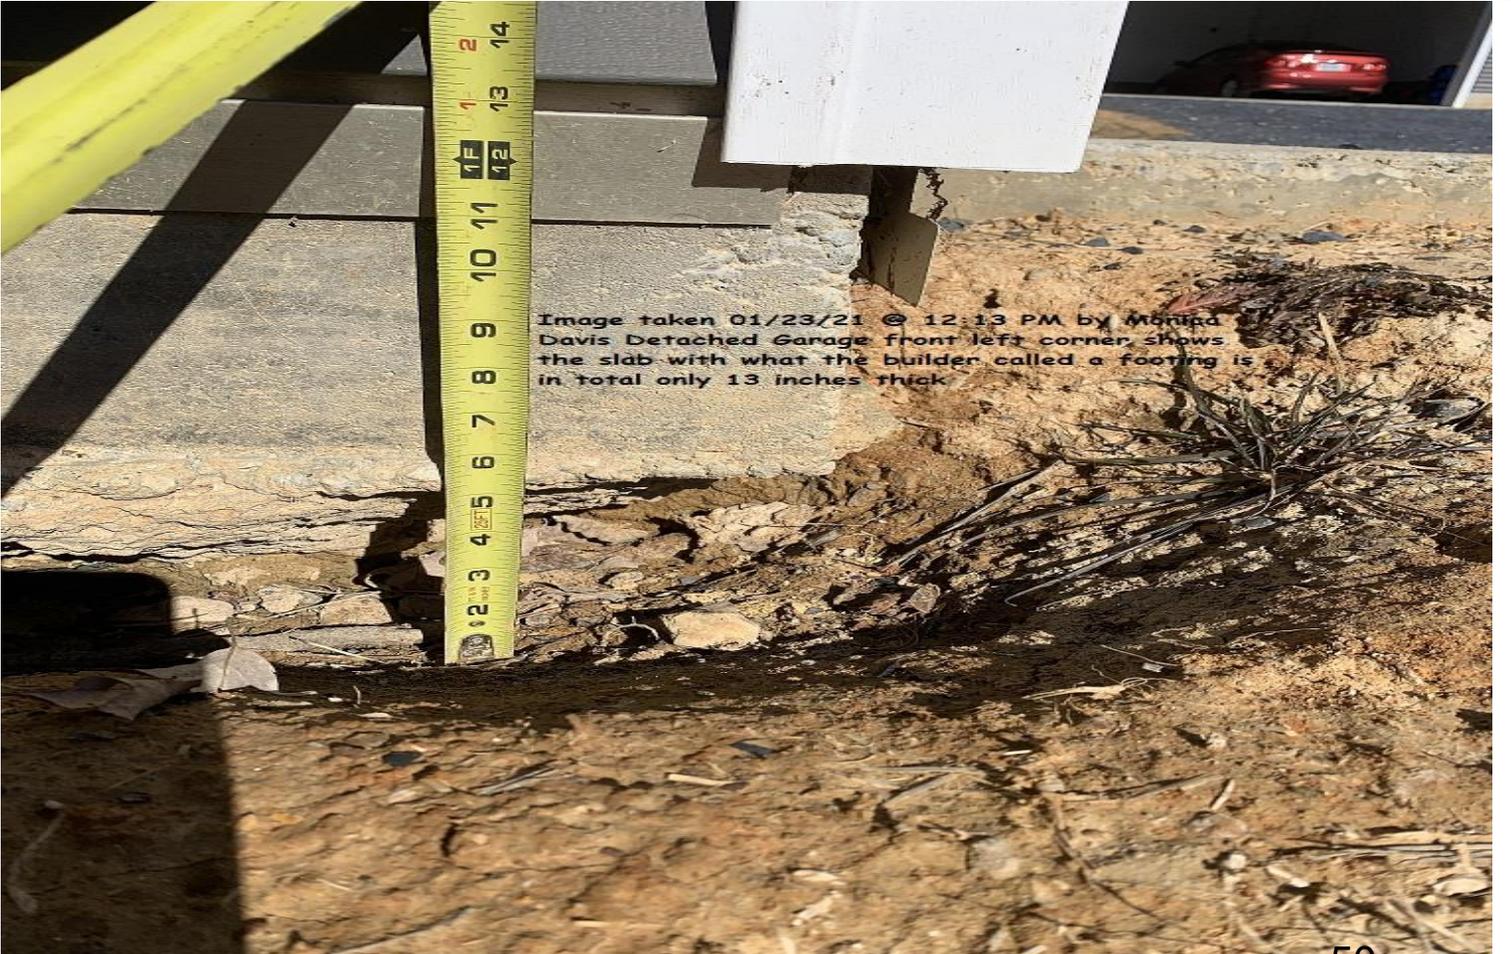
Image taken 01/23/21 @ 12:13 PM by Monica Davis Detached Garage front left corner shows the slab with what the builder called a footing is in total only 13 inches thick

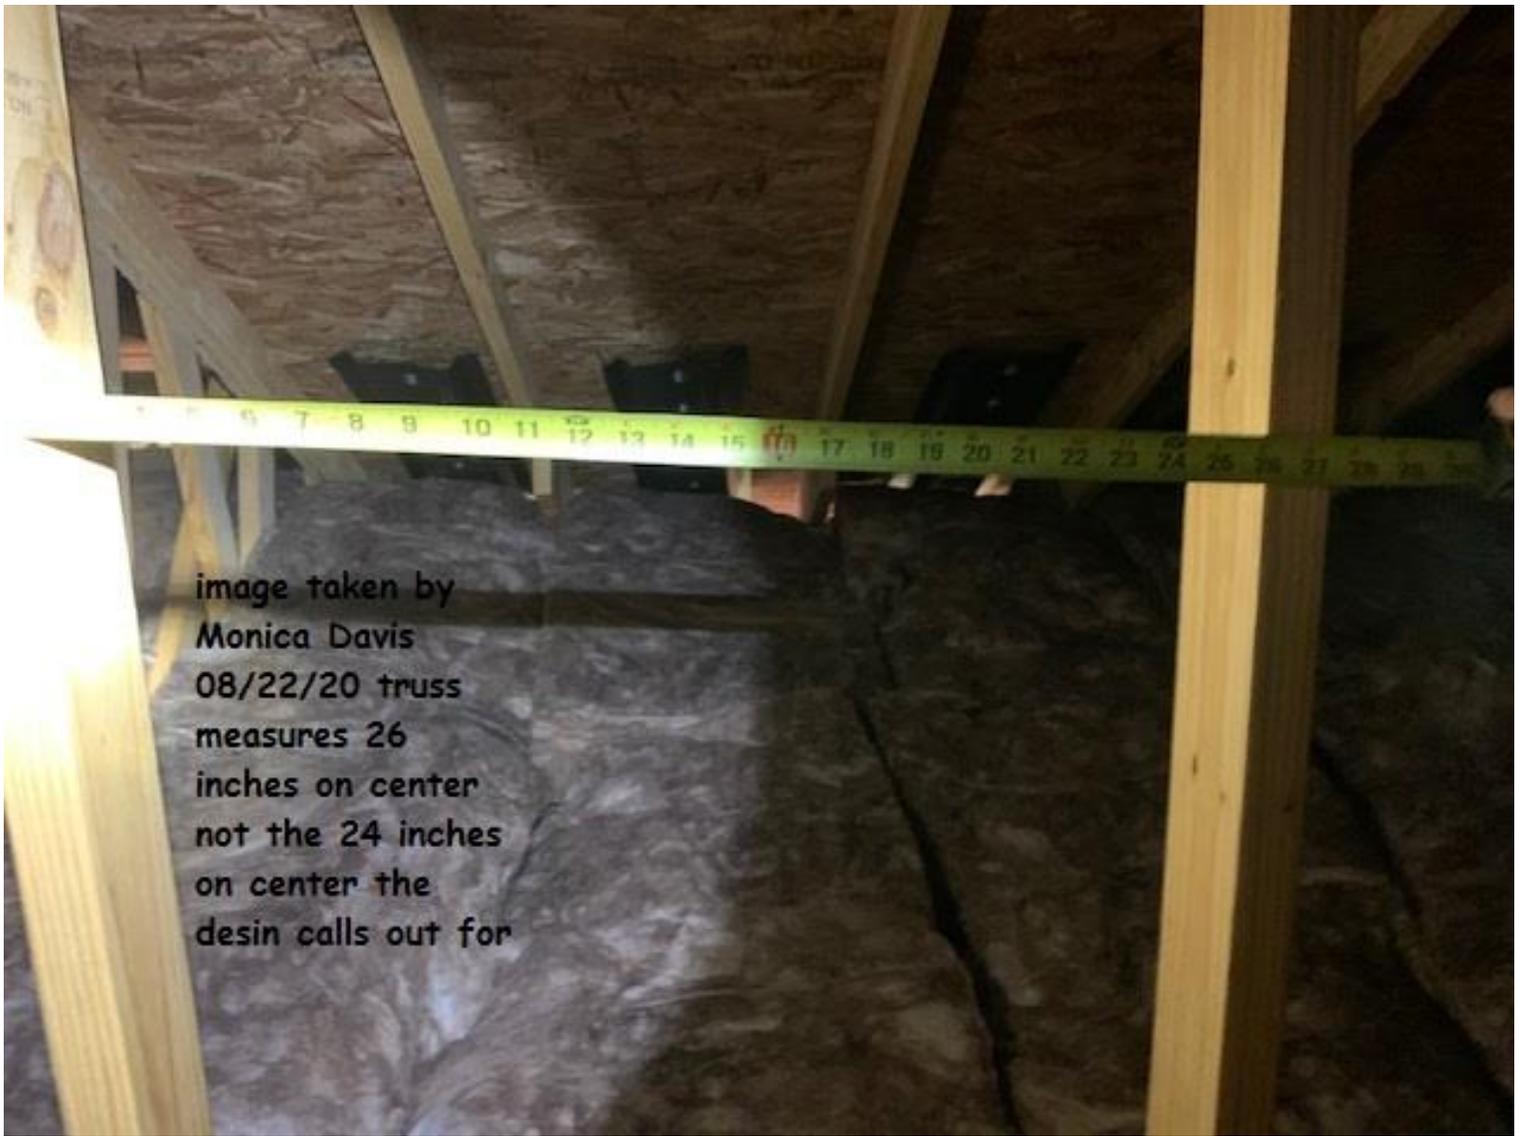
image taken by
Monica Davis
08/22/20 truss
measures 26
inches on center
not the 24 inches
on center the
desin calls out for

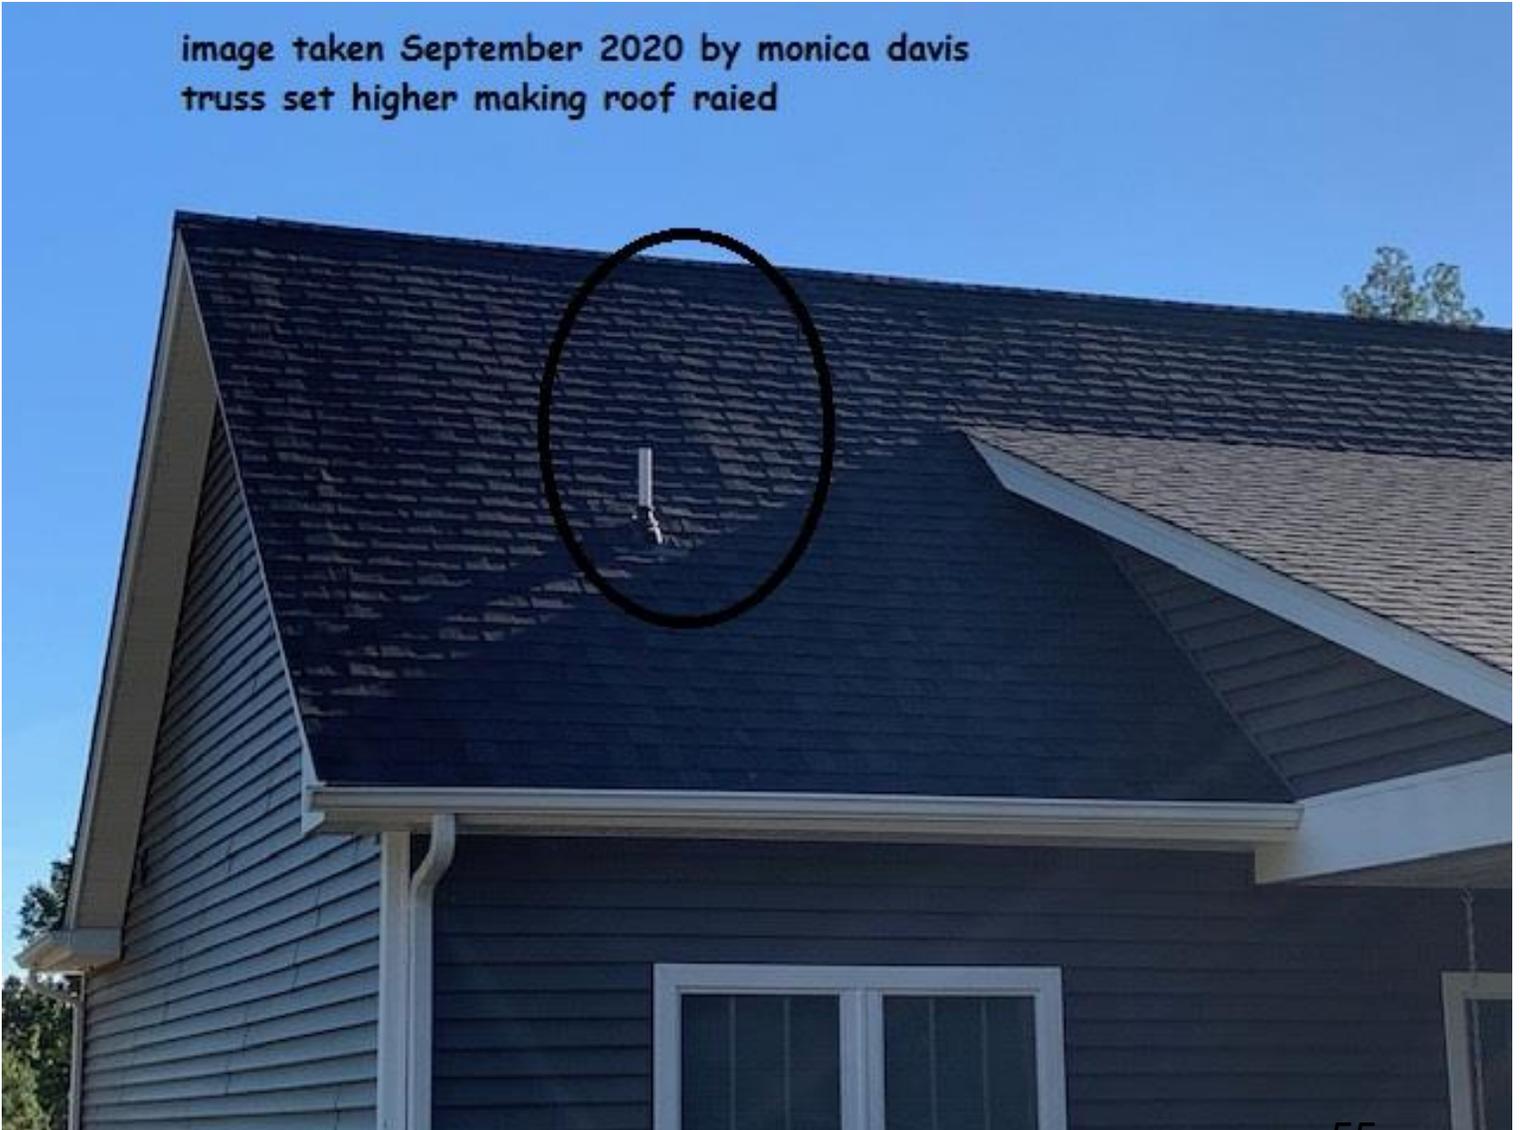
image taken September 2020 by monica davis
truss set higher making roof raied

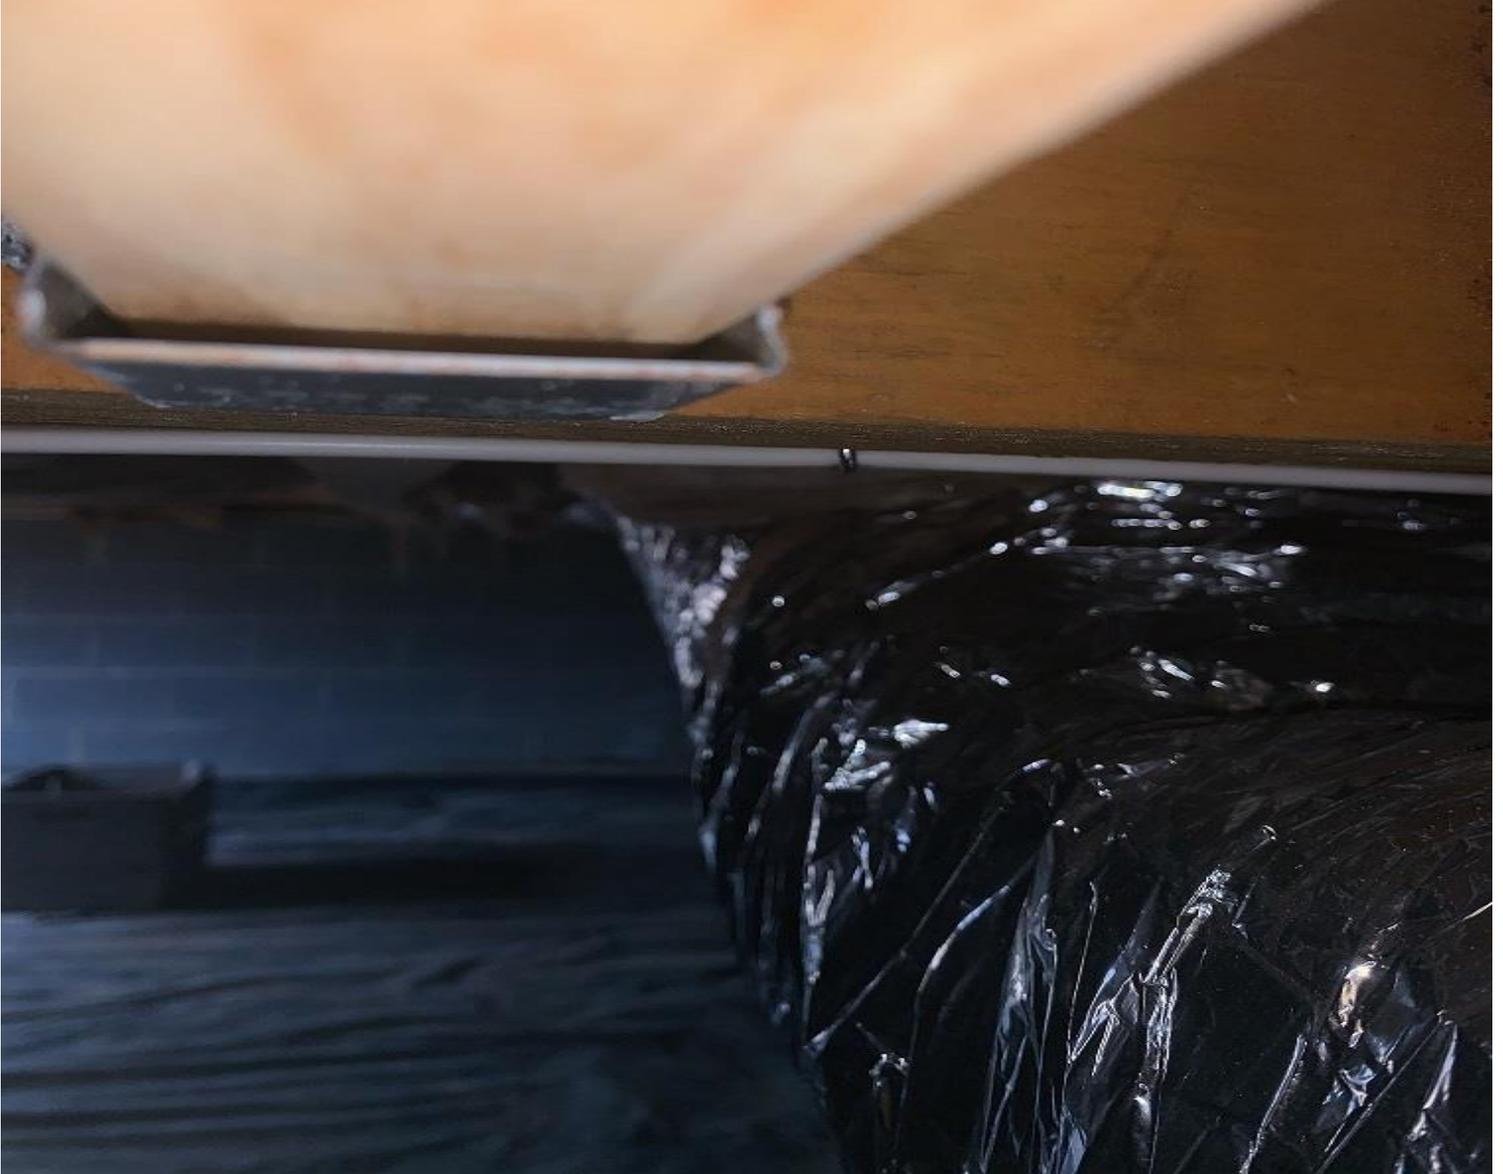
Image taken 01/18/21 by Monica Davis Image shows double shear nails do not even penetrate the header board

We request the floor joist hangers be reviewed and both the twice the size of the up to allowable gap and improper hardware be required to be repaired to Simpson's literature.

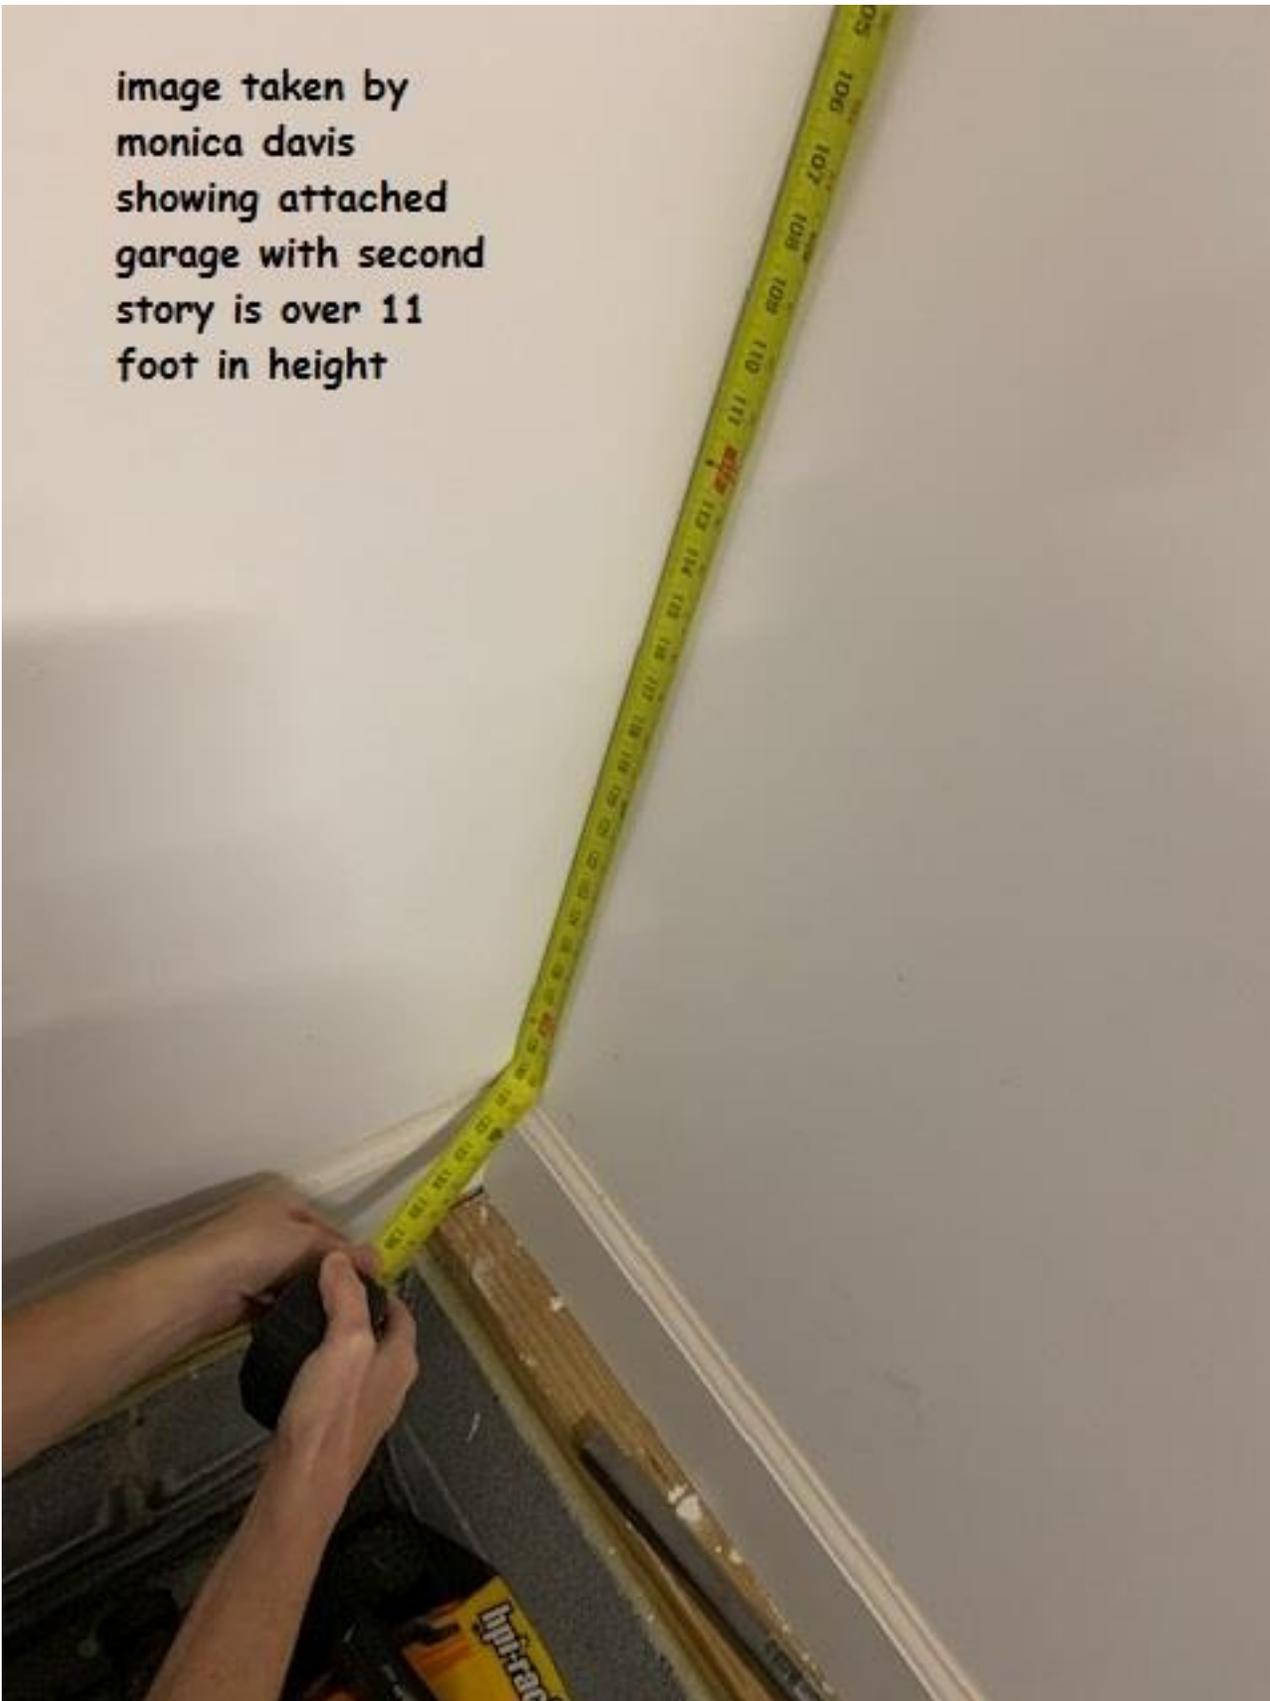
image taken by
monica davis
showing attached
garage with second
story is over 11
foot in height

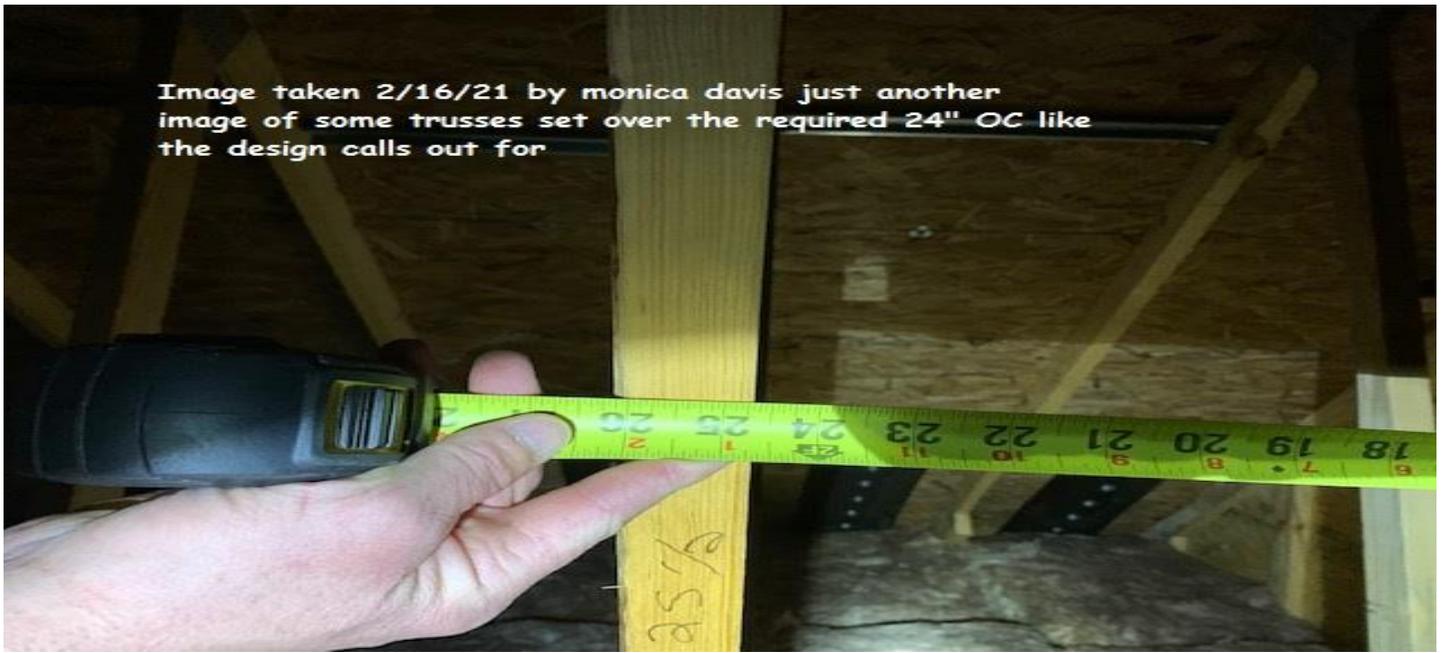
Item 6: Roof Truss System. Provided are additional images showing that the truss system was set more than the 24" OC that the truss design calls out for.

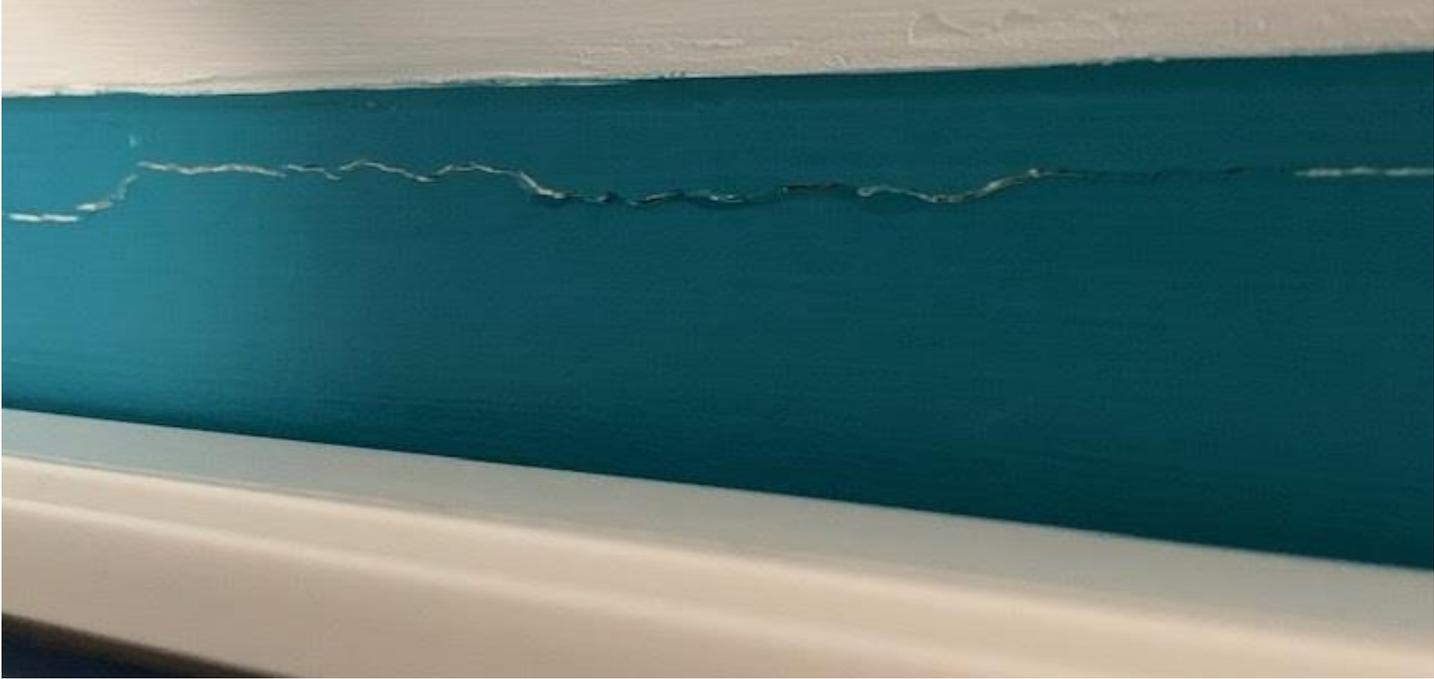
Image taken by Monica Davis January 2021 taken where ceiling meets wall. Shows ceiling and walls are seprating due to floor joist improper install in hanger allowing floor to drop

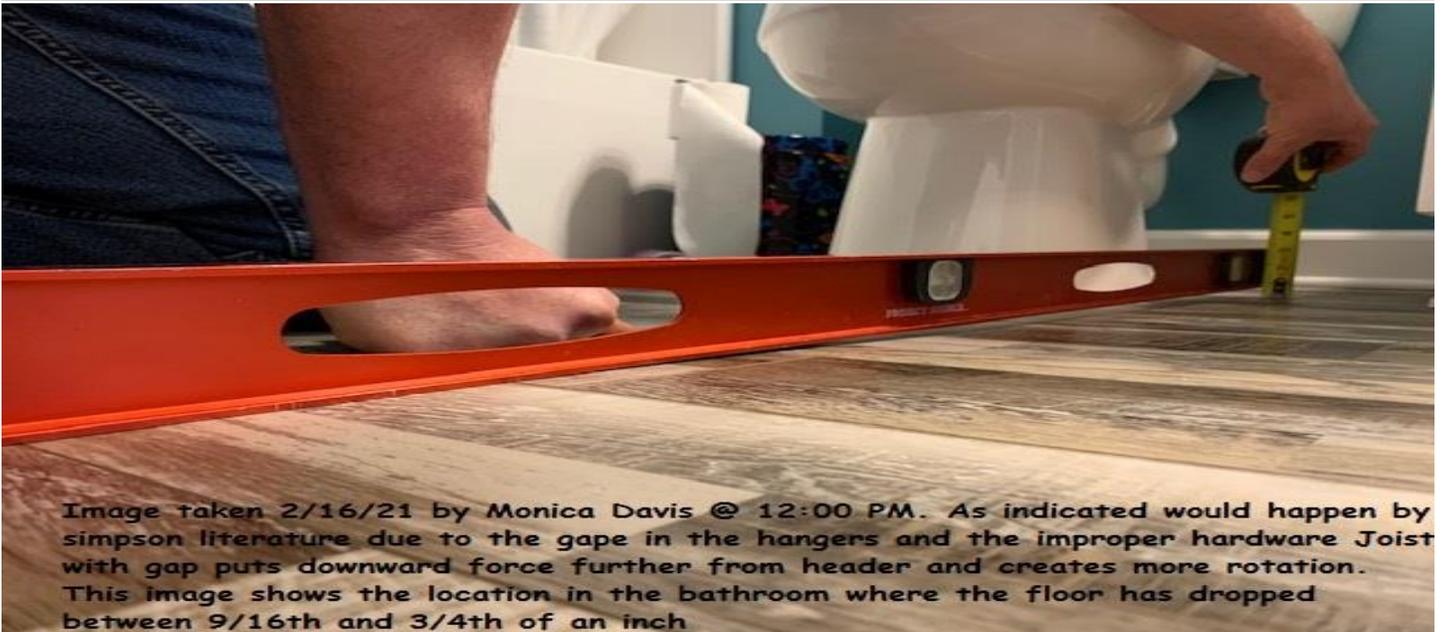
Image taken 2/16/21 by Monica Davis @ 12:00 PM. As indicated would happen by simpson literature due to the gape in the hangers and the improper hardware Joist with gap puts downward force further from header and creates more rotation. This image shows the location in the bathroom where the floor has dropped between 9/16th and 3/4th of an inch

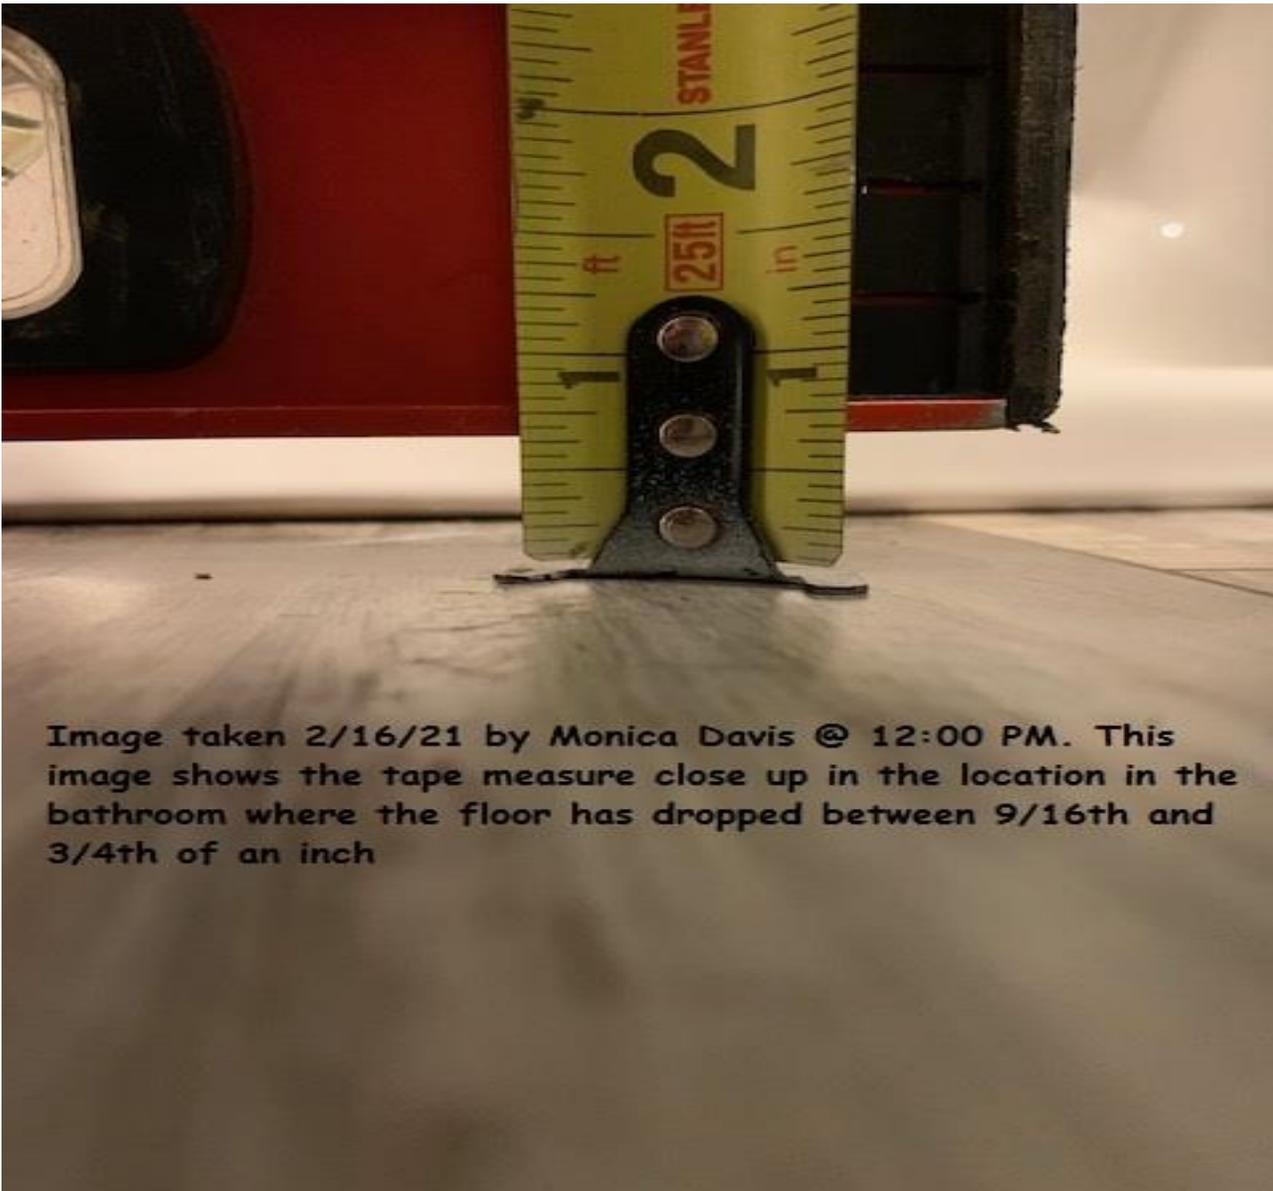
Image taken 2/16/21 by Monica Davis @ 12:00 PM. This image shows the tape measure close up in the location in the bathroom where the floor has dropped between $\frac{9}{16}$ th and $\frac{3}{4}$ th of an inch

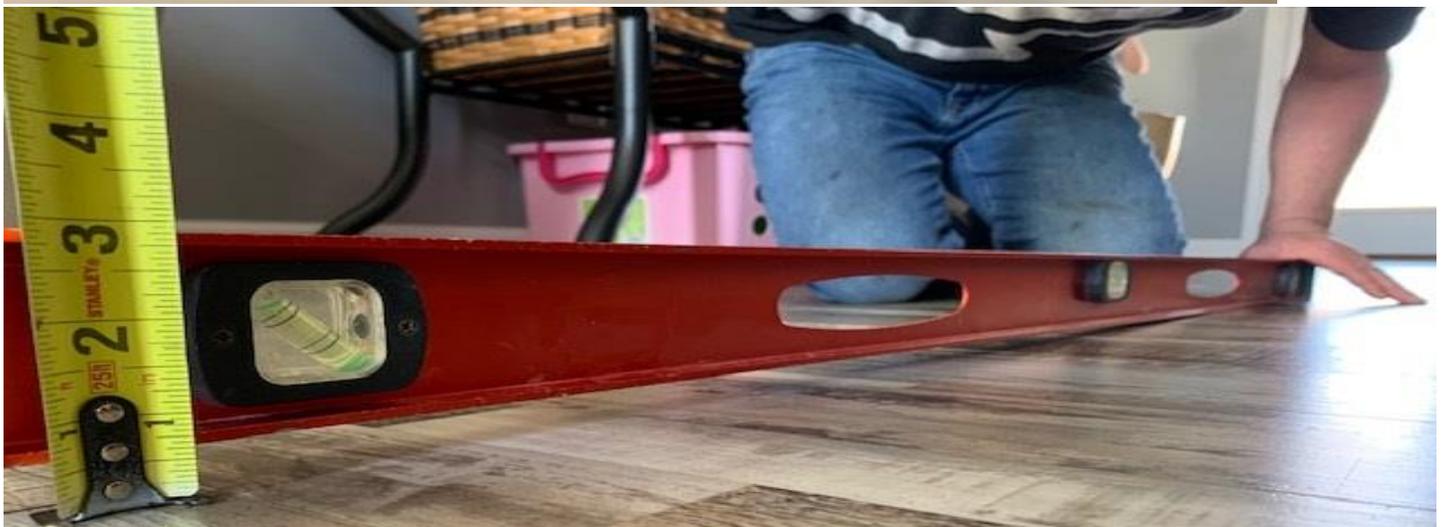
Image taken 2/16/21 by Monica Davis @ 11:56 AM. As indicated would happen by simpson literature due to the gape in the hangers and the improper hardware Joist with gap puts downward force further from header and creates more rotation. This image shows the location in the living room where the floor has dropped 5/8th of an inch

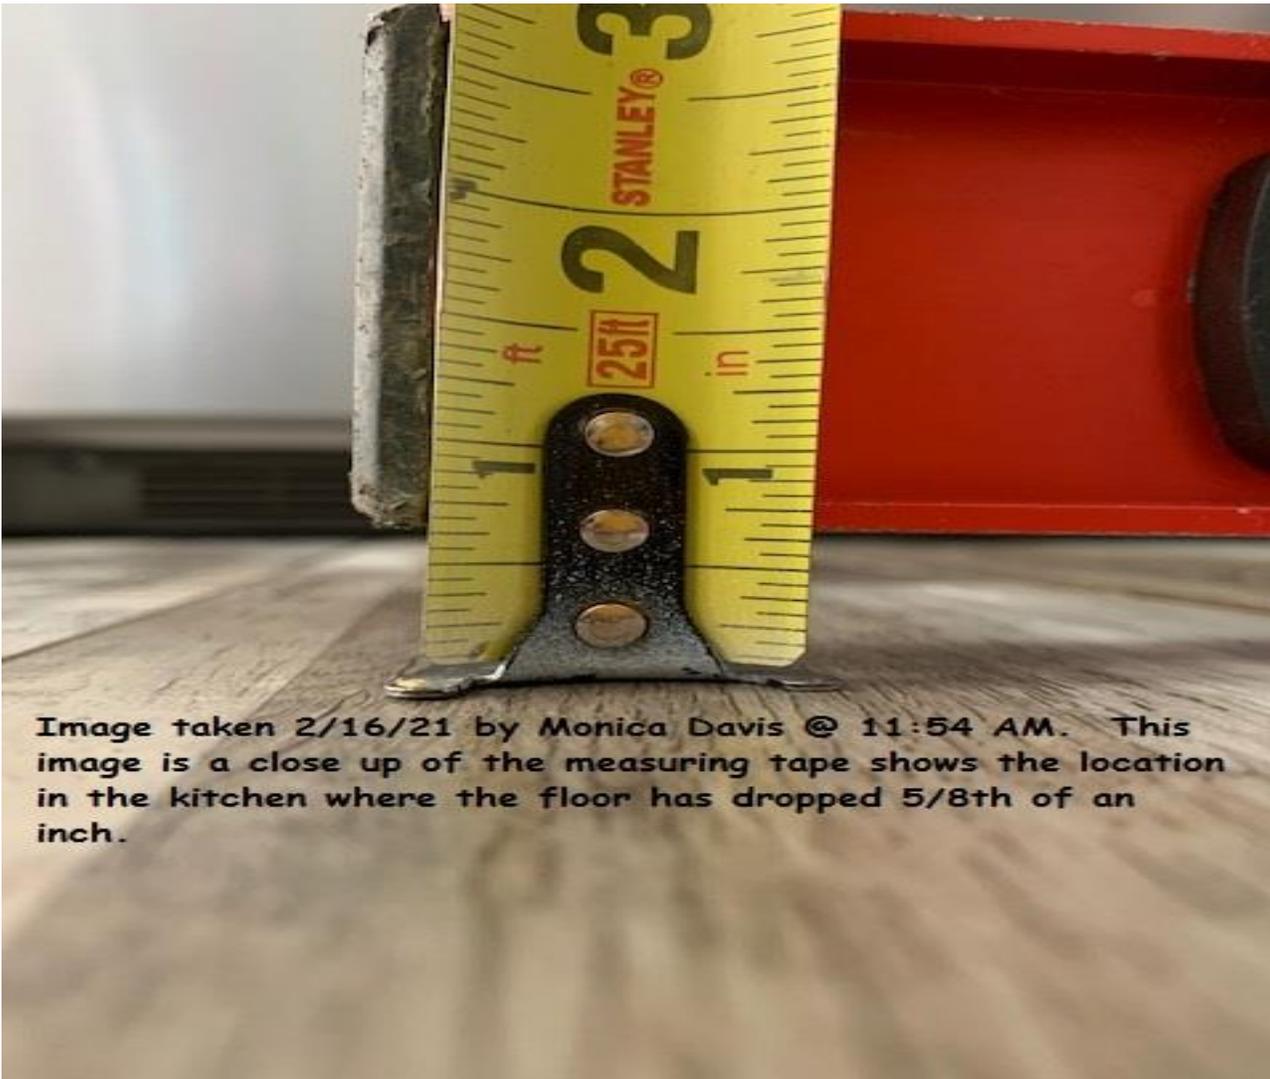
Image taken 2/16/21 by Monica Davis @ 11:54 AM. This image is a close up of the measuring tape shows the location in the kitchen where the floor has dropped $\frac{5}{8}$ th of an inch.

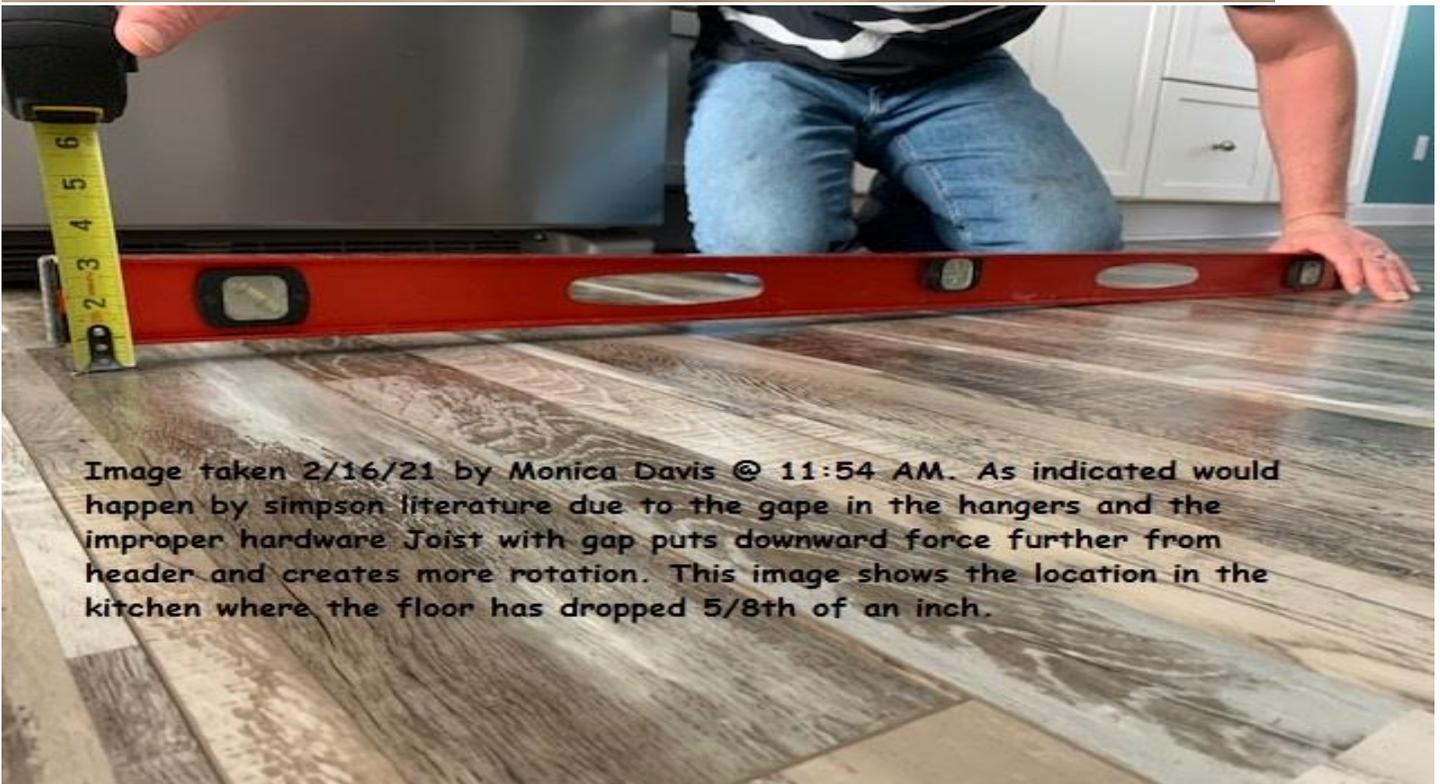
Image taken 2/16/21 by Monica Davis @ 11:54 AM. As indicated would happen by simpson literature due to the gape in the hangers and the improper hardware Joist with gap puts downward force further from header and creates more rotation. This image shows the location in the kitchen where the floor has dropped $\frac{5}{8}$ th of an inch.

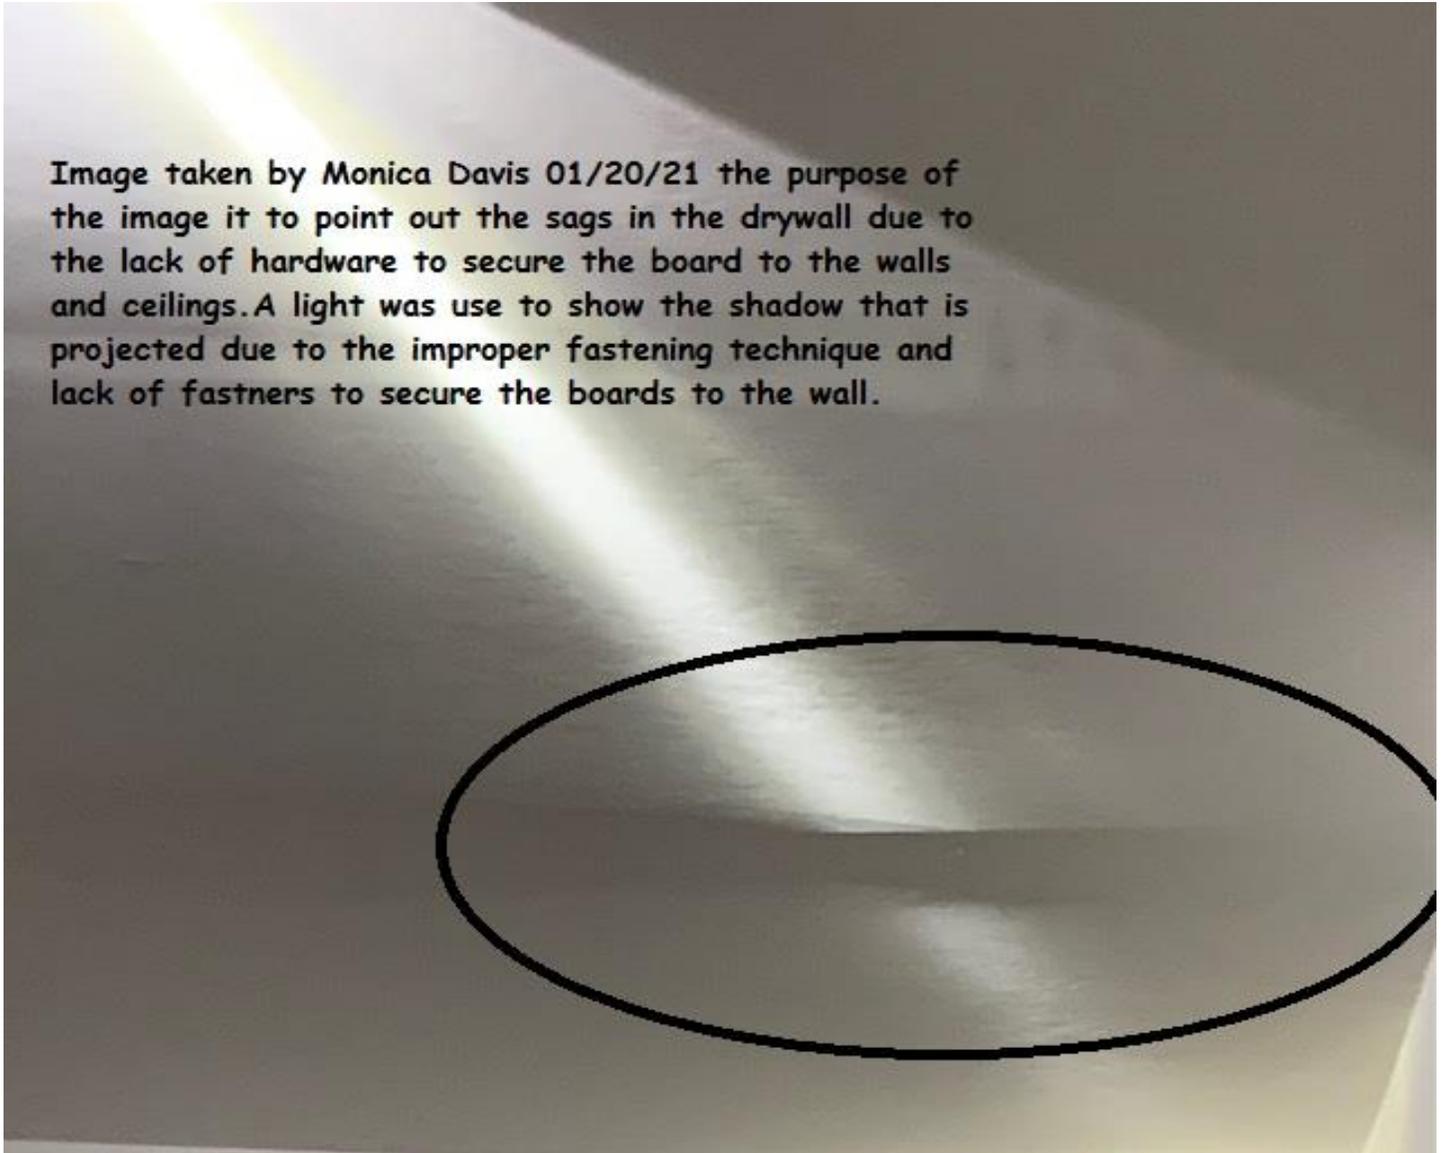
Image taken by Monica Davis 01/20/21 the purpose of the image is to point out the sags in the drywall due to the lack of hardware to secure the board to the walls and ceilings. A light was used to show the shadow that is projected due to the improper fastening technique and lack of fasteners to secure the boards to the wall.

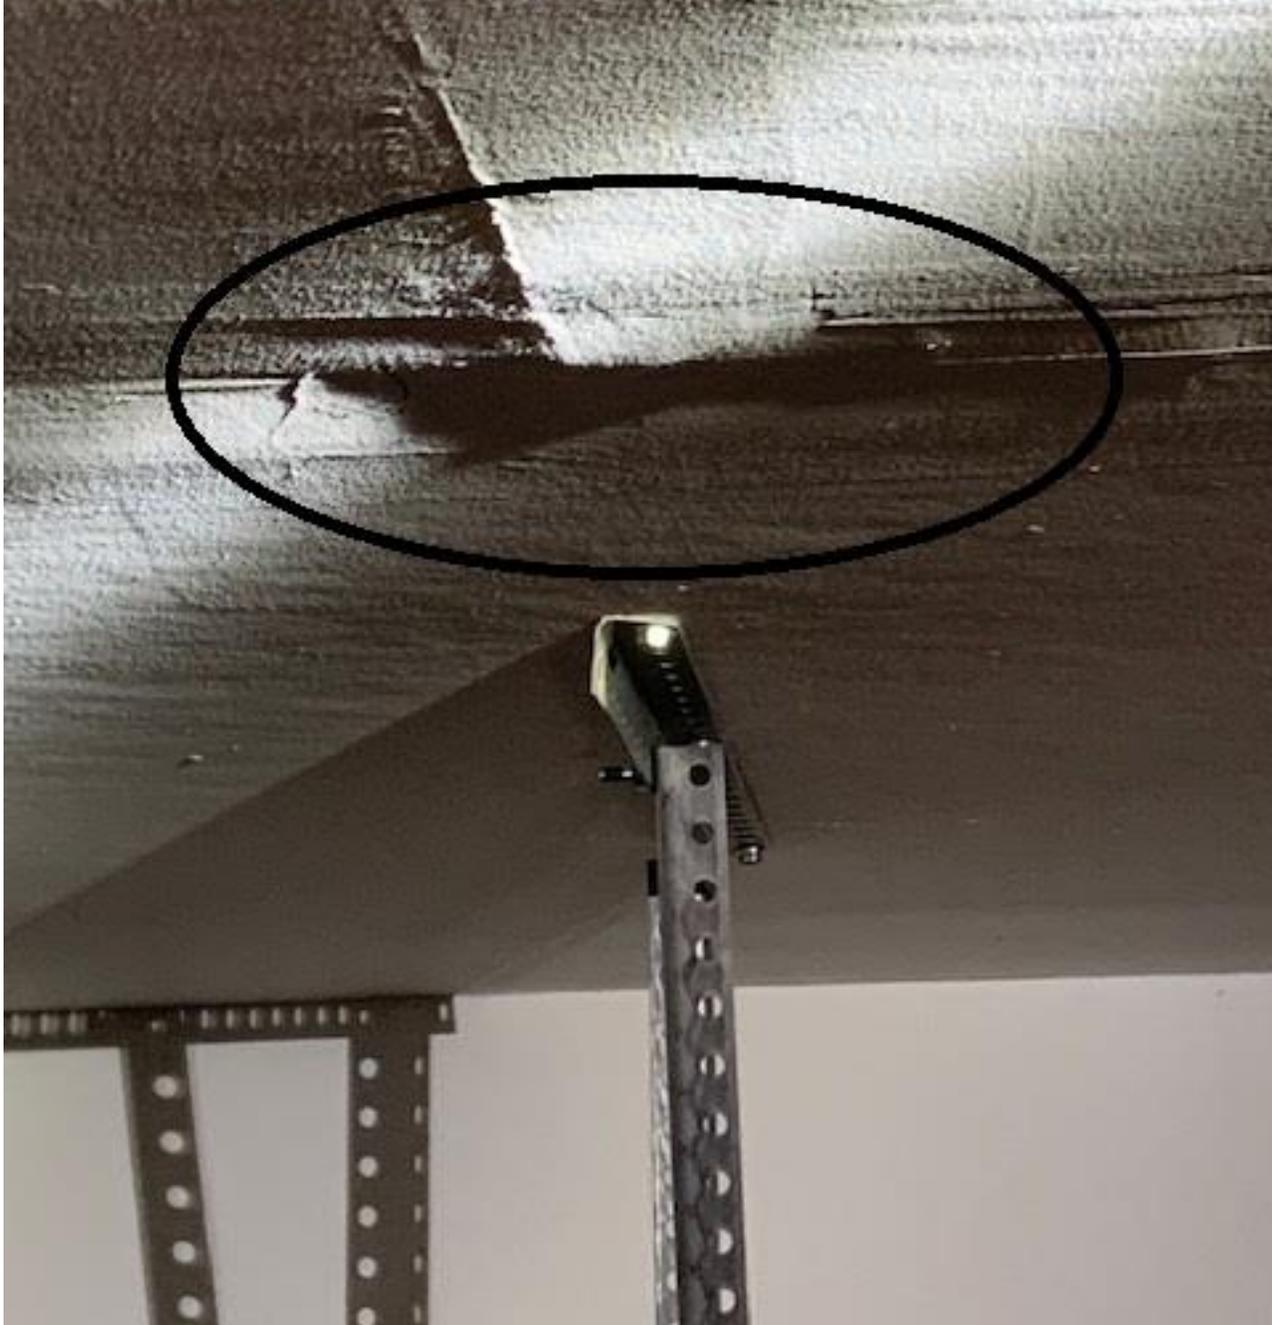
Image taken by Monica Davis 01/20/21 the purpose of the image is to point out the sags in the drywall due to the lack of hardware to secure the board to the walls and ceilings. A light was used to show the shadow that is projected due to the improper fastening technique and lack of fasteners to secure the boards to the wall.

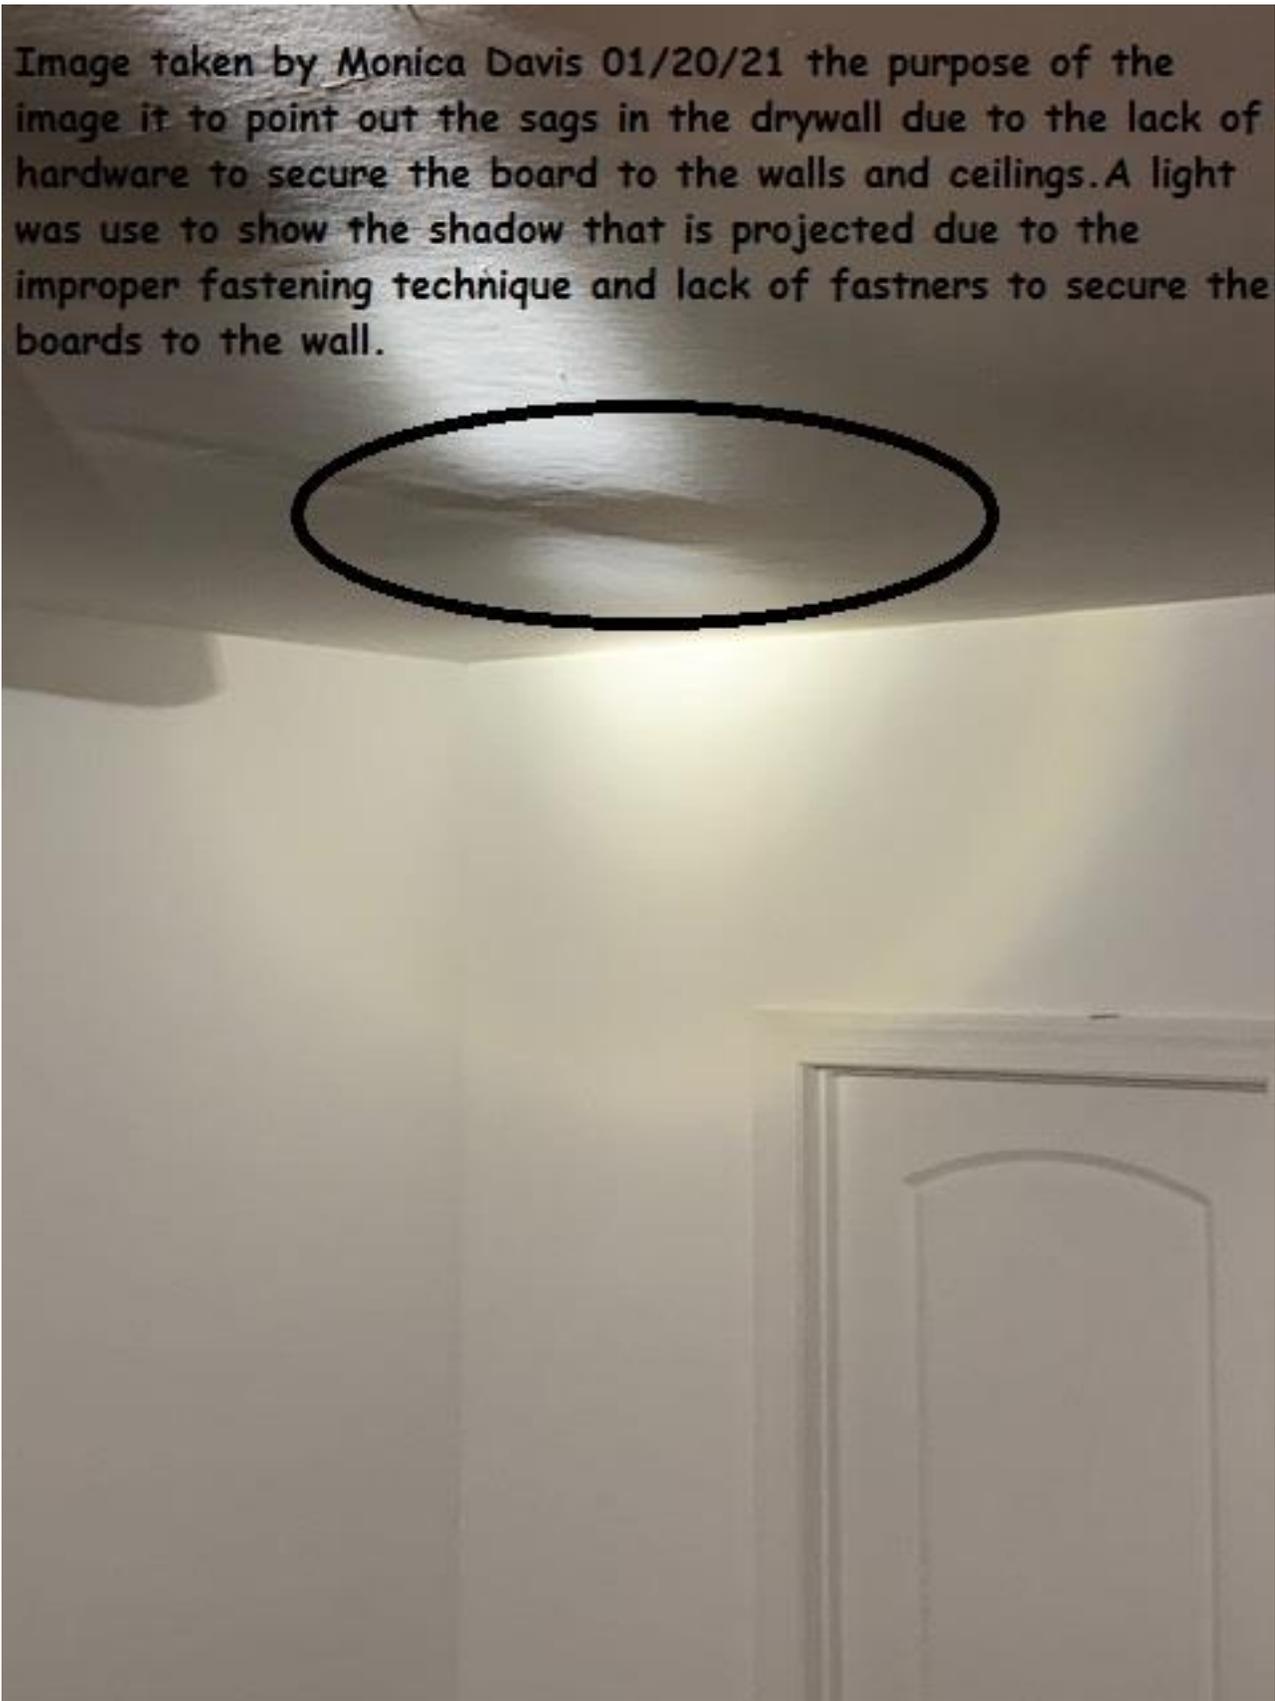
Image taken by Monica Davis 01/20/21 the purpose of the image is to point out the sags in the drywall due to the lack of hardware to secure the board to the walls and ceilings. A light was used to show the shadow that is projected due to the improper fastening technique and lack of fasteners to secure the boards to the wall.
