AGENDA

STATE BUILDING CODE TECHNICAL REVIEW BOARD

Friday, May 21, 2021 - 10:00am (Virtual Meeting)

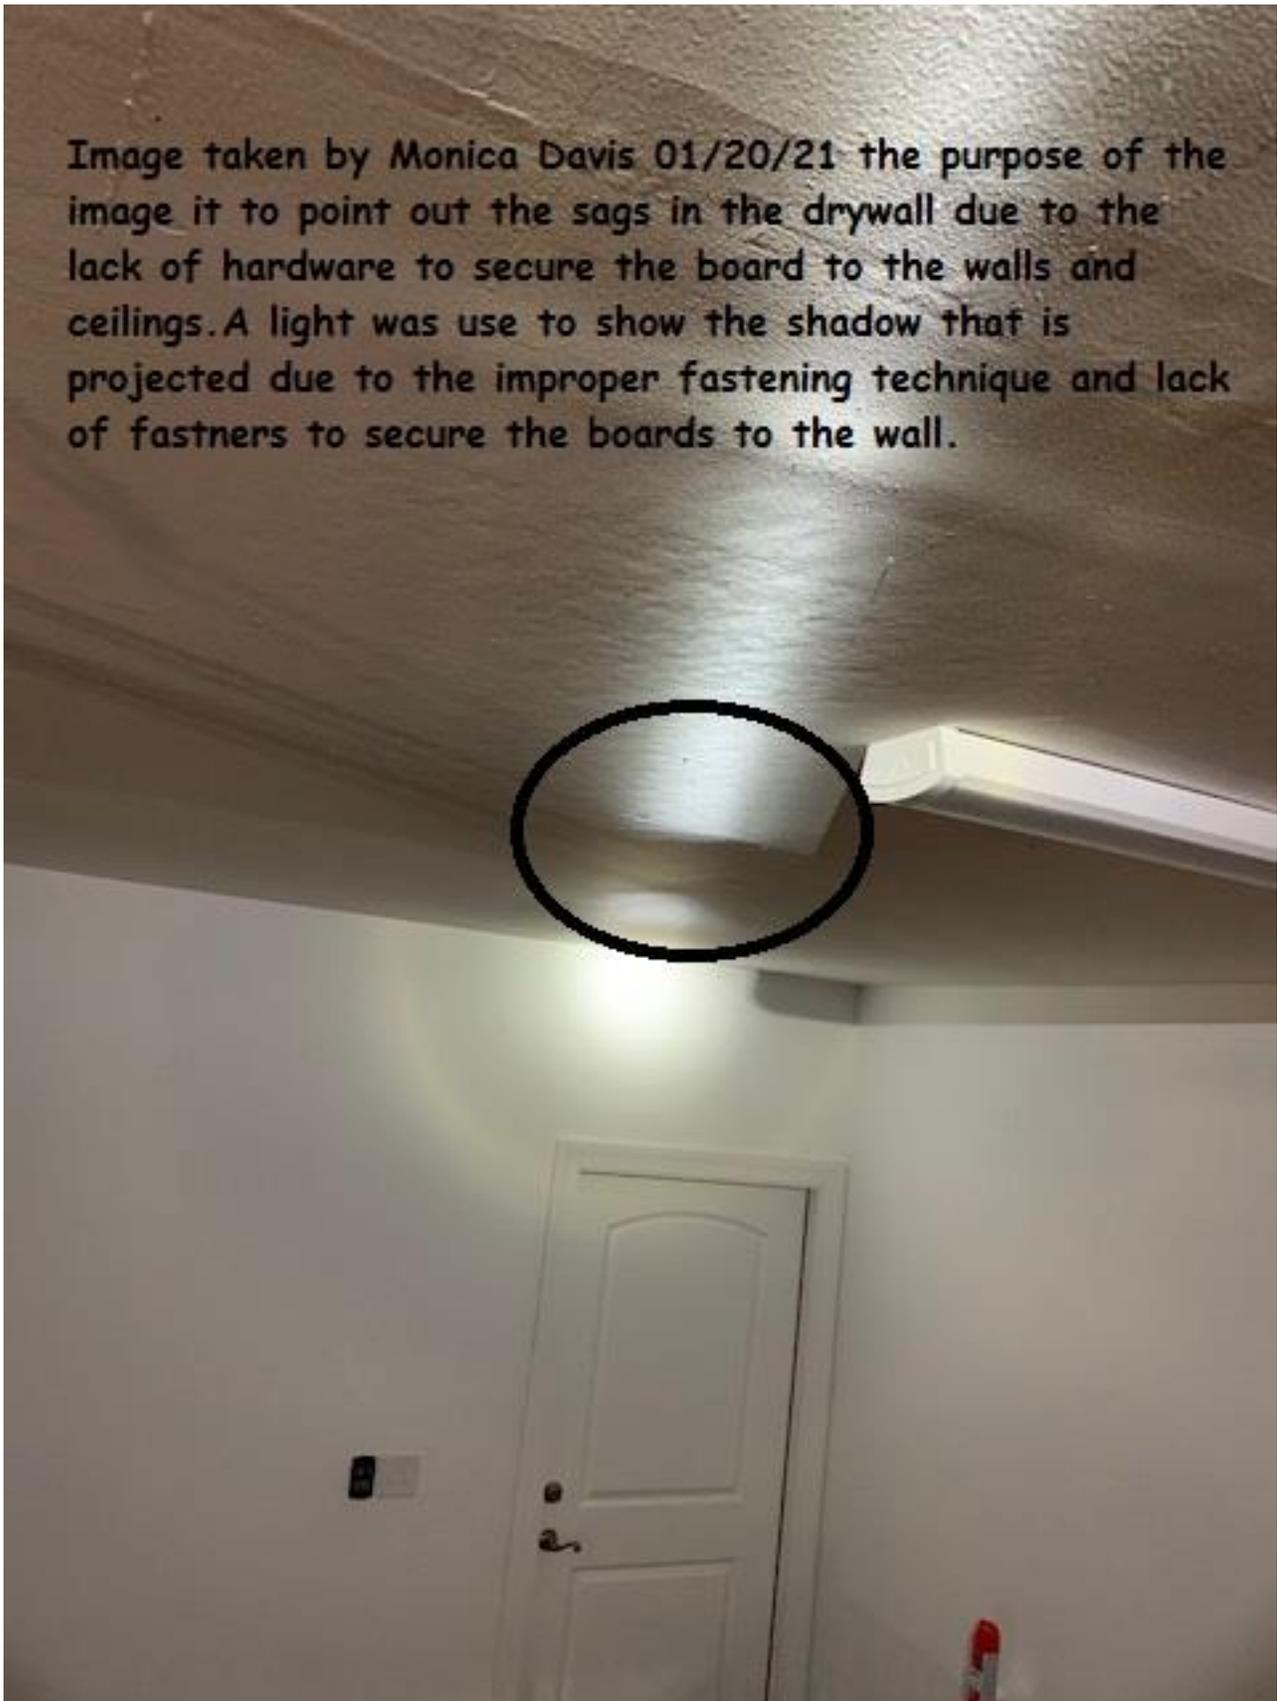
Image taken by Monica Davis 01/20/21 the purpose of the image is to point out the sags in the drywall due to the lack of hardware to secure the board to the walls and ceilings. A light was used to show the shadow that is projected due to the improper fastening technique and lack of fasteners to secure the boards to the wall.

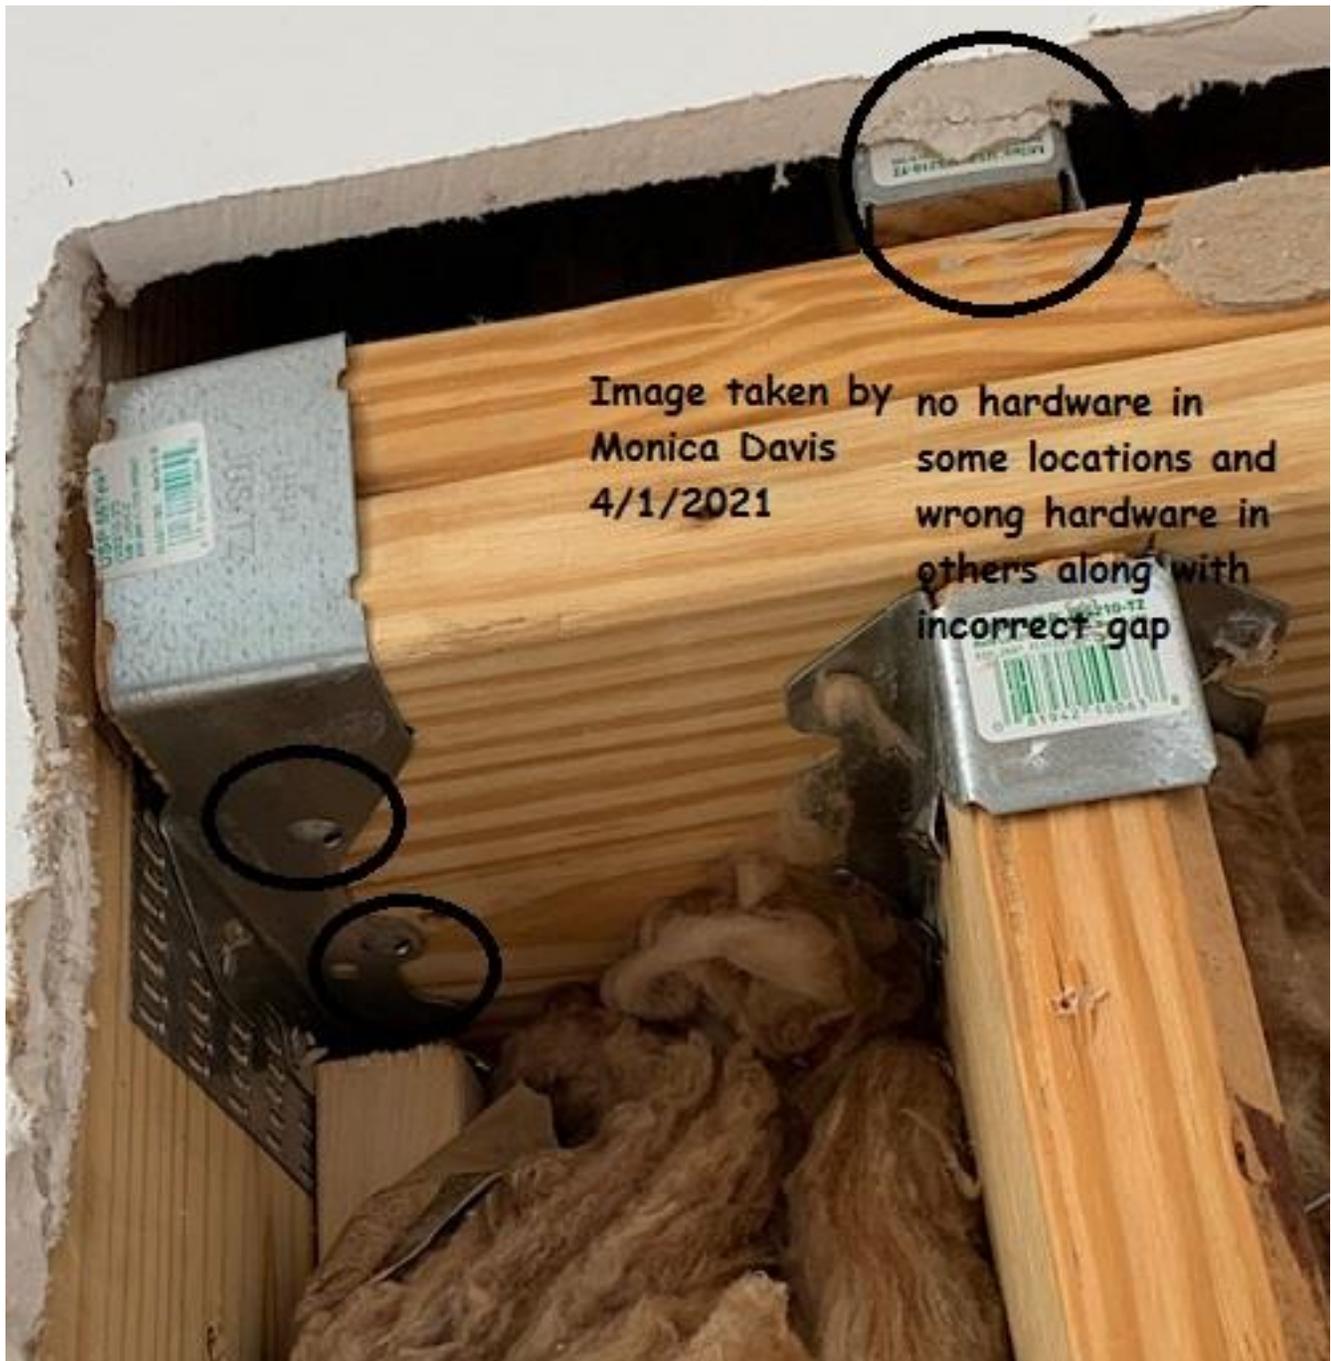
Image taken by no hardware in
Monica Davis some locations and
4/1/2021 wrong hardware in
others along with
incorrect gap

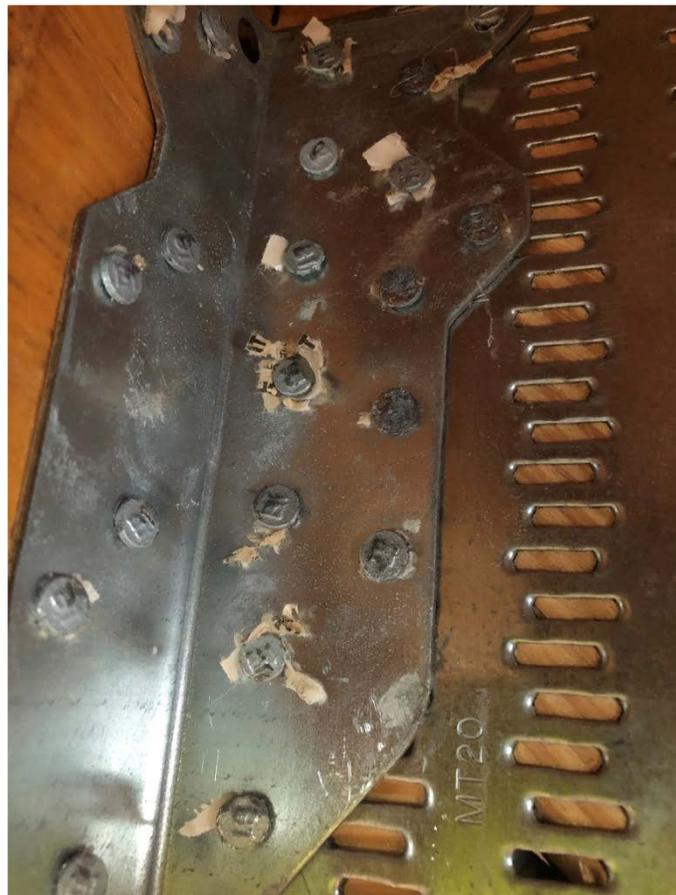
For the USP THD hanger that supports this LVL, the wrong nails were used. As indicated by the ESR3445 attached, the only nails approved by the ESR is 16d Common for the header nails as shown in Table 8 of the ESR on page 13. It is very clear in the picture that the nails into the header are not 16d nails. A picture of the installed nails is shown in the picture to the right.

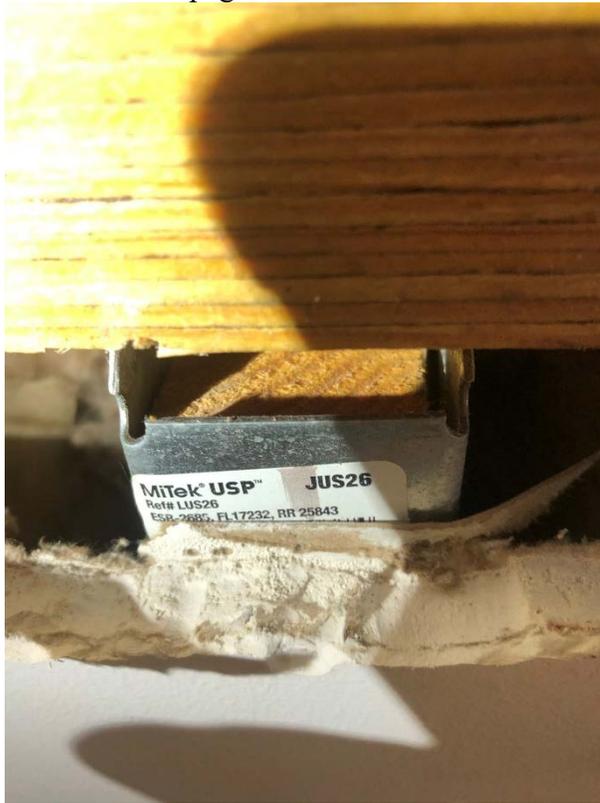
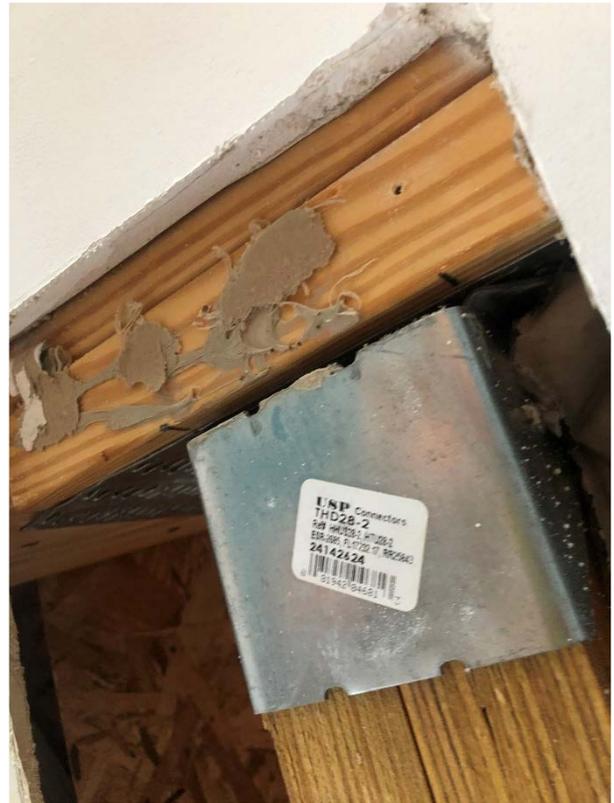
There are several areas where the gap appears to be non-conforming with the joist hanger manufacturer's specifications. The gap is over a half inch in some locations. As previously mentioned in this report on Page 2, the maximum end gap is ¼". Two such examples are shown on this page.
