AGENDA

STATE BUILDING CODE TECHNICAL REVIEW BOARD

Friday, September 20, 2013 – 10:00 a.m.

In Re: Appeal of Keith Kurtz
Appeal No. 13-2

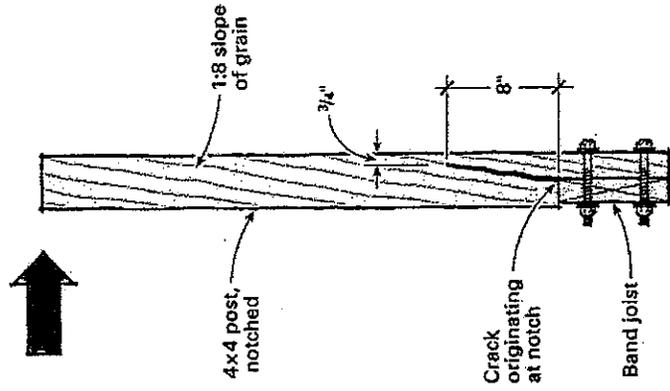
Cracks will typically develop from the corner of a notch (left). As a crack develops, a steep "slope of grain" can critically reduce the section of the post, as the drawing (right) shows.

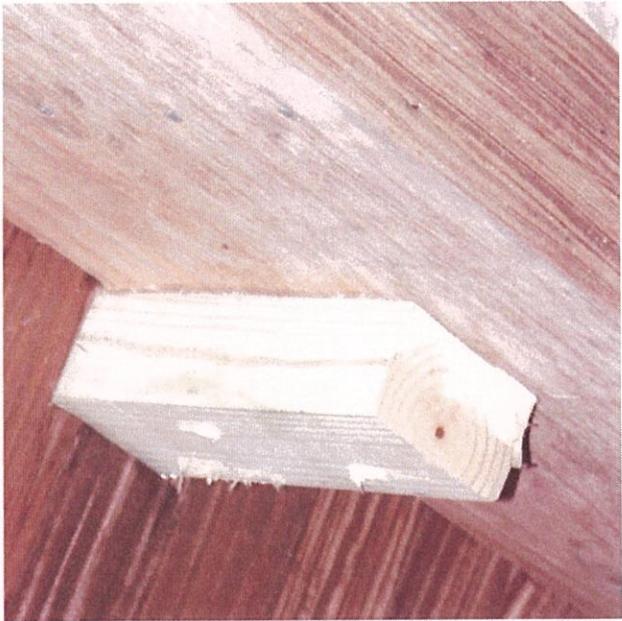
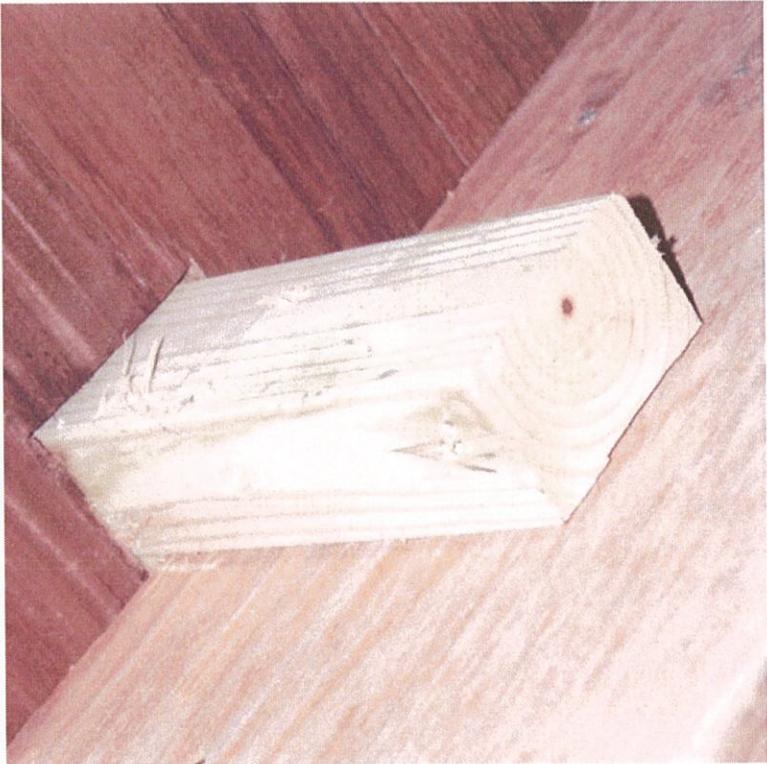
State Appeal Item 1 F. Connection of Support post carrying 4577 lbs load.

County Appeal item I. G. Sketch 3.2 shows a notched 4x4 post with 4577 lbs. load on the front LVLs. We questioned this previously. At our November 2011 meeting [with Arlington County Building Official, Mr. Amiri] one of the County staff said that this was not a problem because the post did not carry a significant load. Mr. Amiri asked that they verify that.

Now that it is known that this post carries a significant load, neither SDS nor Arlington County has addressed the connection of the post to the LVL. The post is notched (with problems as noted above), and if 3.5" deep (a standard 4x4), has less than 1.5 " bearing on the LVLs at the notch.

The only attachment of this notched 4x4 carrying over 4500 lbs. load appears to be two lag screws installed at angles on left side of the post.

We believe the combination of the questionable use of a notched 4x4 and inadequate attachment results in a structural element that could fail to carry the identified load over time.

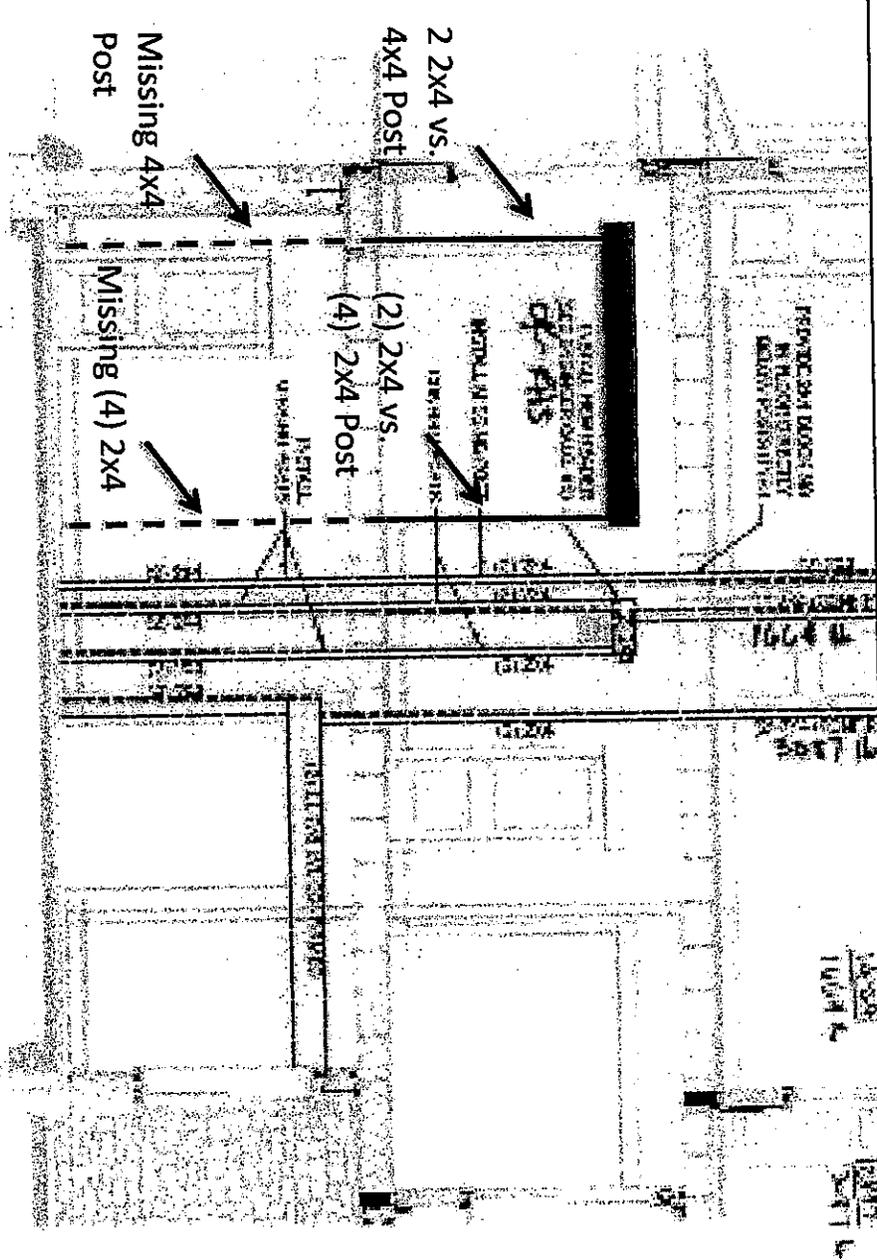
CENTRAL LOAD PATH DIAGRAM

Currently both support posts for this path in the basement level are missing, a 4x4 post on one side and a quadruple 2x4 on the other. On the first floor, the LVL over the opening is supported by double 2x4s on each side instead of the specified 4x4 on one side and quadruple 2x4 on the other.

Correcting the violation cited by the County would provide support on one side by replacing the missing 4x4, but leave the other side unsupported.

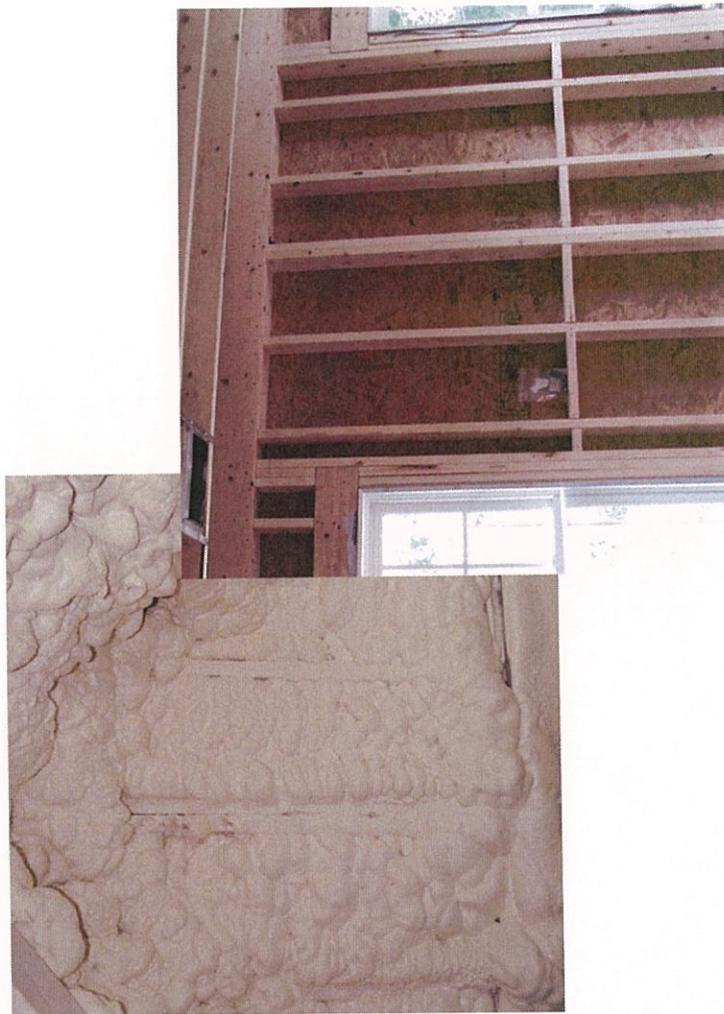
Master BR rear wall after insulation
About 2 weeks after framing inspection
Image 1612

In uncovered areas of the framing, we have found the required nailing pattern absent along the built up posts/columns. Consistent with this finding, in the MBR photos of the load path, the nailing required along the post is not visible. If it's not nailed properly, then it is simply two adjacent 2x6s rather than a double 2x6, further reducing the capacity.

The builder has provided no evidence that the deviation from a properly constructed triple 2x6 post, as specified in the approved drawings, is acceptable for this location.

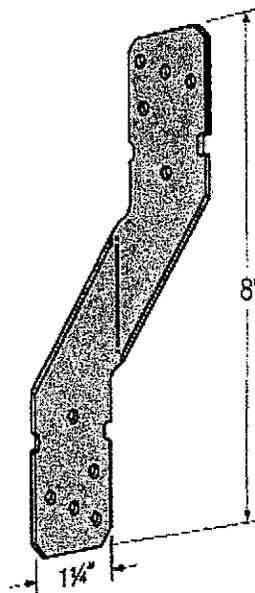
Simpson H8
Hurricane Tie

Item 4 B. Approved plans call for a Hurricane Tie (shown below)

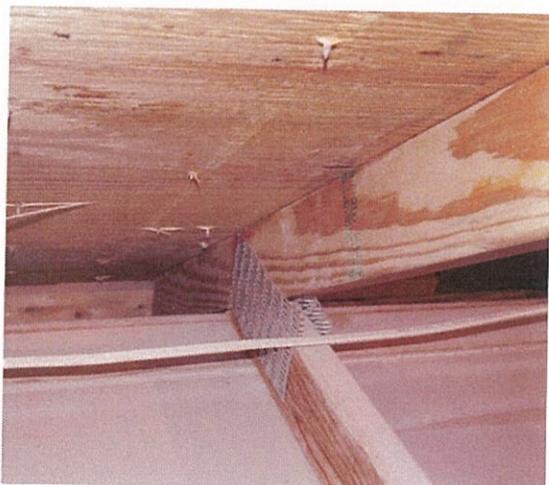
Left Side

Photo shows left and right side of rafter without the ties.
All rafters in the Garage lacked these ties.

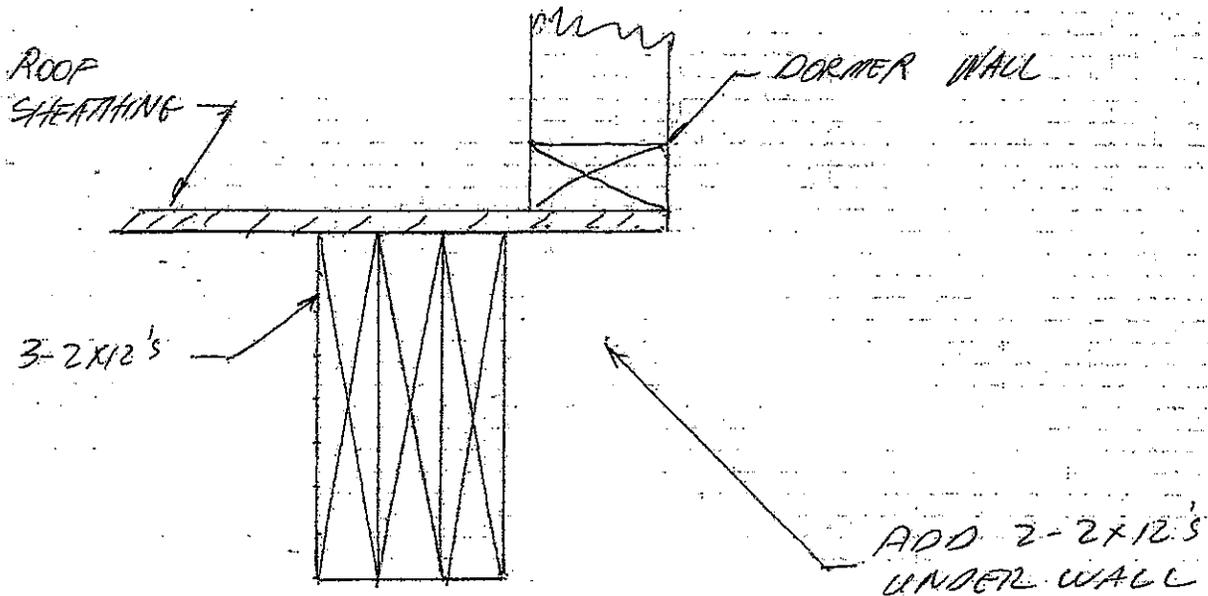
FIGURE 6

5. The dormer wall at the master bedroom (see CM 1.1 dated 3/25/11) was constructed off center (inboard) of the 3 - 2 X 12 rafters at the dormer (see Figure 6). This condition should be corrected by bolting 2 - 2 X 12's to the existing 3 - 2 X 12's and under the dormer wall for the entire wall length.

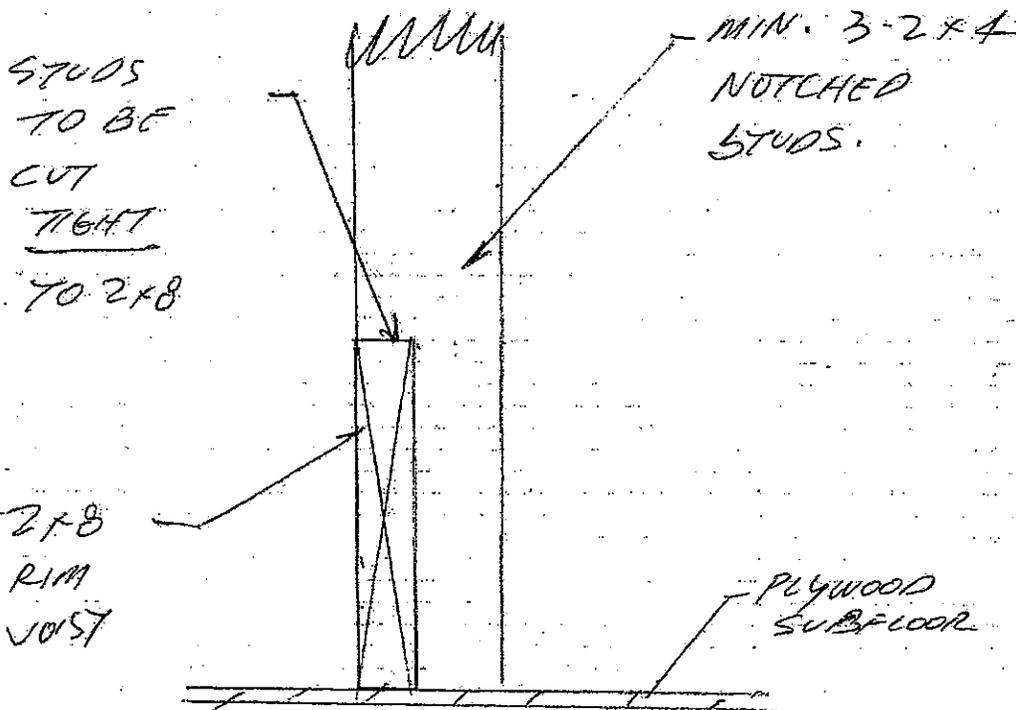
FIGURE 7

7. Post condition at first level study indicates a notched stud with inadequate bearing (see Figure 7). Also, it appears that this post does not track down to foundation below level 1. This condition needs to be corrected by installing 3 - 2 X 4 studs notched as indicated but having complete bearing on the let-in 2 X 8 joist. In addition, this post shall track down below level 1 to foundation.

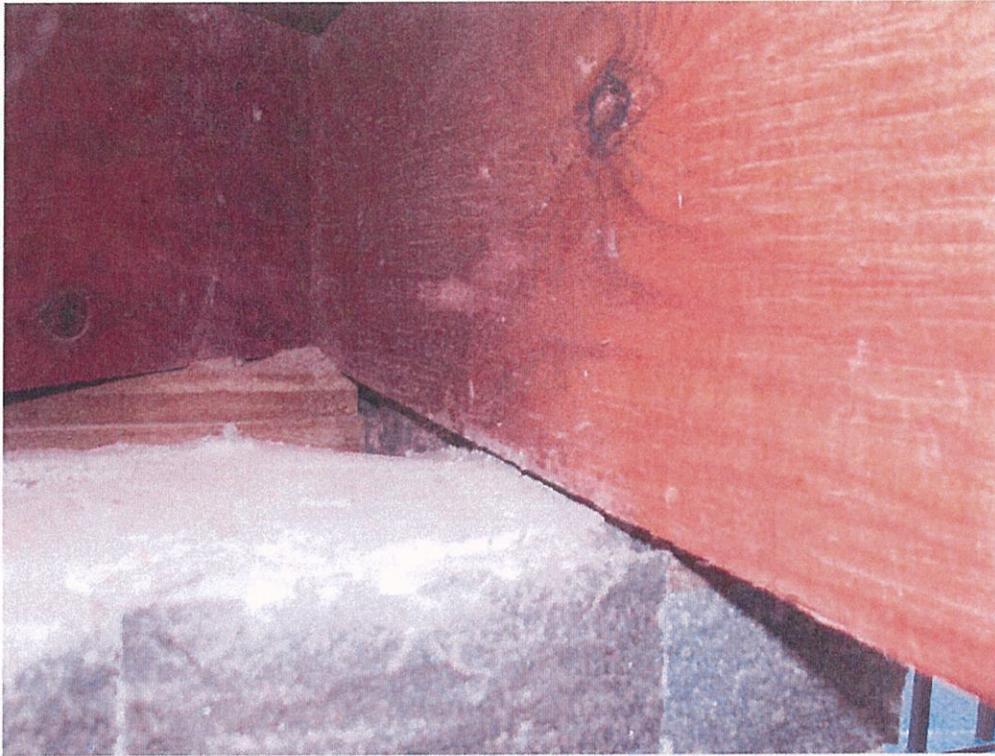
Bearing issue: LVL beam slightly bearing on the wood

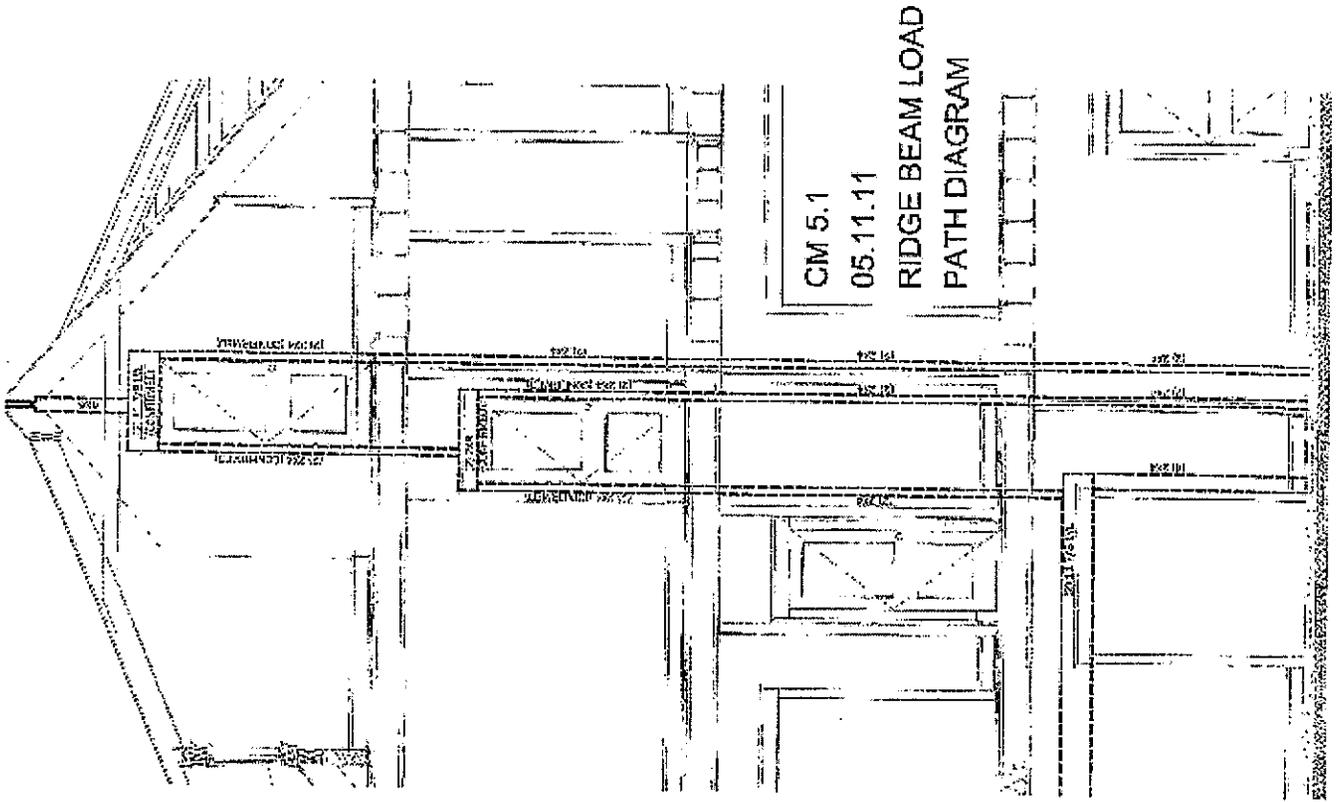
(Note: Left and Right reversed on drawing GM S.1)

It only takes a few seconds to see that this drawing is not accurate. Standing on the stairs and tracing the line of the door frame down from the second floor to the first, a large vent is clearly in the way. It was clear from photos, from visible evidence and from the use of a stud finder that this drawing was wrong. No attempt was made to contact us to verify the accuracy of the drawing.

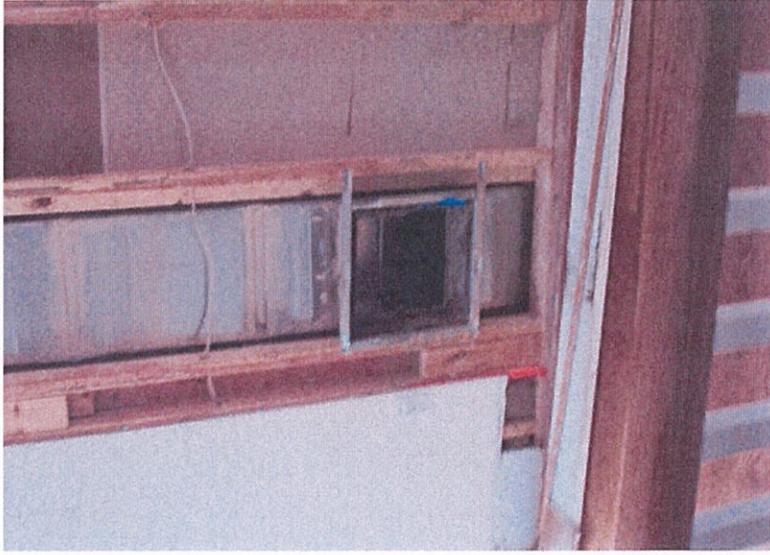
First Floor

In September 2011 walls were opened up on three floors to prove the Moore was inaccurate.
