AGENDA

STATE BUILDING CODE TECHNICAL REVIEW BOARD

Friday, May 21, 2021 - 10:00am (Virtual Meeting)

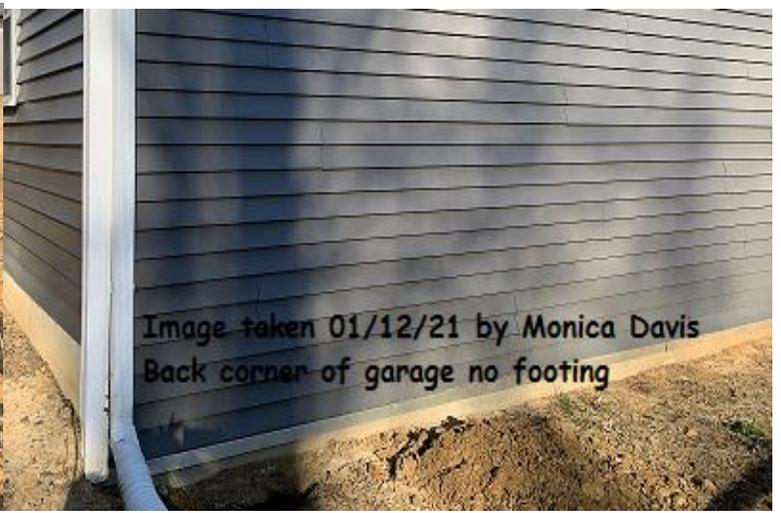
Image taken 01/12/21 by Monica Davis
Back corner of garage no footing close up

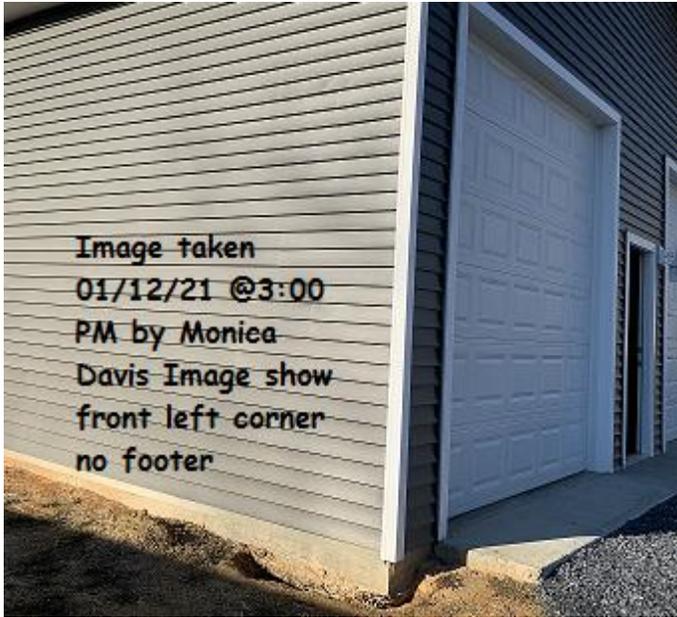
Image taken 01/12/21 by Monica Davis
Back corner of garage no footing

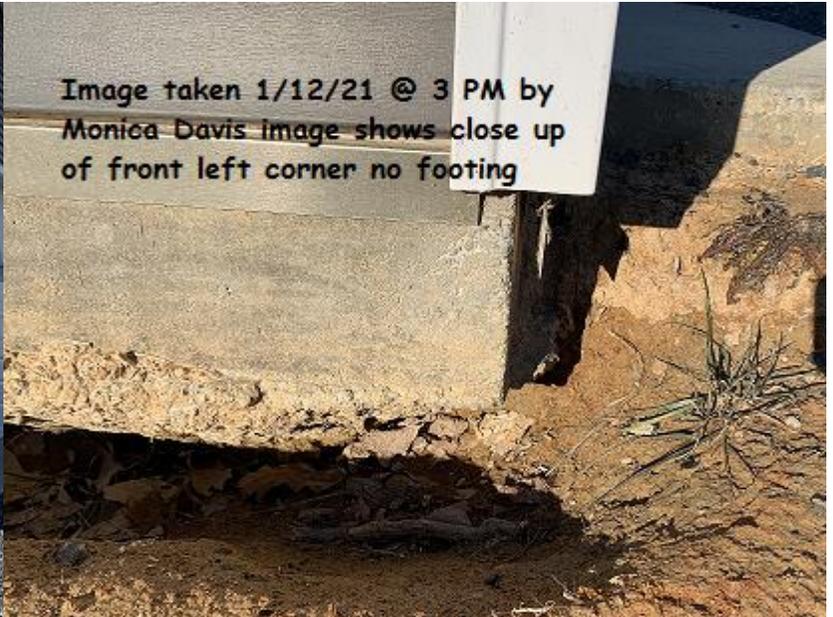
Image taken
01/12/21 @3:00
PM by Monica
Davis Image show
front left corner
no footer

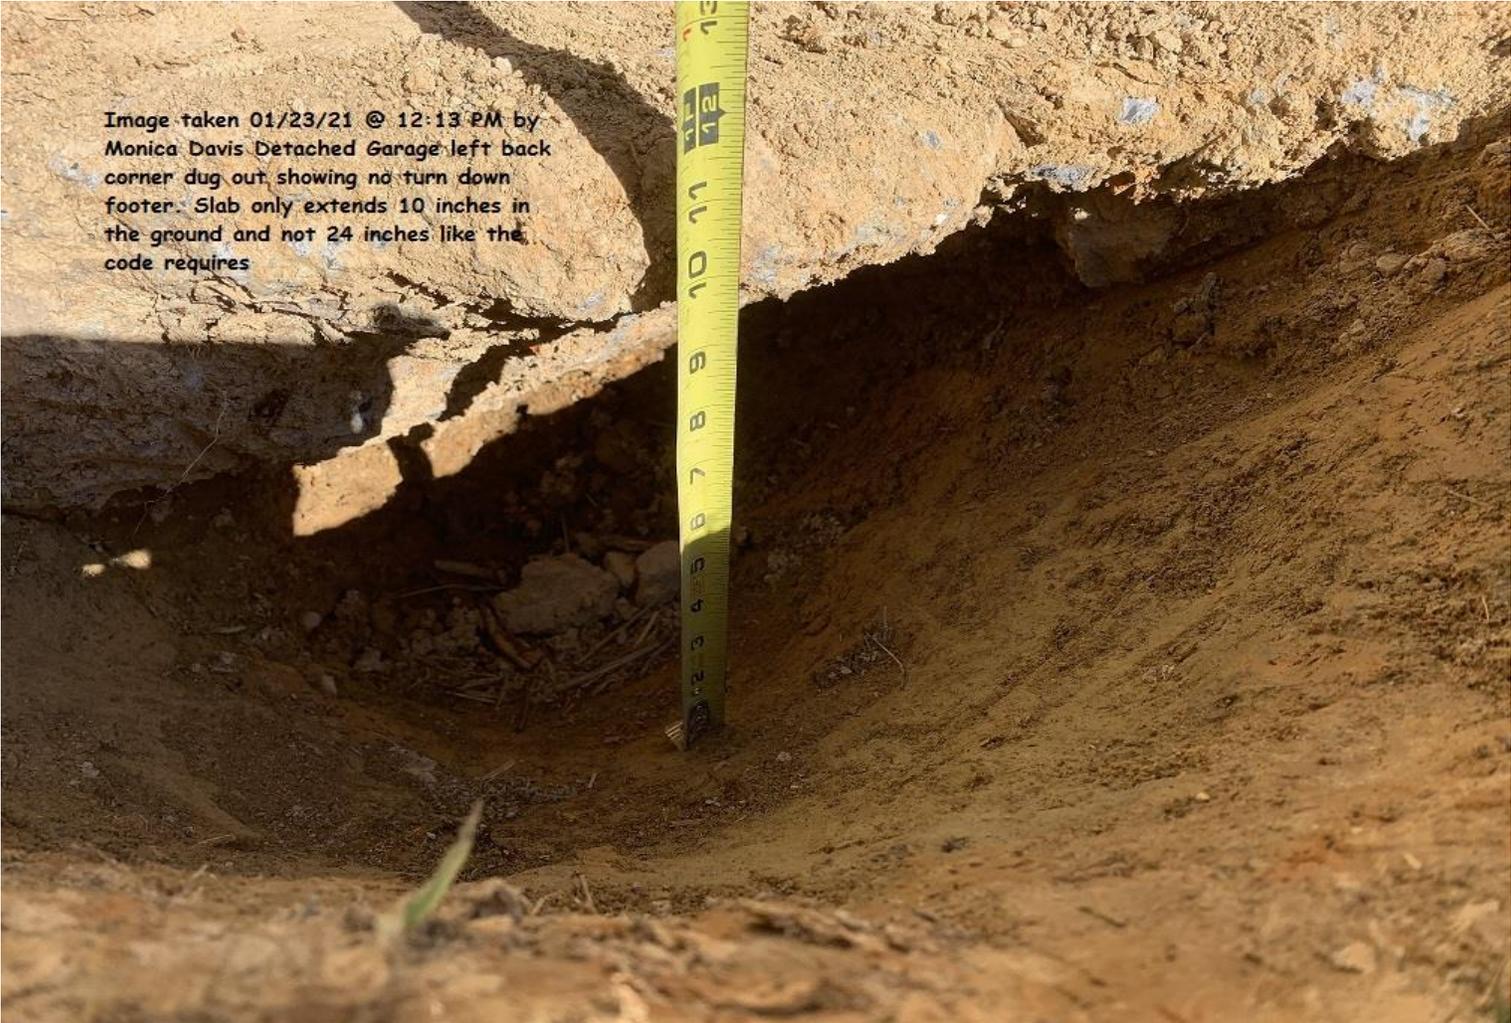
Image taken 01/23/21 @ 12:13 PM by Monica Davis Detached Garage left back corner dug out showing no turn down footer. Slab only extends 10 inches in the ground and not 24 inches like the code requires

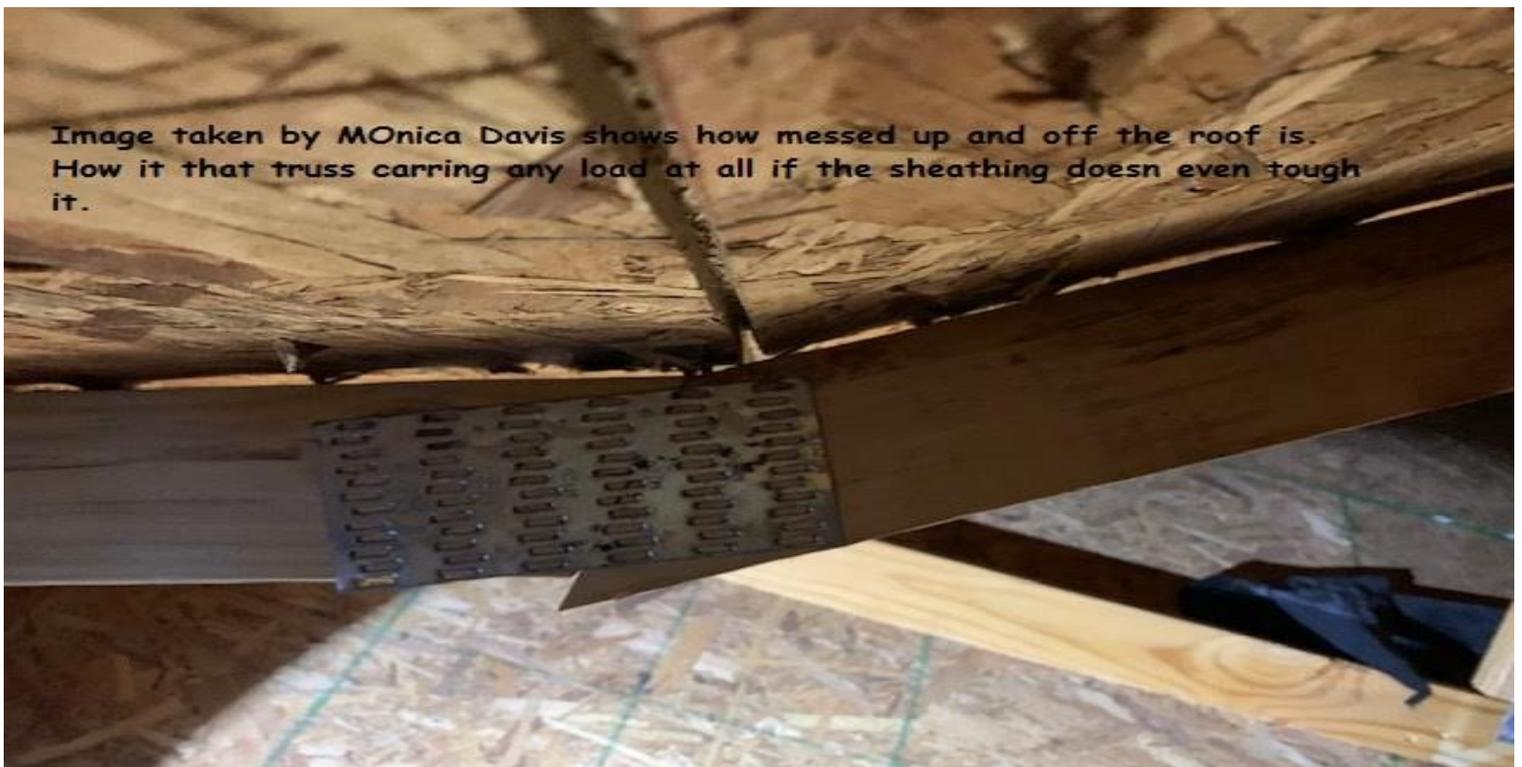
Image taken by MOnica Davis shows how messed up and off the roof is.
How it that truss carring any load at all if the sheathing doesn't even tough
it.

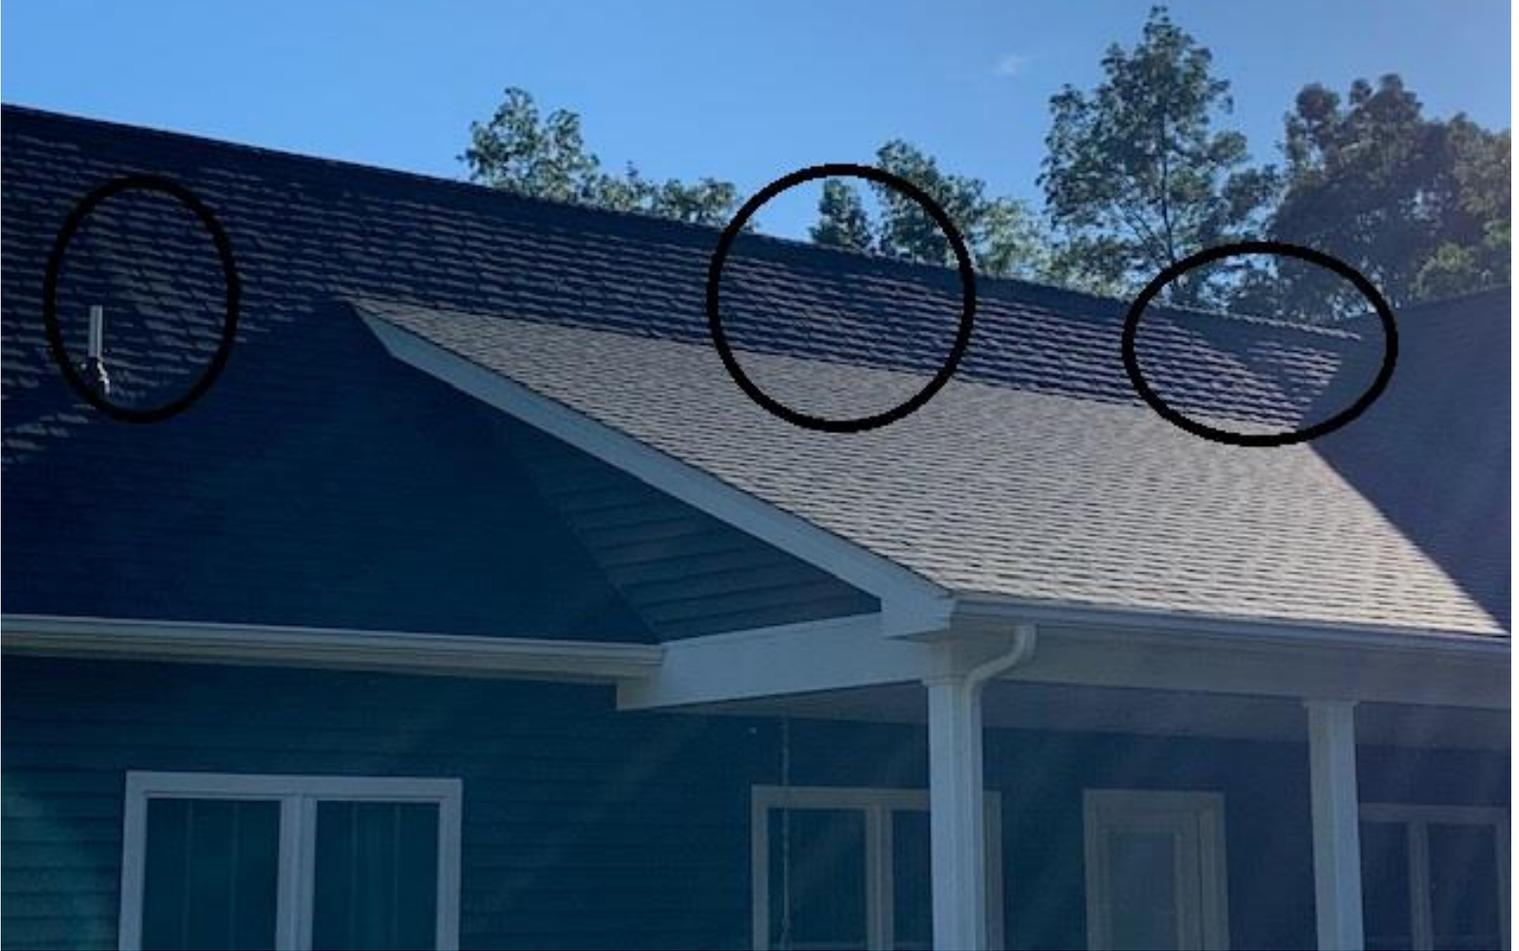
image taken by monica davis trusses raised higher causing sags in roof

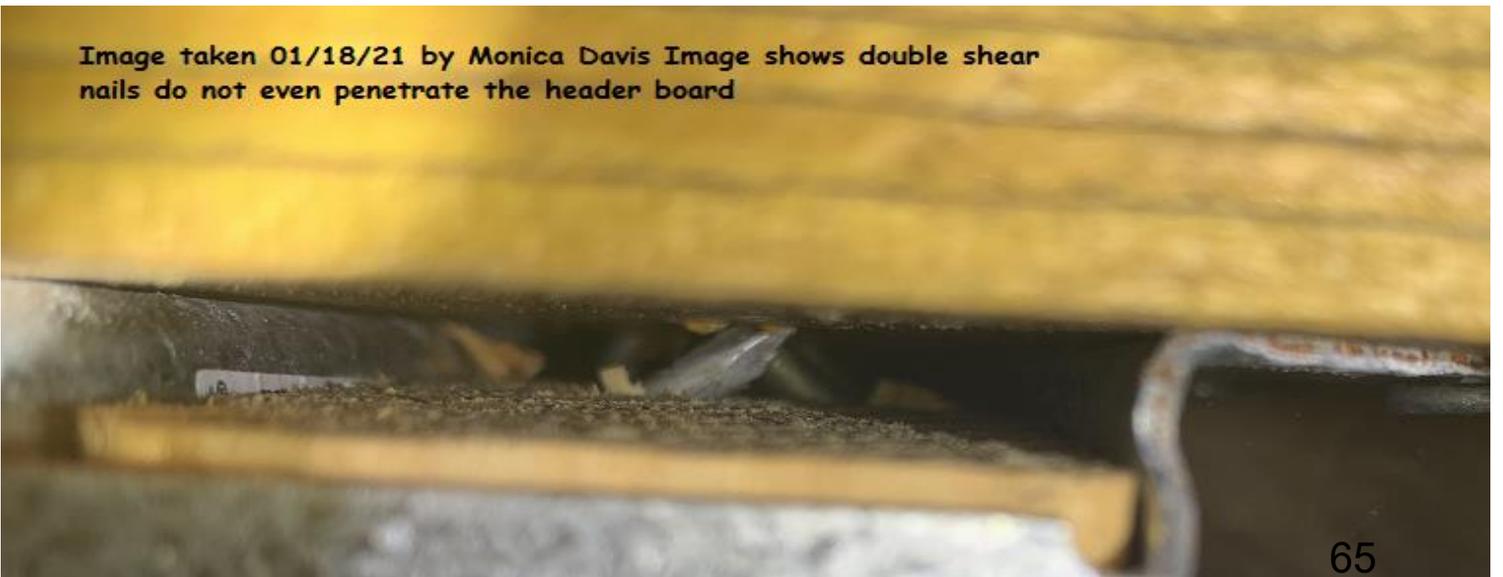
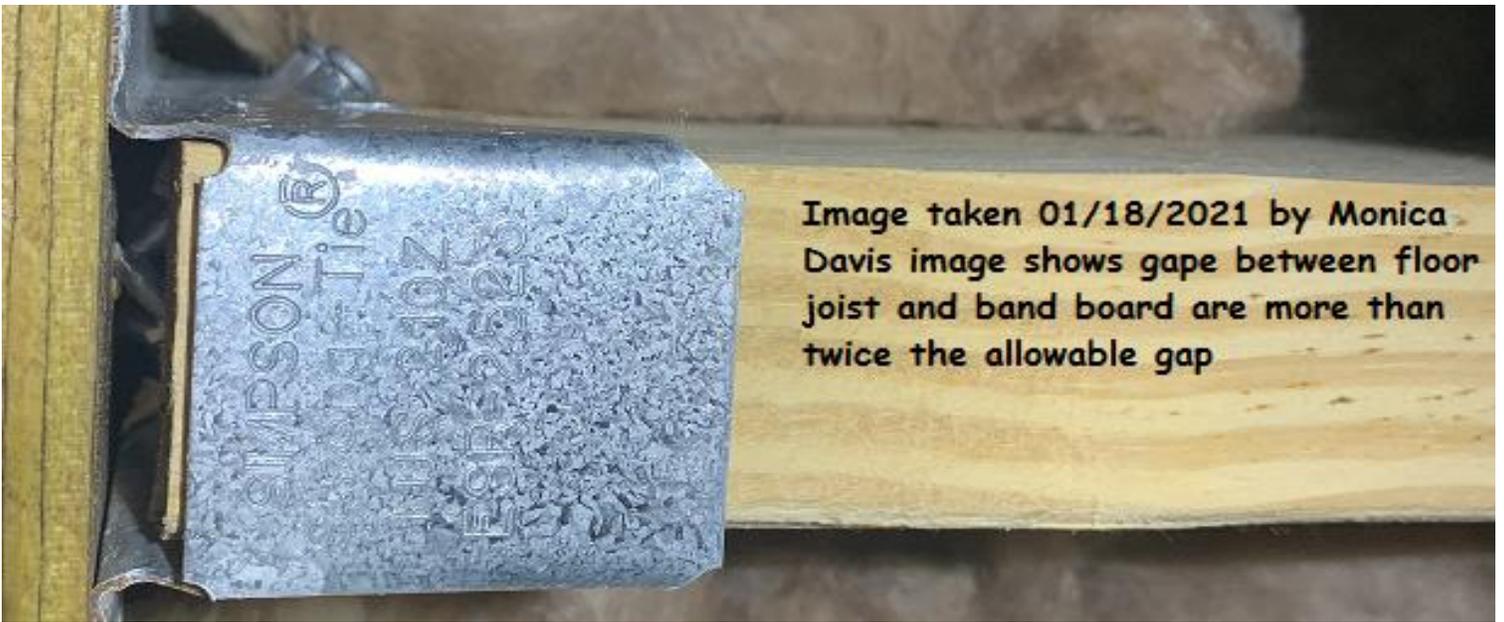
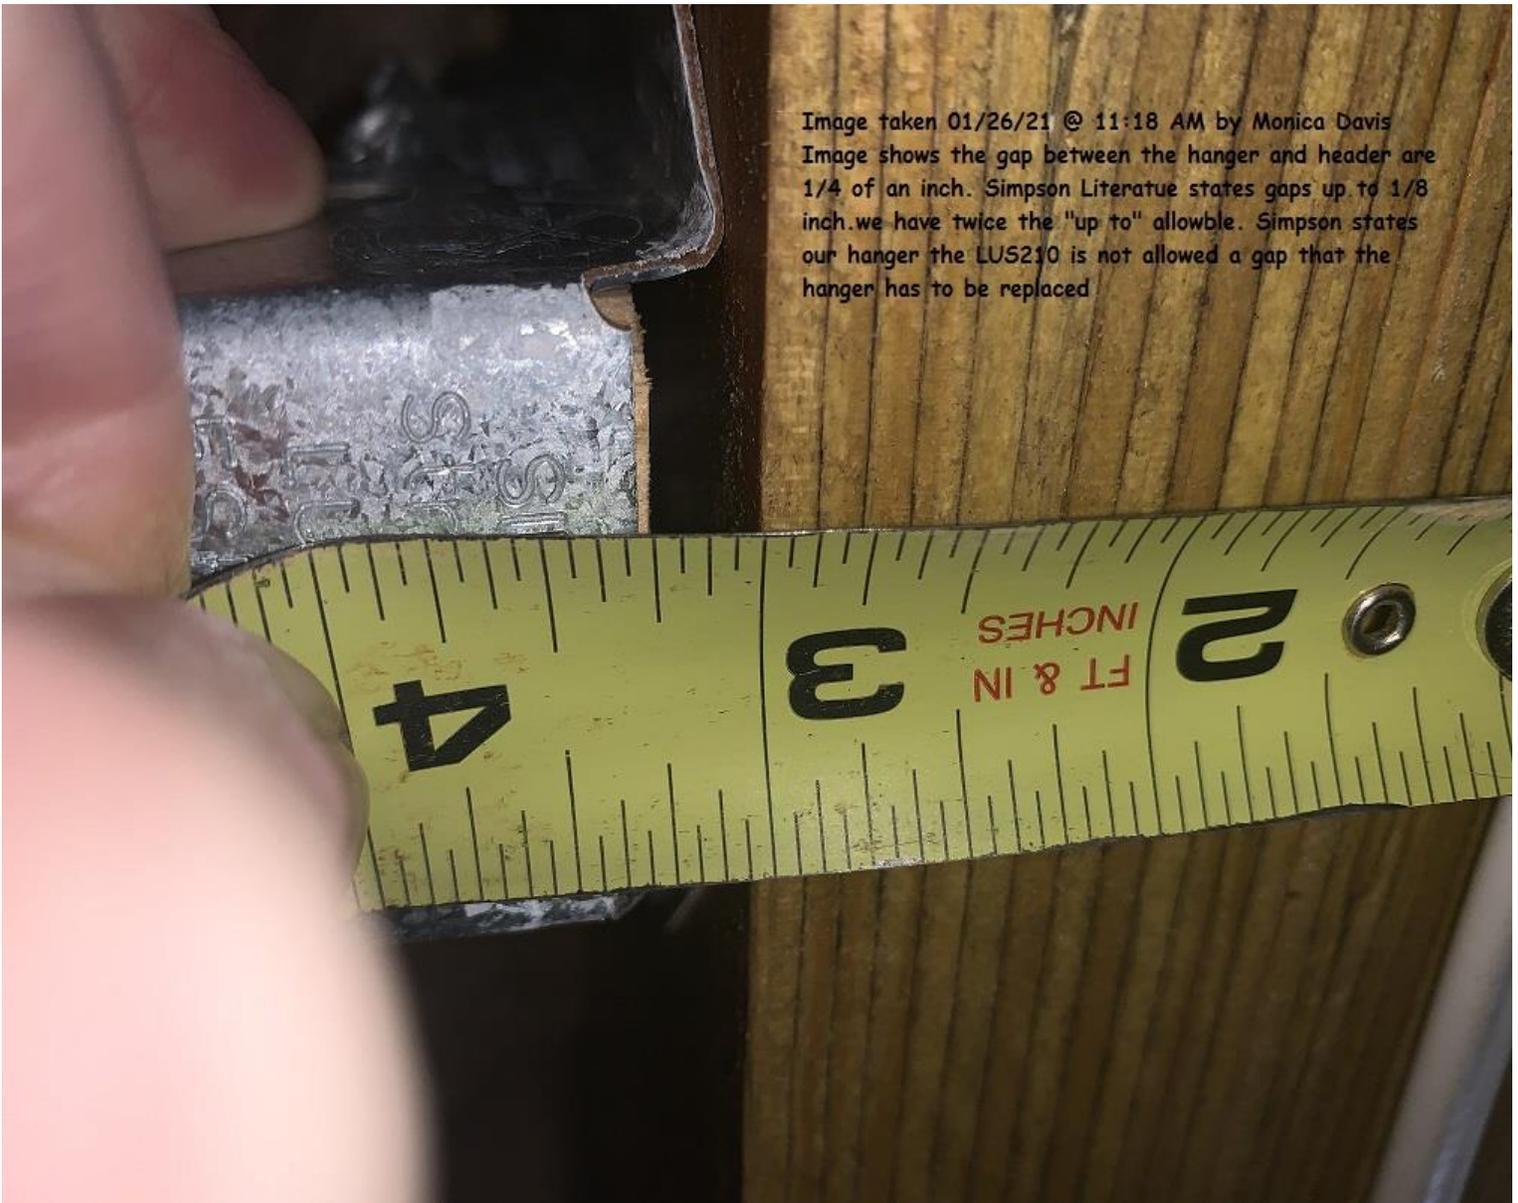
Image taken 01/18/21 by Monica Davis Image shows double shear nails do not even penetrate the header board

We request the floor joist hangers be reviewed and both the twice the size of the up to allowable gap and improper hardware be required to be repaired to Simpson's literature.

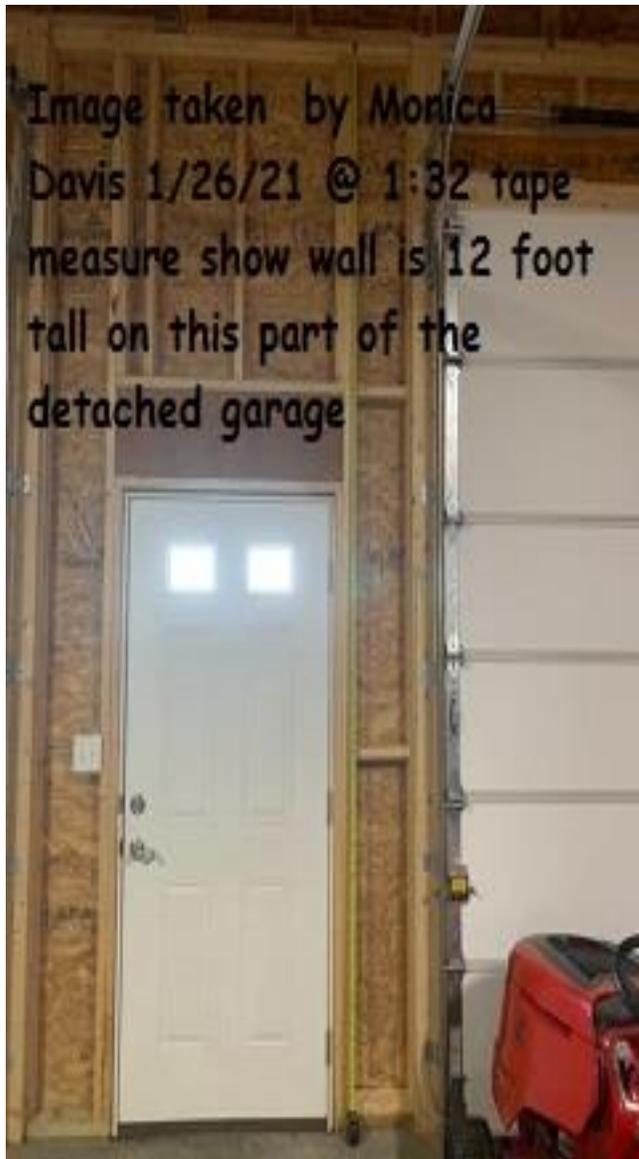
Image taken by Monica Davis 1/26/21 @ 1:32 tape measure show wall is 12 foot tall on this part of the detached garage

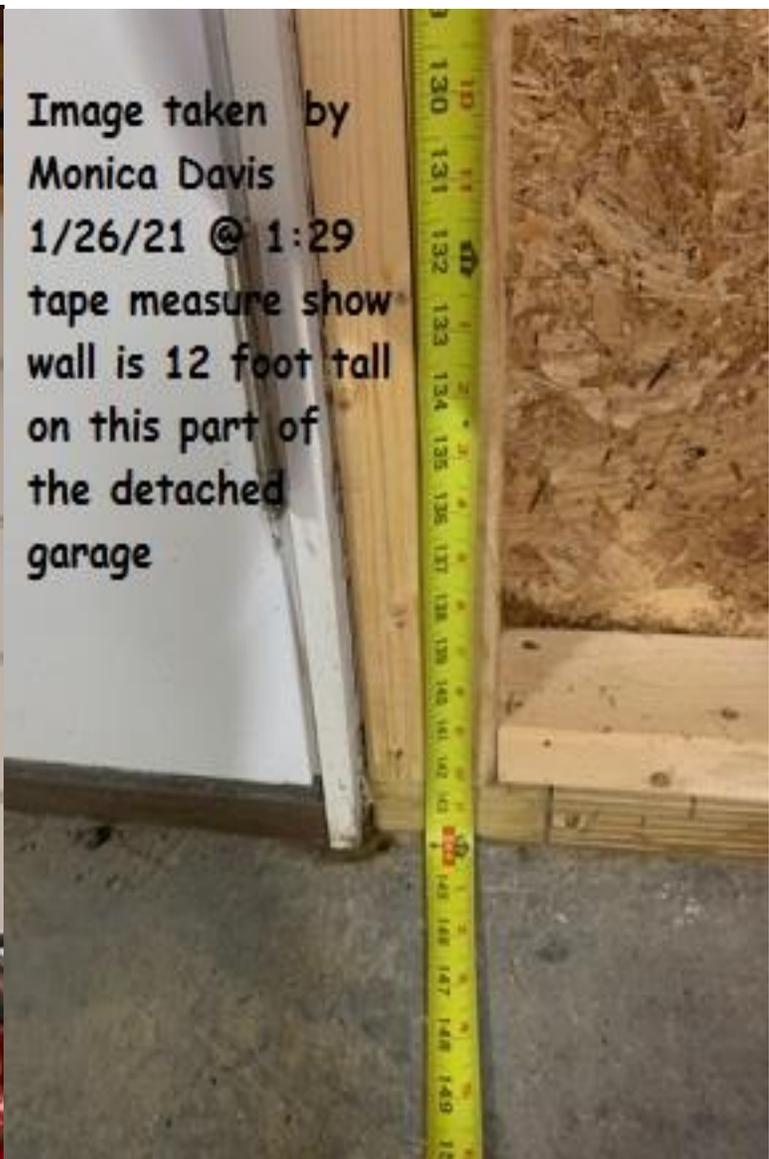
Image taken by Monica Davis 1/26/21 @ 1:29 tape measure show wall is 12 foot tall on this part of the detached garage

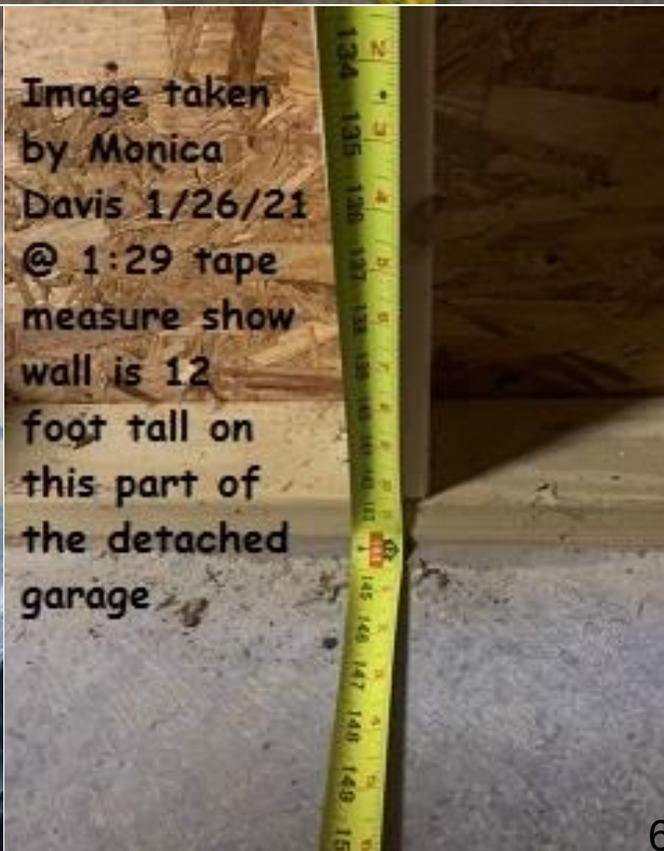
Image taken by Monica Davis 1/26/21 @ 1:29 tape measure show wall is 12 foot tall on this part of the detached garage

Image taken @ 1:21 PM by Monica Davis 1/26/21
image shows blocking in wall between studs that
sheathing should be attached to is not. Blocks can be
moved with your hands. location detached garage

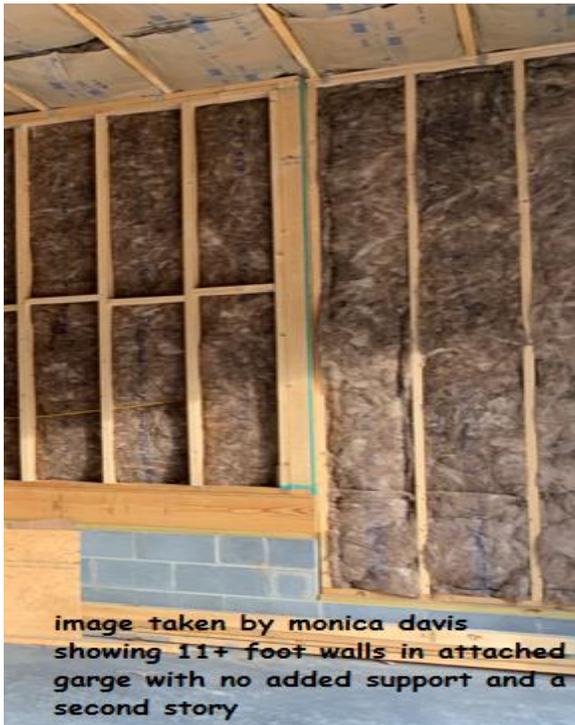
image taken by
monica davis
showing attached
garage with second
story is over 11
foot in height

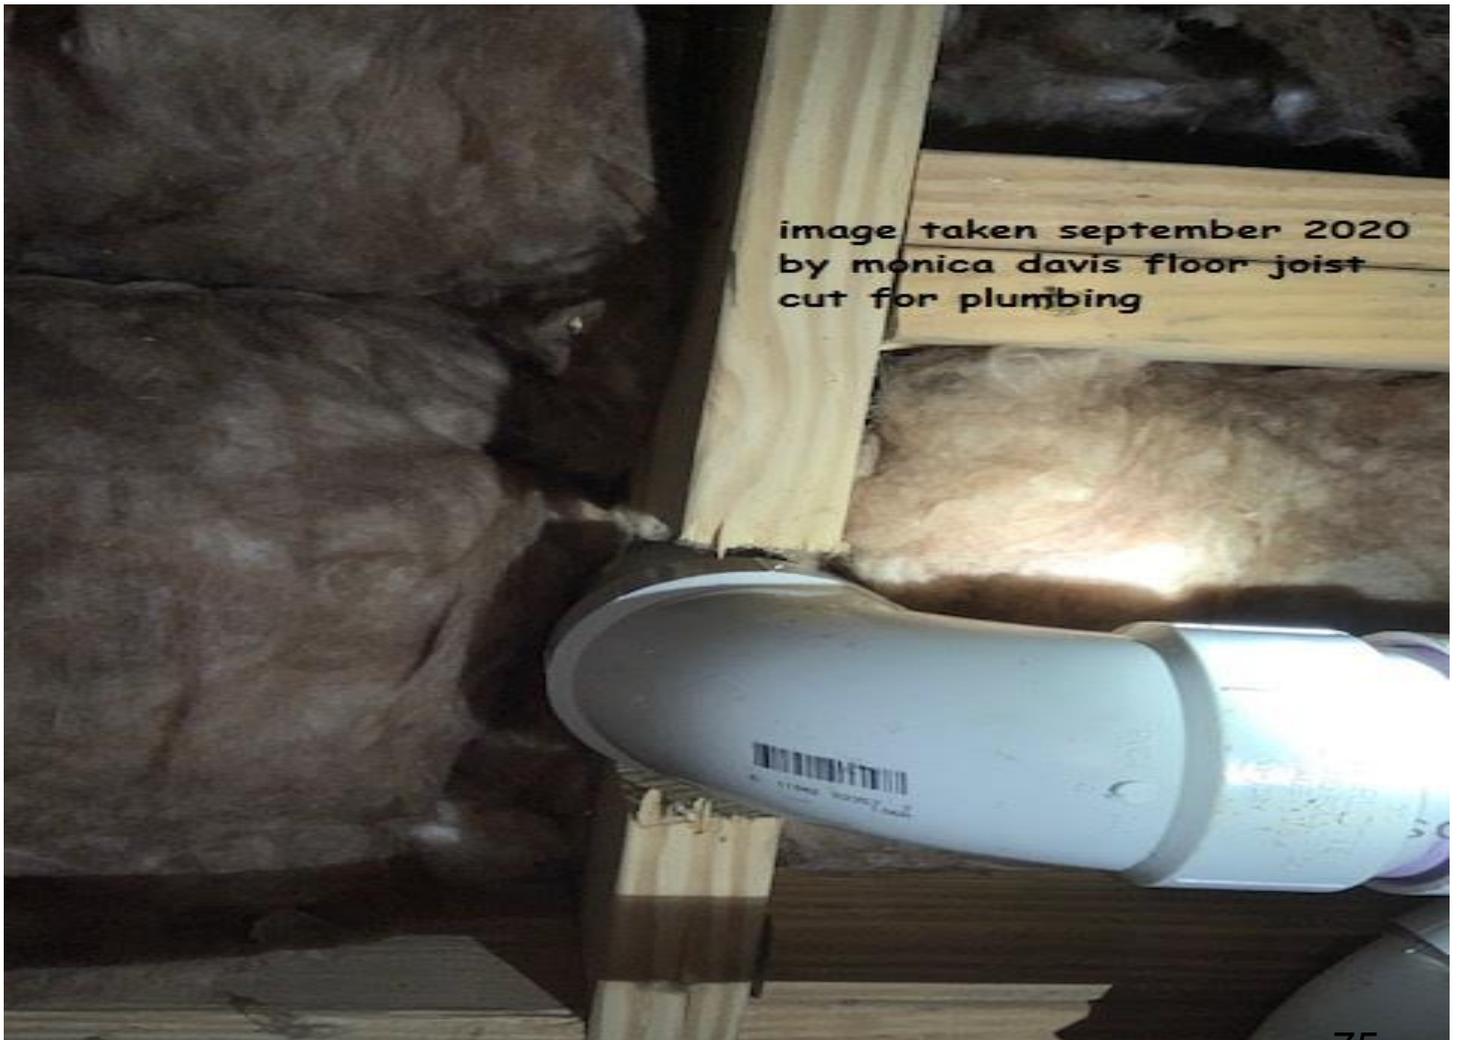
Item 13: on the NOV for the Header at master bath plumbing R502.10 or provide engineer design and approve in accordance with section R301.1.3 YOU WILL FIND THIS UNDER NUMBER 9 ON THE ENGINEERS REPORT FROM SCHNITZHOFFER

The image clearly shows the cut floor joist for plumbing to be installed. We request a proper design be provided and approved in accordance with the code.

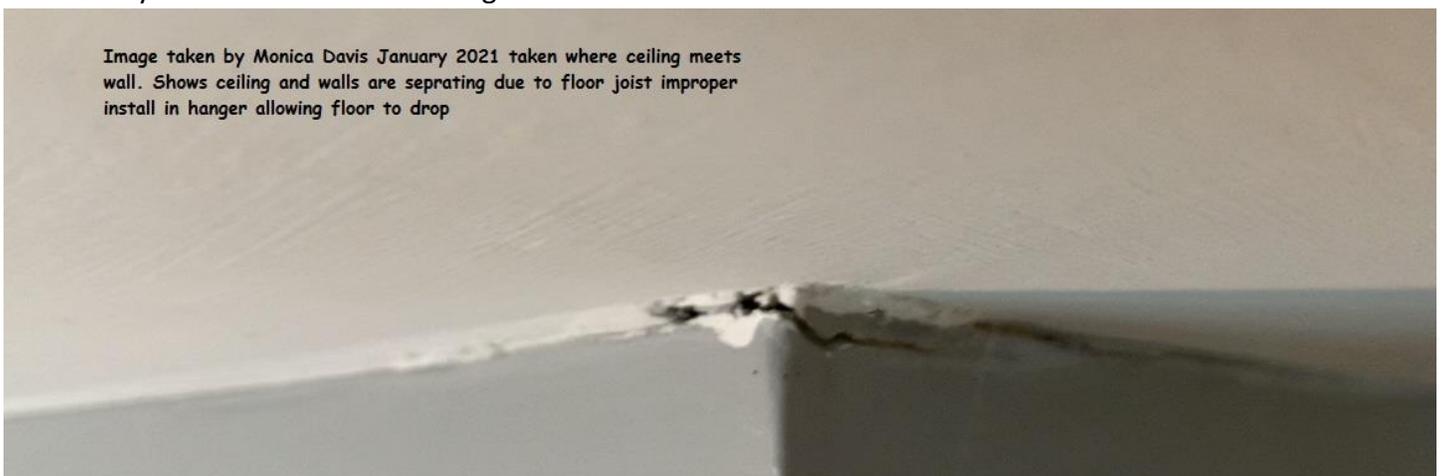
Image taken by Monica Davis January 2021 taken where ceiling meets wall. Shows ceiling and walls are seprating due to floor joist improper install in hanger allowing floor to drop

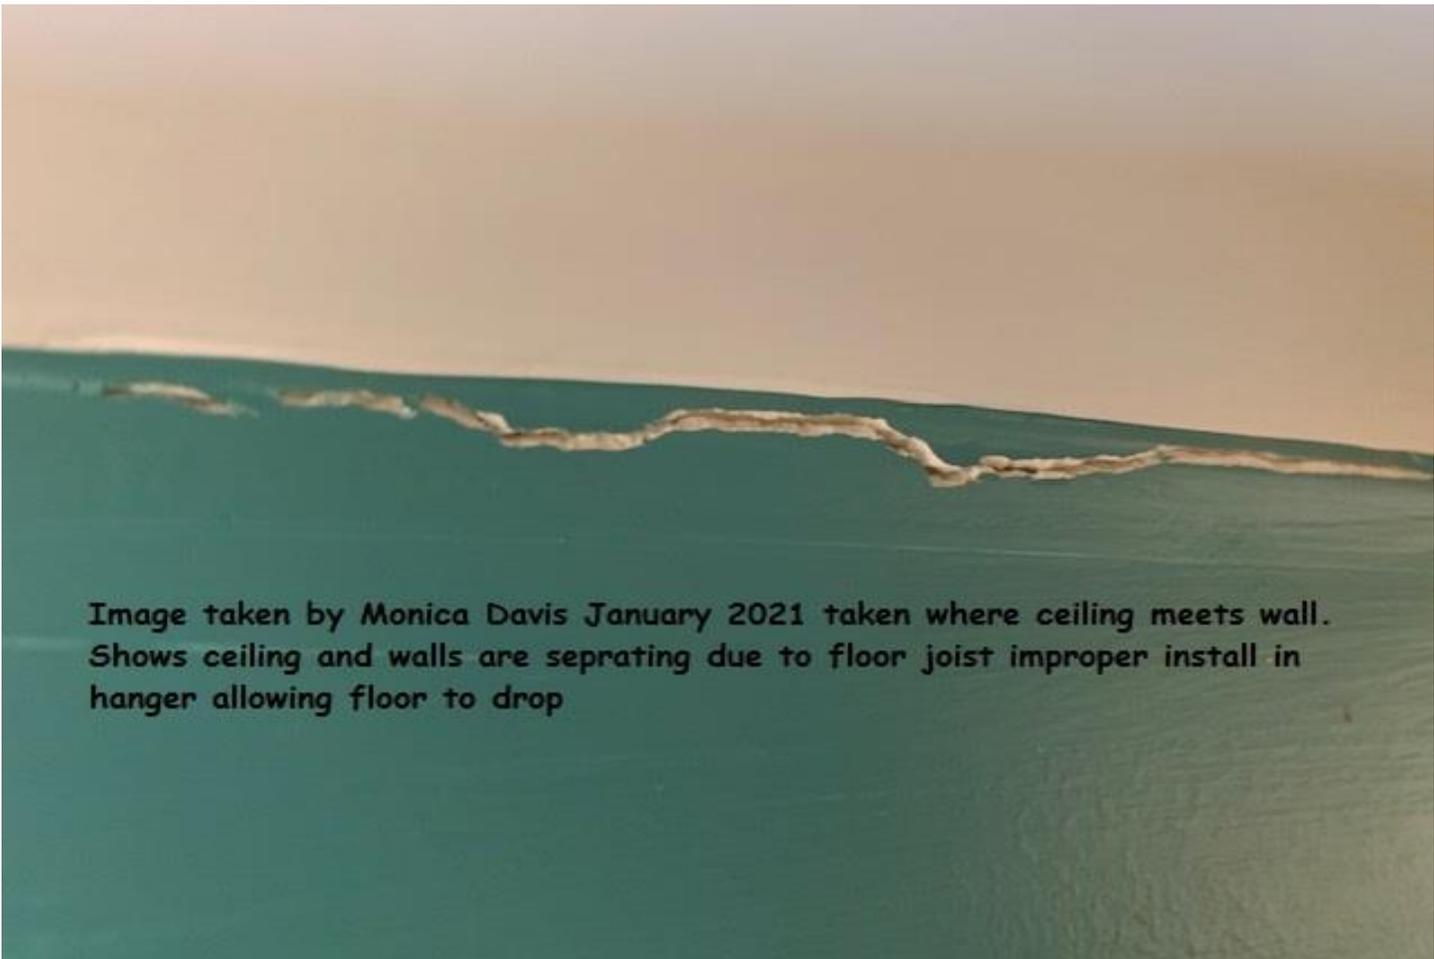
Image taken by Monica Davis January 2021 taken where ceiling meets wall. Shows ceiling and walls are separating due to floor joist improper install in hanger allowing floor to drop

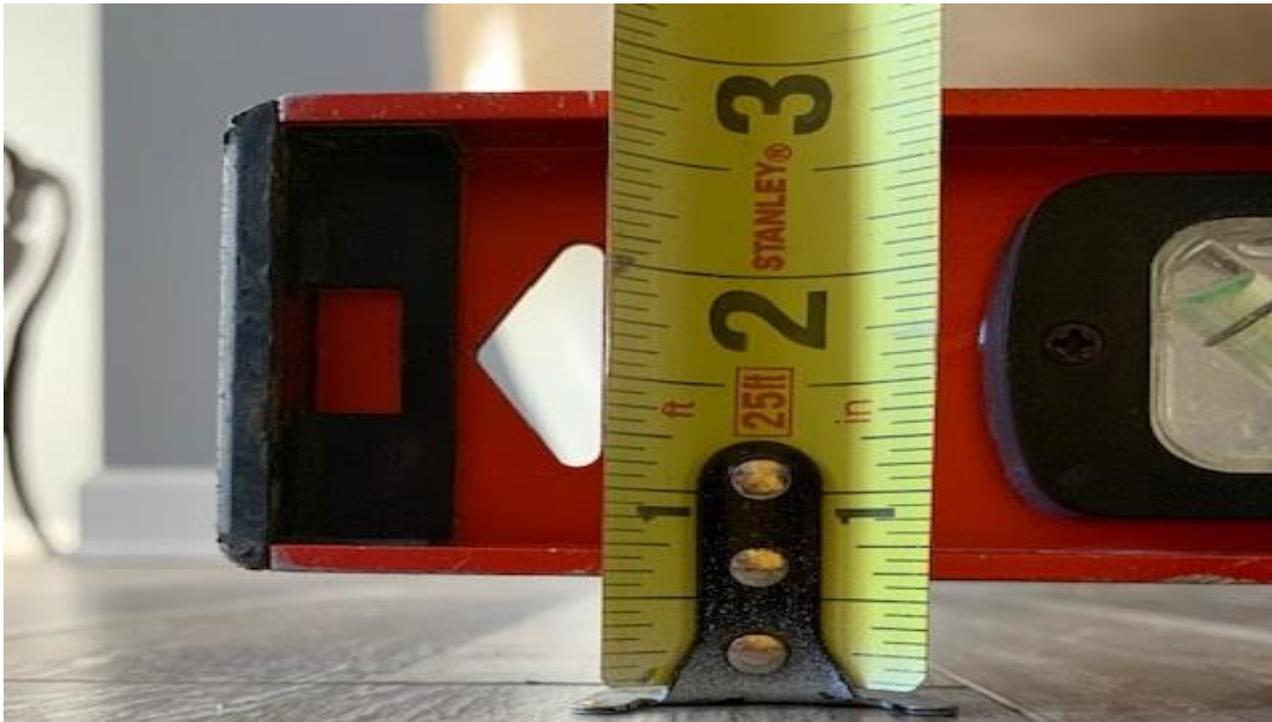
Image taken 2/16/21 by Monica Davis @ 11:56 AM. This image shows the tape measure close up in the location in the living room where the floor has dropped 5/8th of an inch

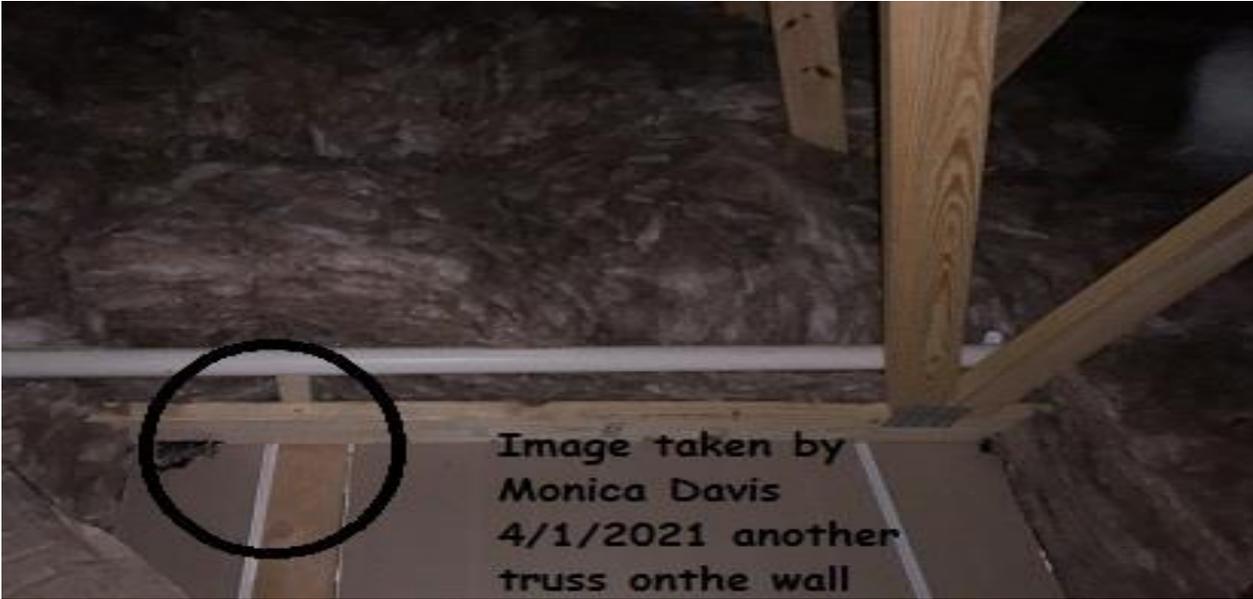
Image taken by
Monica Davis
4/1/2021 another
truss onthe wall

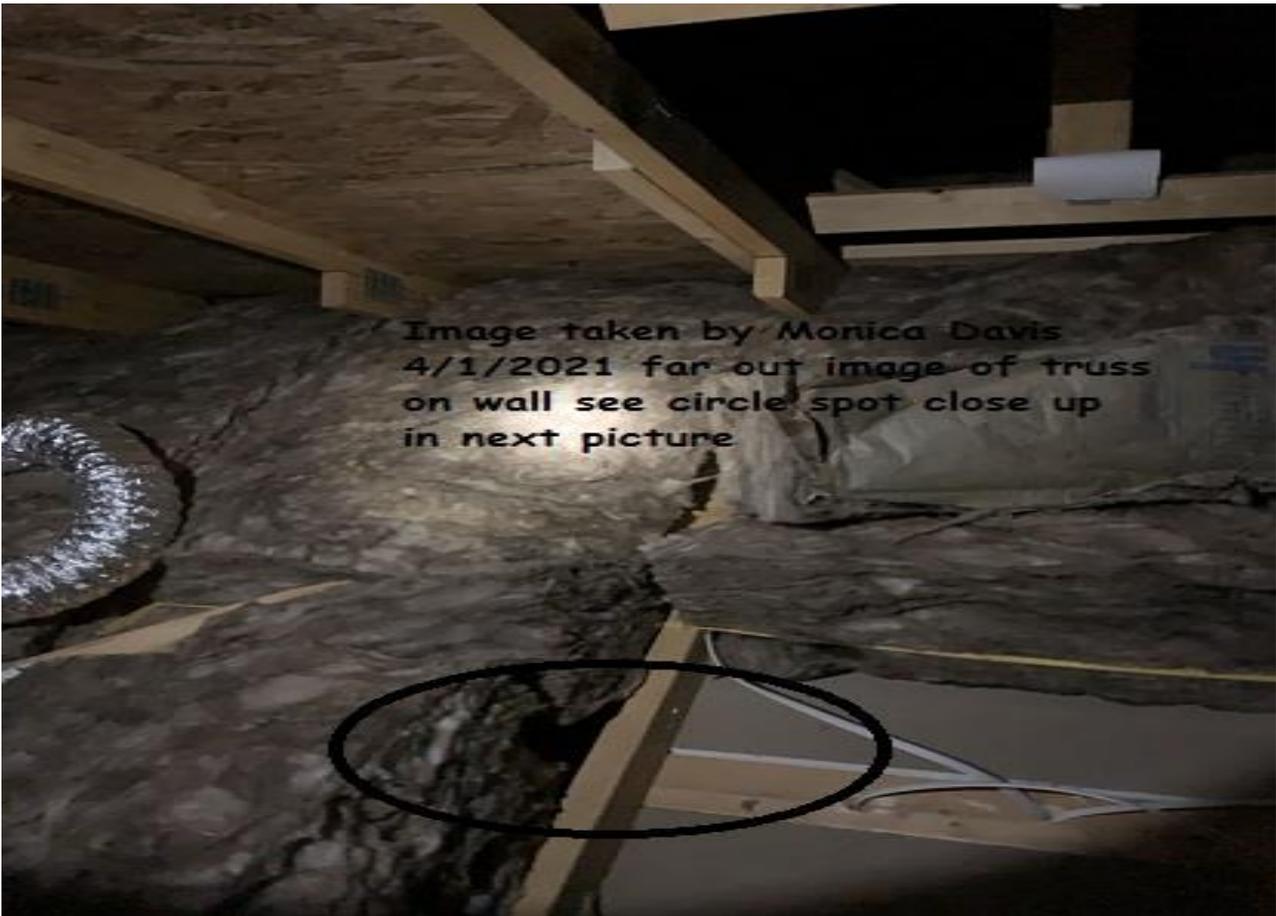
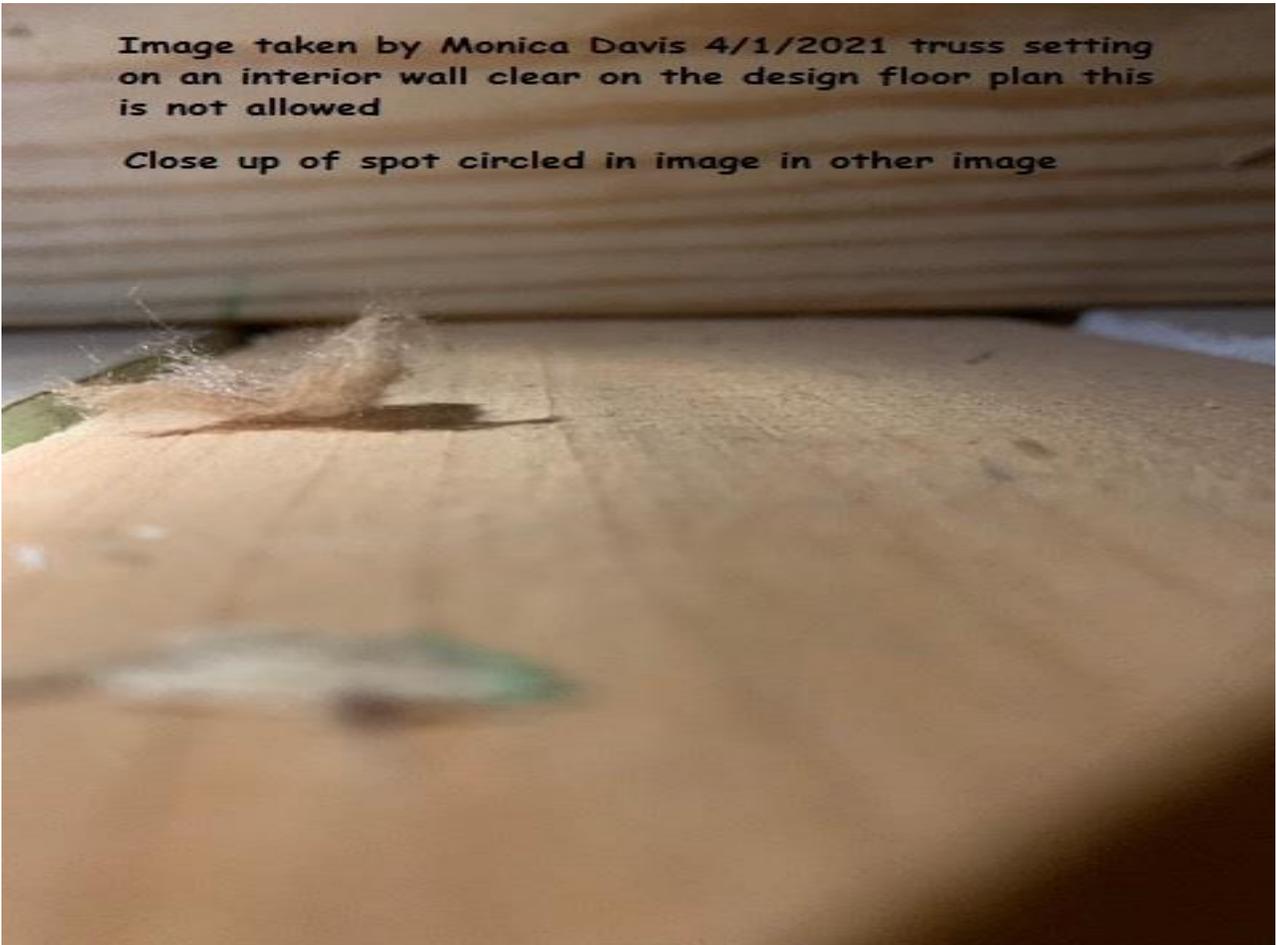
Image taken by Monica Davis 4/1/2021 show after dtwall removed LVL beam in the ceiling that belongs in the floor

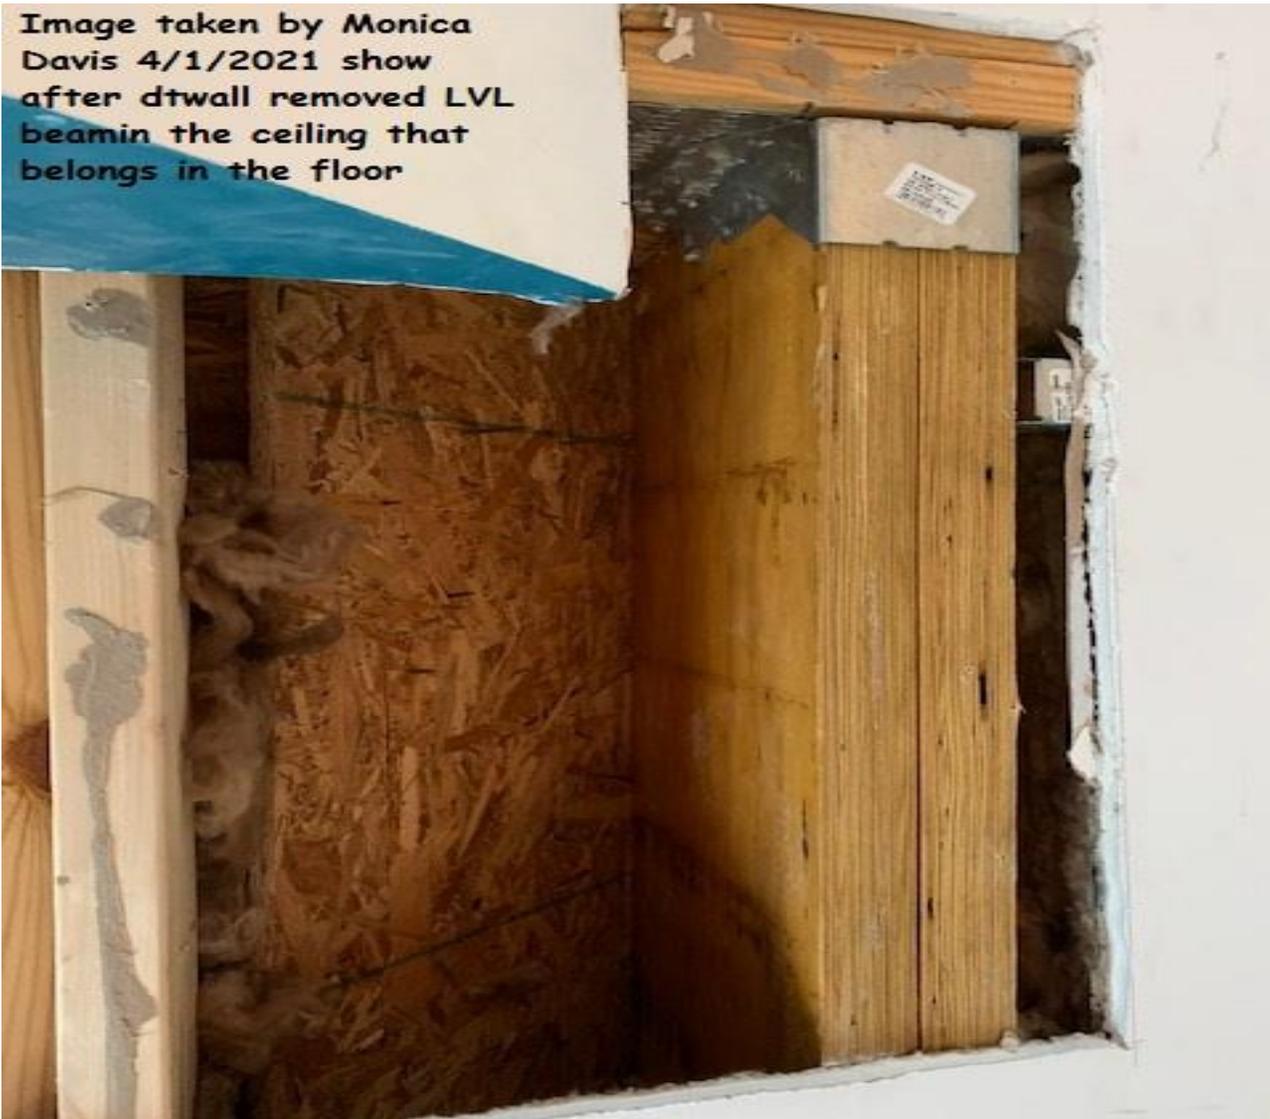
Image taken by Monica Davis 4/1/2021 gap in hanger over half of an inch

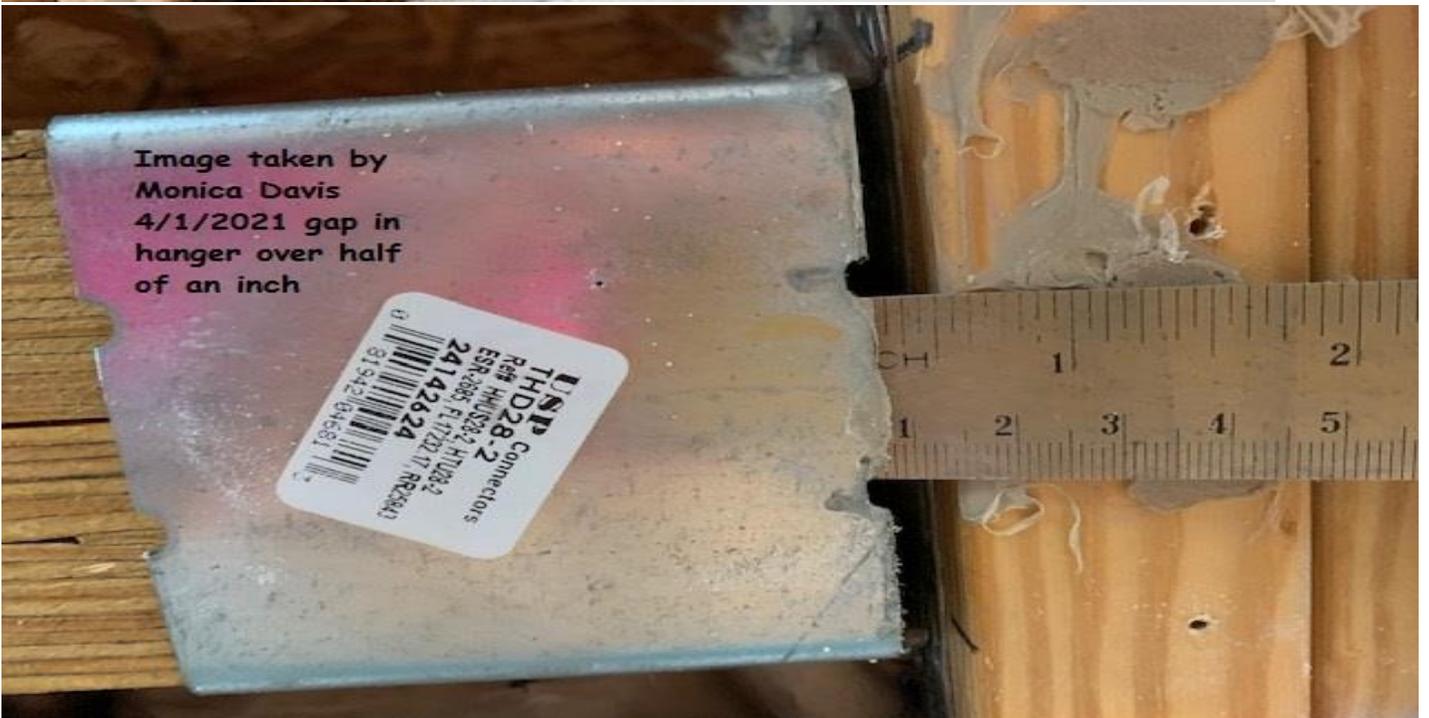
Image taken by
Monica Davis
4/1/2021 VERY
BAD gap in hager
to wood of truss
is over an inch
wide
