AGENDA

STATE BUILDING CODE TECHNICAL REVIEW BOARD

Friday, May 21, 2021 - 10:00am (Virtual Meeting)

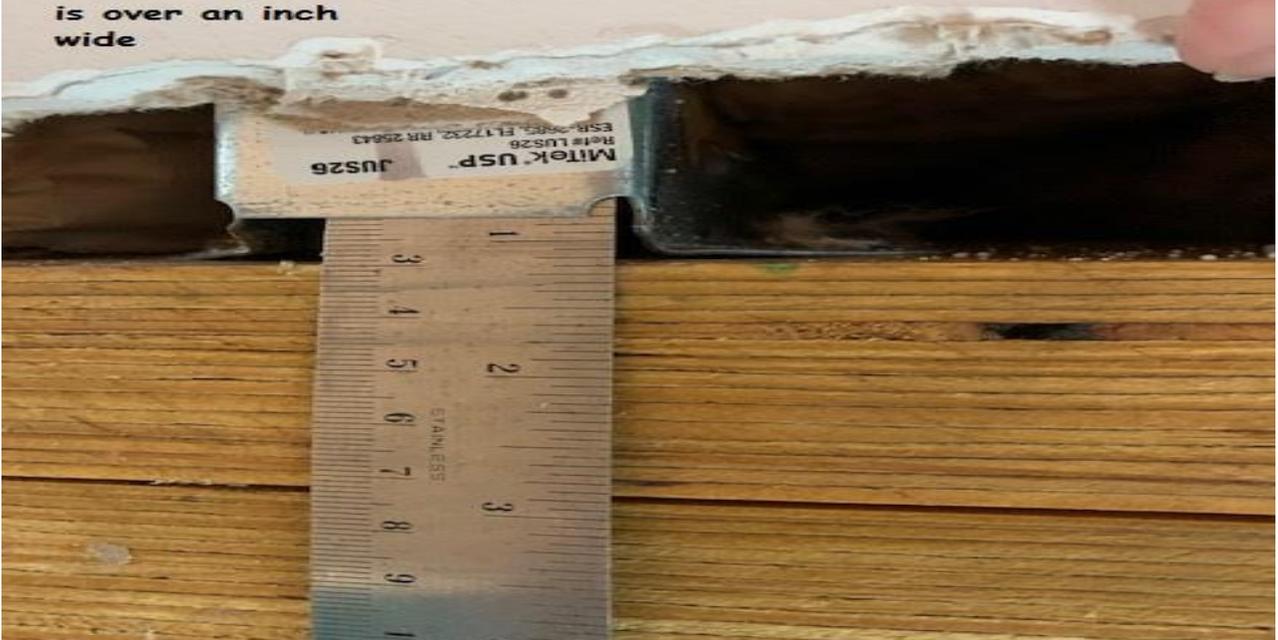
Image taken by
Monica Davis
4/1/2021 VERY
BAD gap in hager
to wood of truss
is over an inch
wide

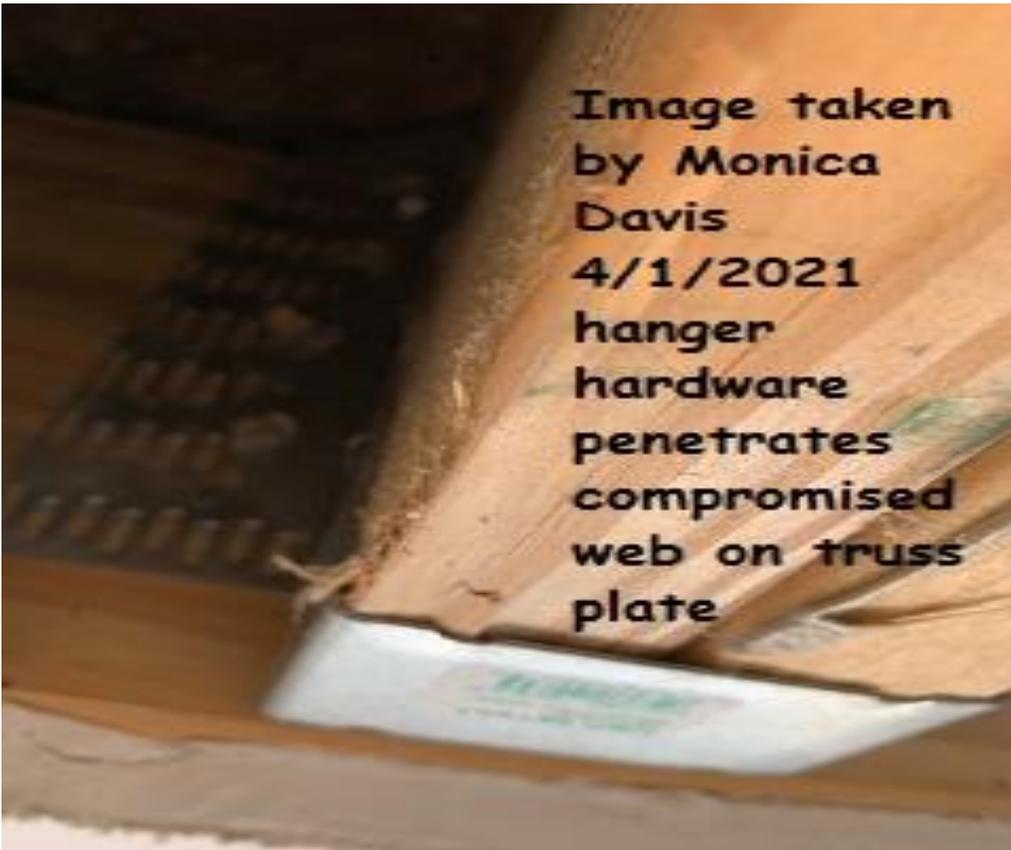
Image taken
by Monica
Davis
4/1/2021
hanger
hardware
penetrates
compromised
web on truss
plate

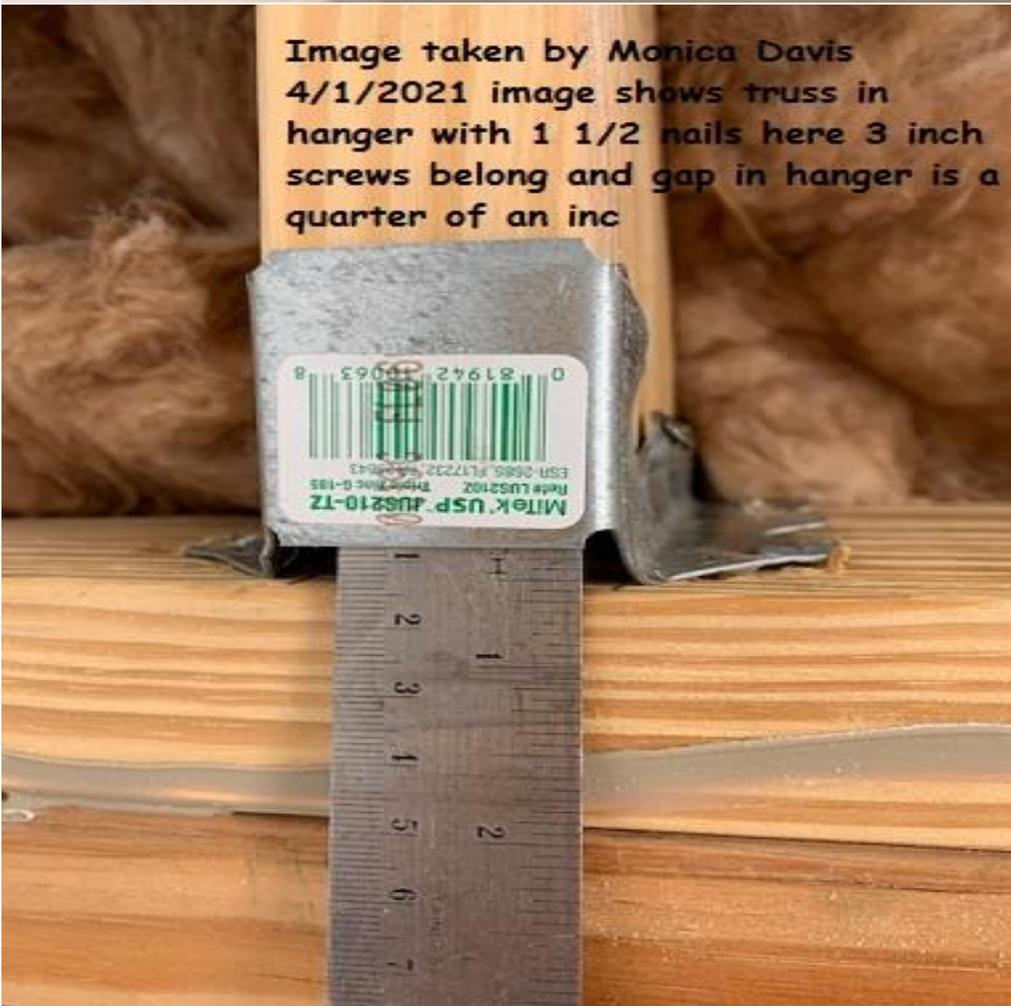
Image taken by Monica Davis
4/1/2021 image shows truss in
hanger with 1 1/2 nails here 3 inch
screws belong and gap in hanger is a
quarter of an inc

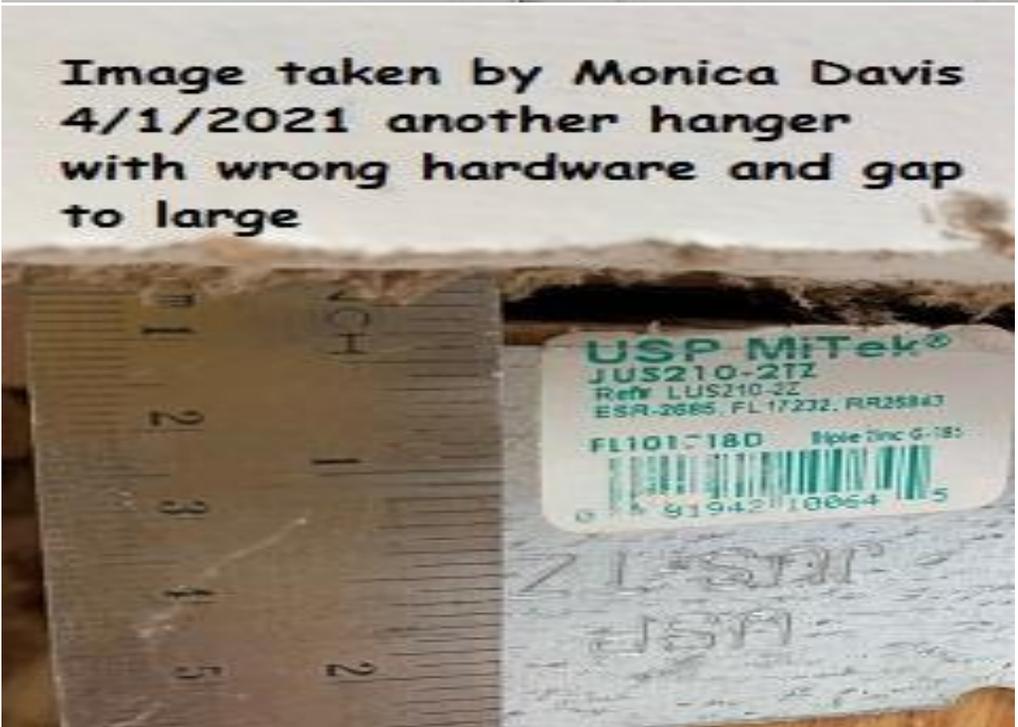
Image taken by Monica Davis
4/1/2021 another hanger
with wrong hardware and gap
to large

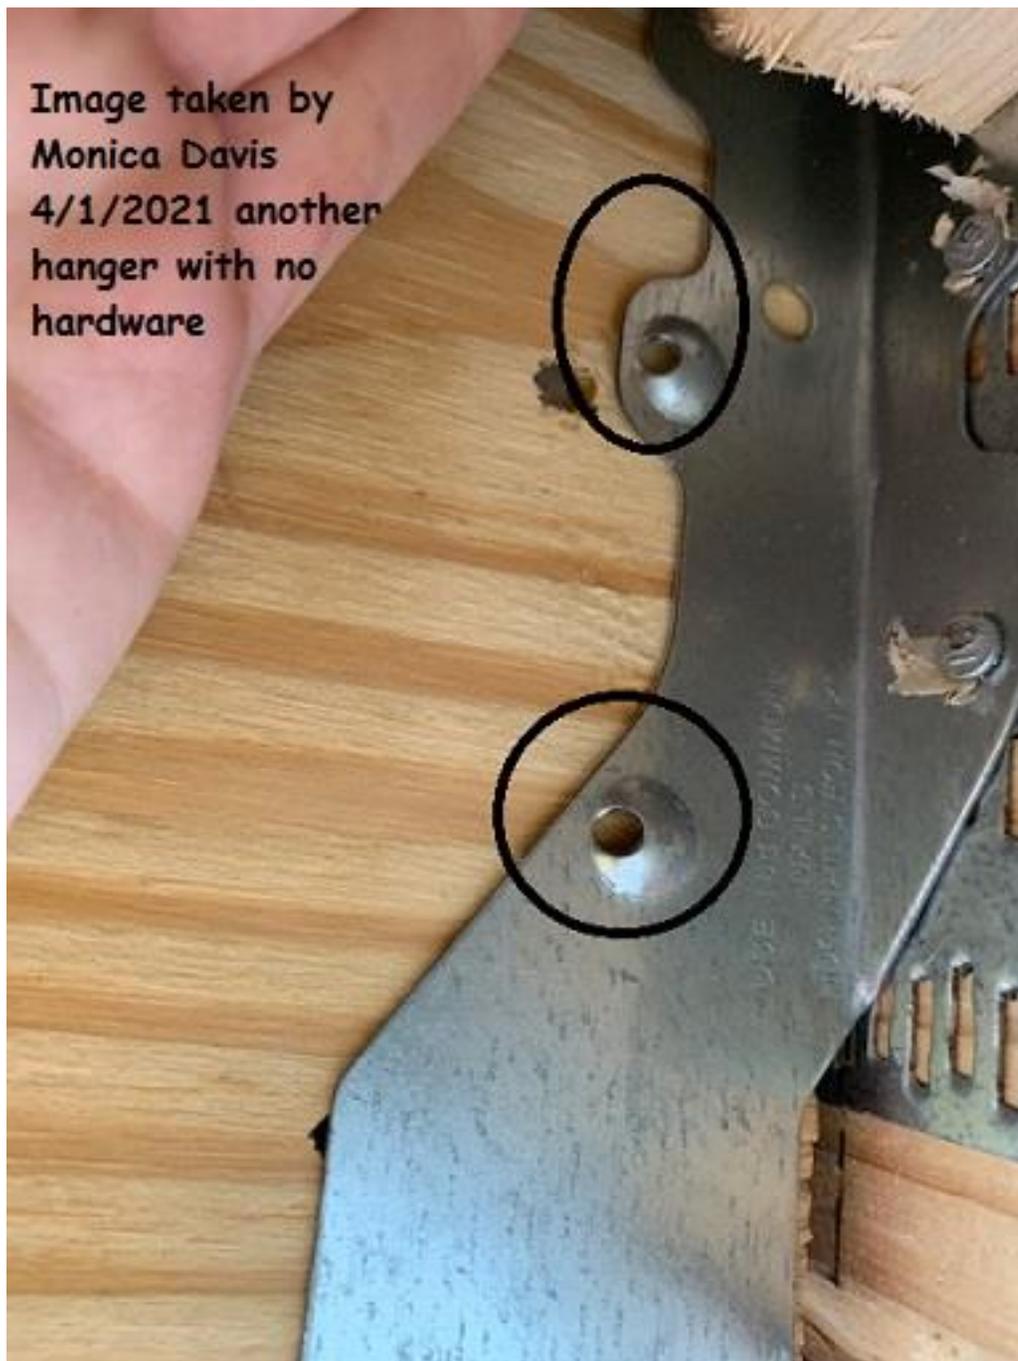
Image taken by
Monica Davis
4/1/2021 half
an inch gap in
hanger

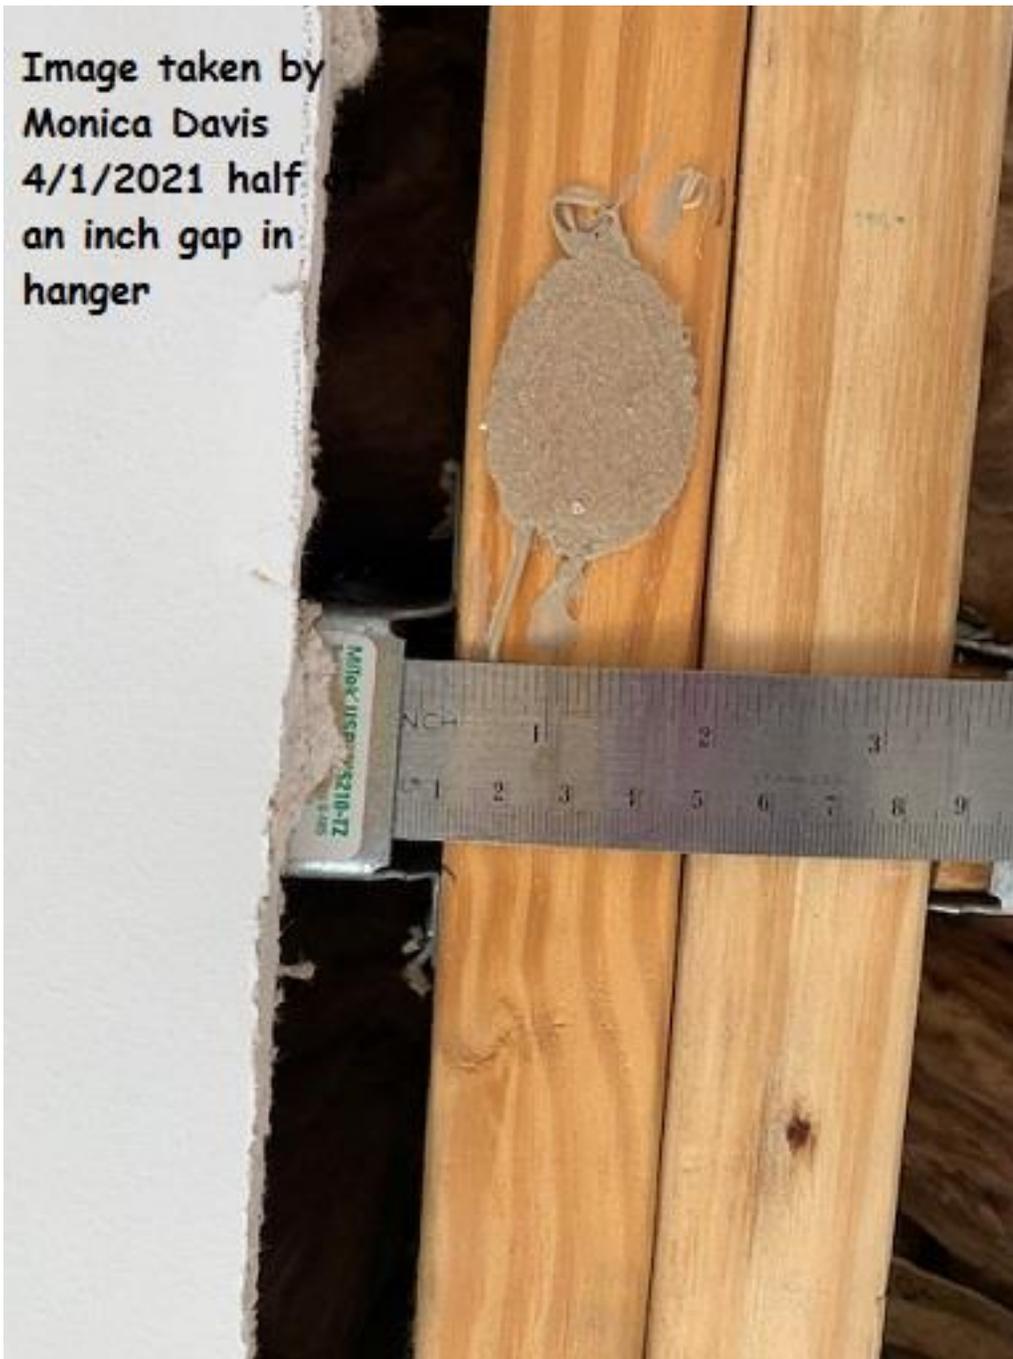
Image taken by
Monica Davis
4/1/2021 wrong
hardware again
and into web plate
of truss

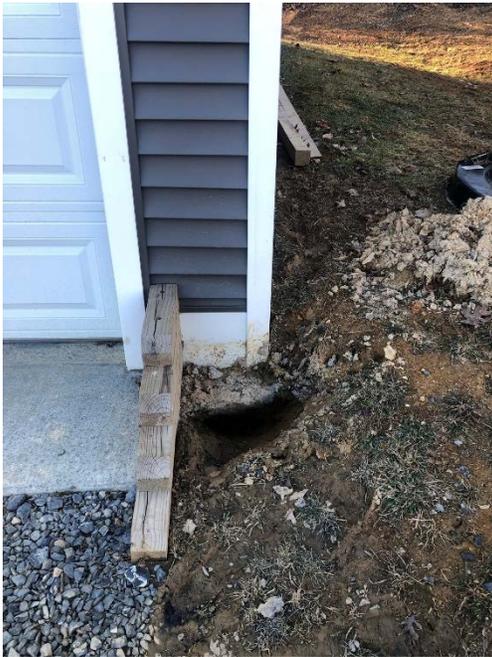
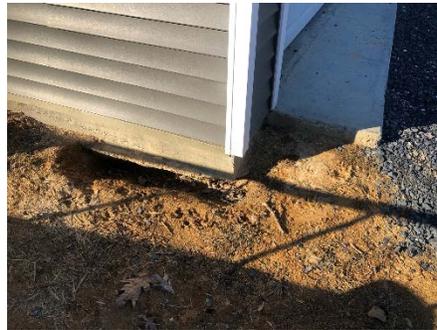
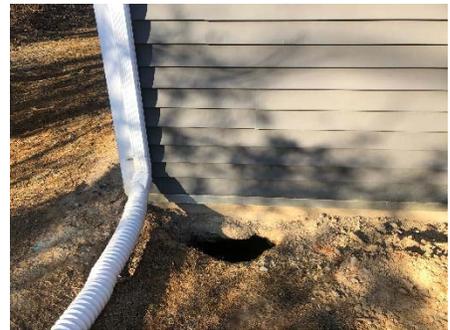
The building code is really clear on all footings need to be below frost depth. The garage footings do not meet frost depth at any of the four corners and likely all the points in between the corners along the walls. Before any work is to be done, we would appreciate the opportunity to review the proposed repair by any contractor. The proposed repair should be presented in a drawing, sealed by a Professional Engineer licensed in the Commonwealth of Virginia.

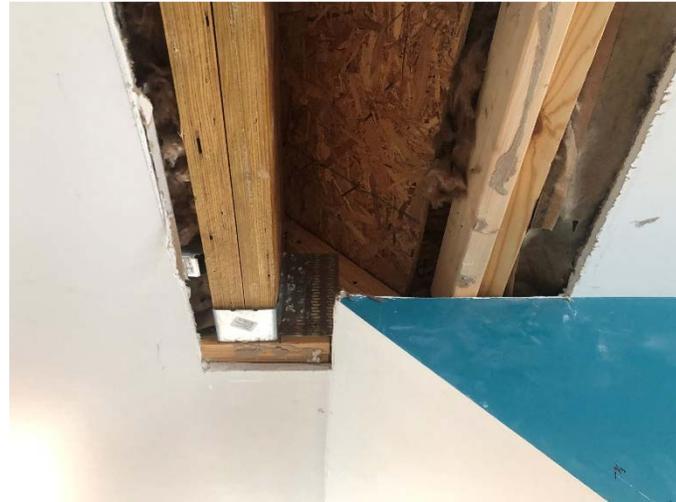
Upstairs in the Bonus Room, the framing does not appear to be consistent with the framing plan provided by the truss manufacturer. A section of drywall was removed in order for Engineering Solutions to evaluate the roof framing. An LVL beam, as shown in the picture to the right, was discovered in the roof framing that is not in the framing plan that was approved by the Augusta County Building Department. The Builder will need to provide an updated drawing sealed by a licensed Professional Engineer showing this field revision.

For the USP THD hanger that supports this LVL, the wrong nails were used. As indicated by the ESR3445 attached, the only nails approved by the ESR is 16d Common for the header nails as shown in Table 8 of the ESR on page 13. It is very clear in the picture that the nails into the header are not 16d nails. A picture of the installed nails is shown in the picture to the right.

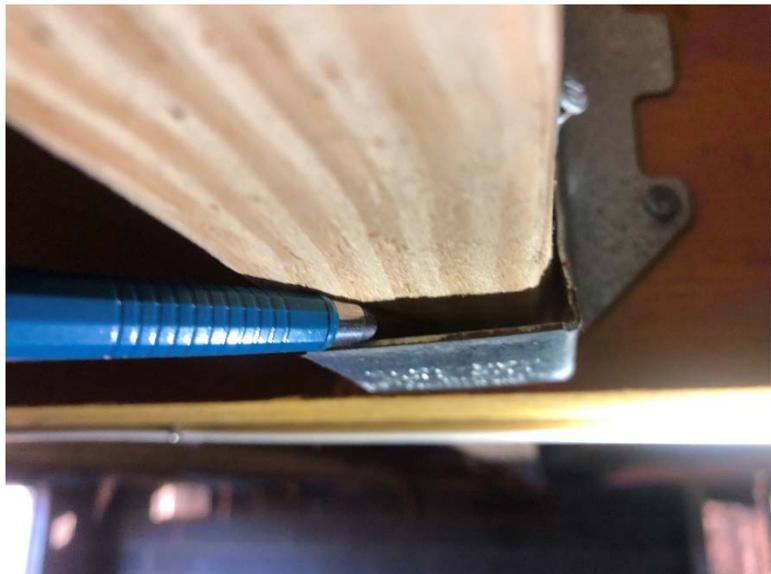
As noted earlier, some connections have too large of a gap between the face of the main member and the end of the wood member supported by the wood hanger.

In other scenarios, there are gaps between the bottom of the floor joist and the hanger. There are multiple examples of this. The floor joists will continue to move and make noises as they are not supported properly. The joist hanger manufacturer should provide a repair sealed by a Professional Engineer licensed in the Commonwealth of Virginia. The picture to the side shows one of the many hangers where this occurs.
